The Identification and Prevention of Defects on Anodized Aluminium Parts

by Ted Short, Aluminium Finishing Consultant

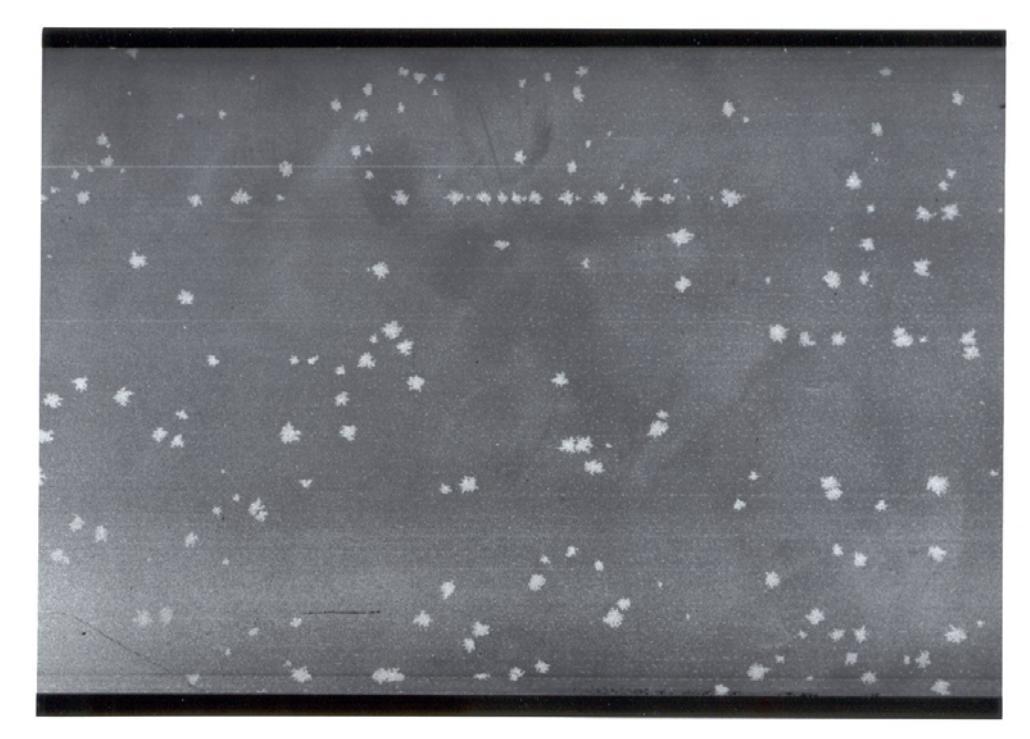
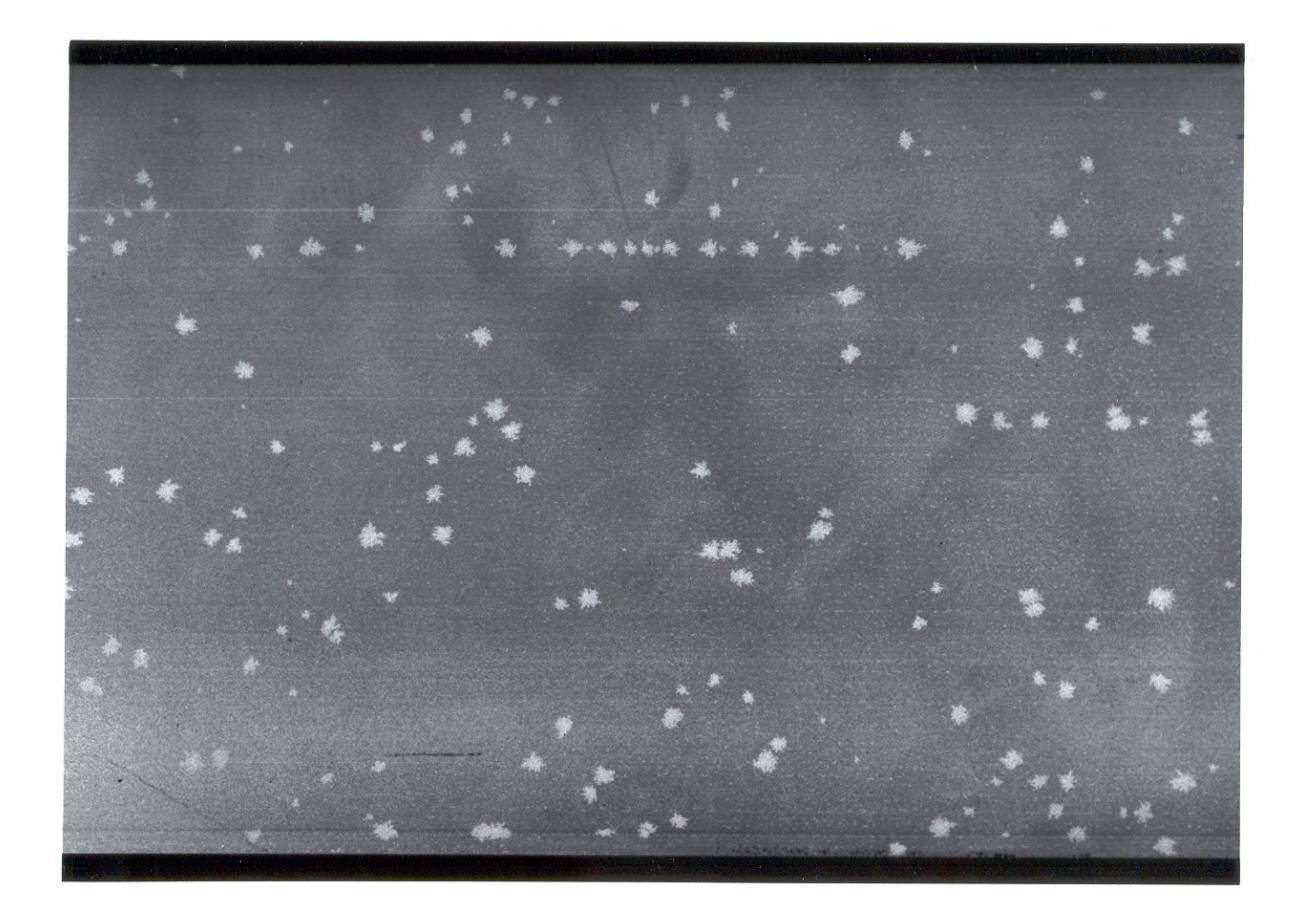
Figure 8. Rinse water corrosion illustrating white star-shaped form.

Once it is established in which rinse tank it is occurring, rinse water corrosion can be usually prevented by the addition of a small amount (0.5%) of an oxidising acid, such as nitric acid, to the offending rinse tank.

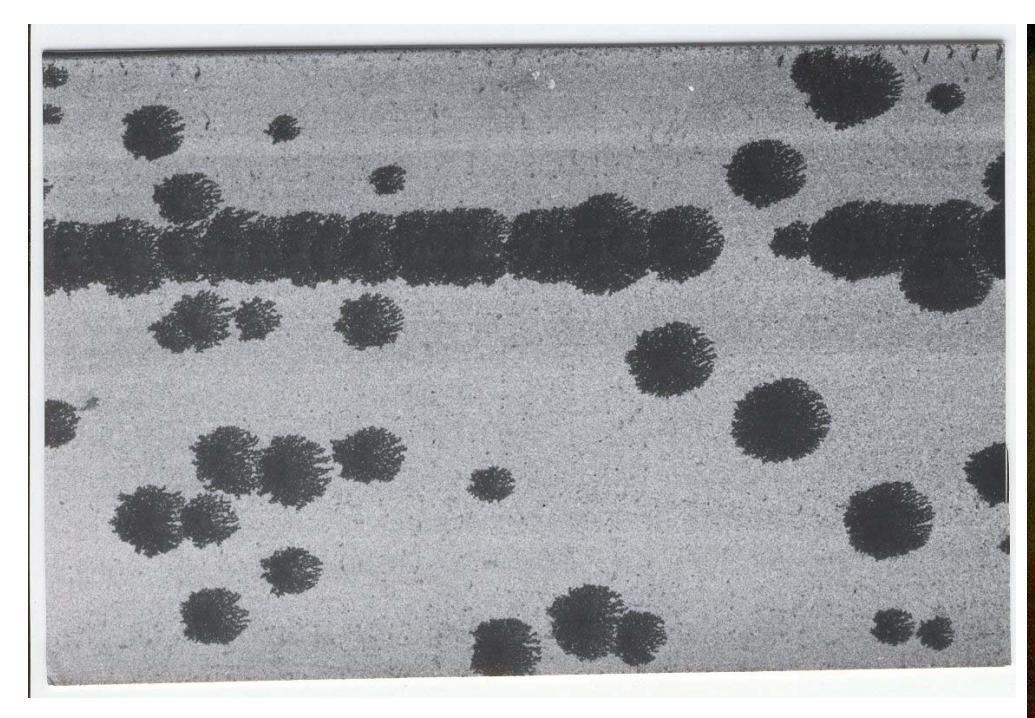
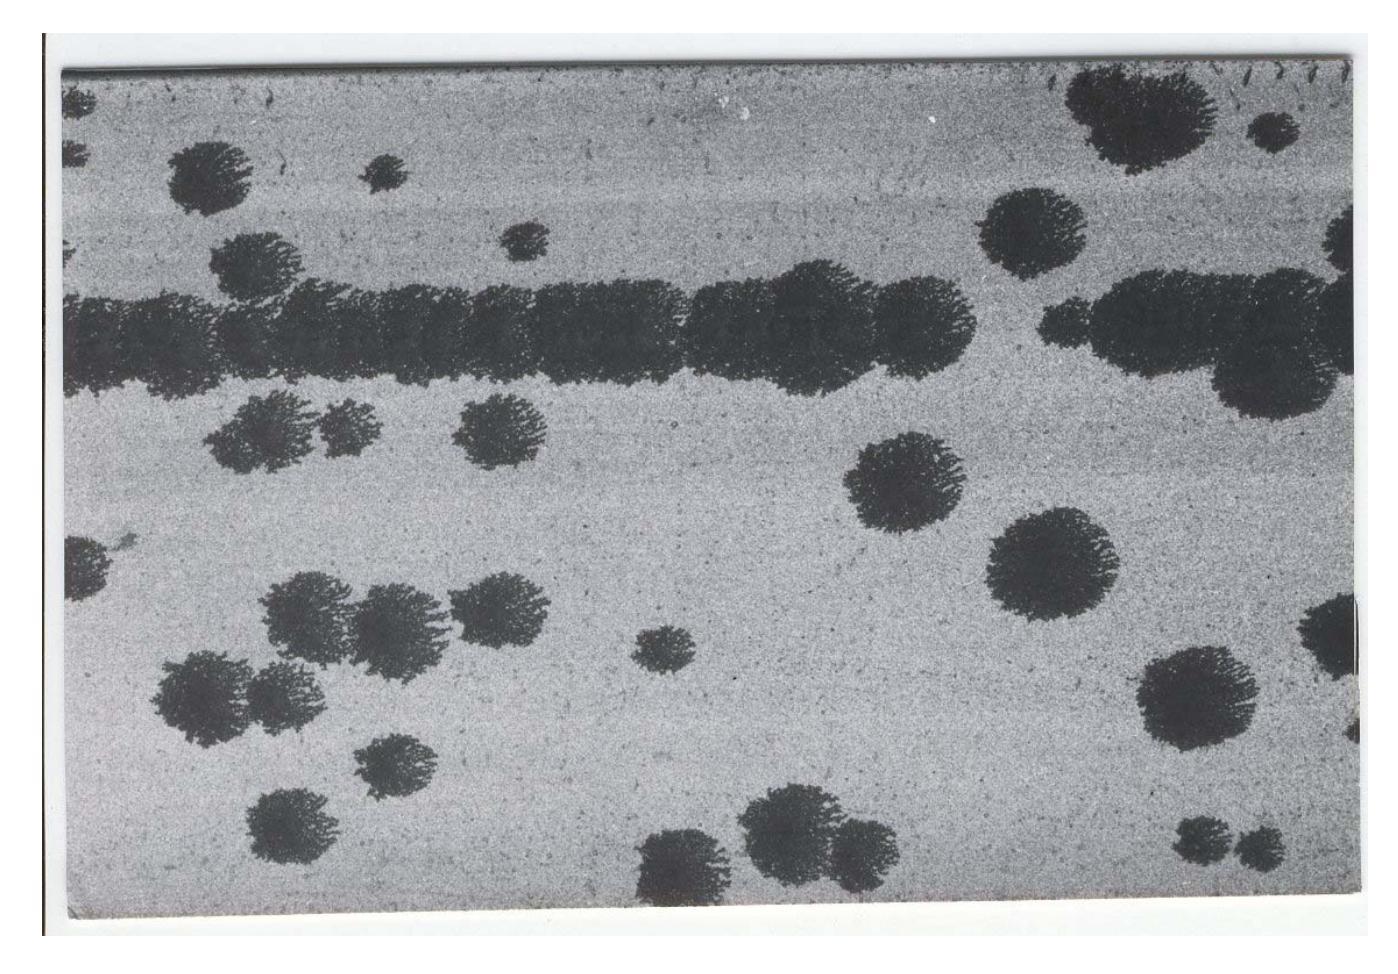
Figure 9. Rinse water corrosion illustrating black floret-shaped pits.

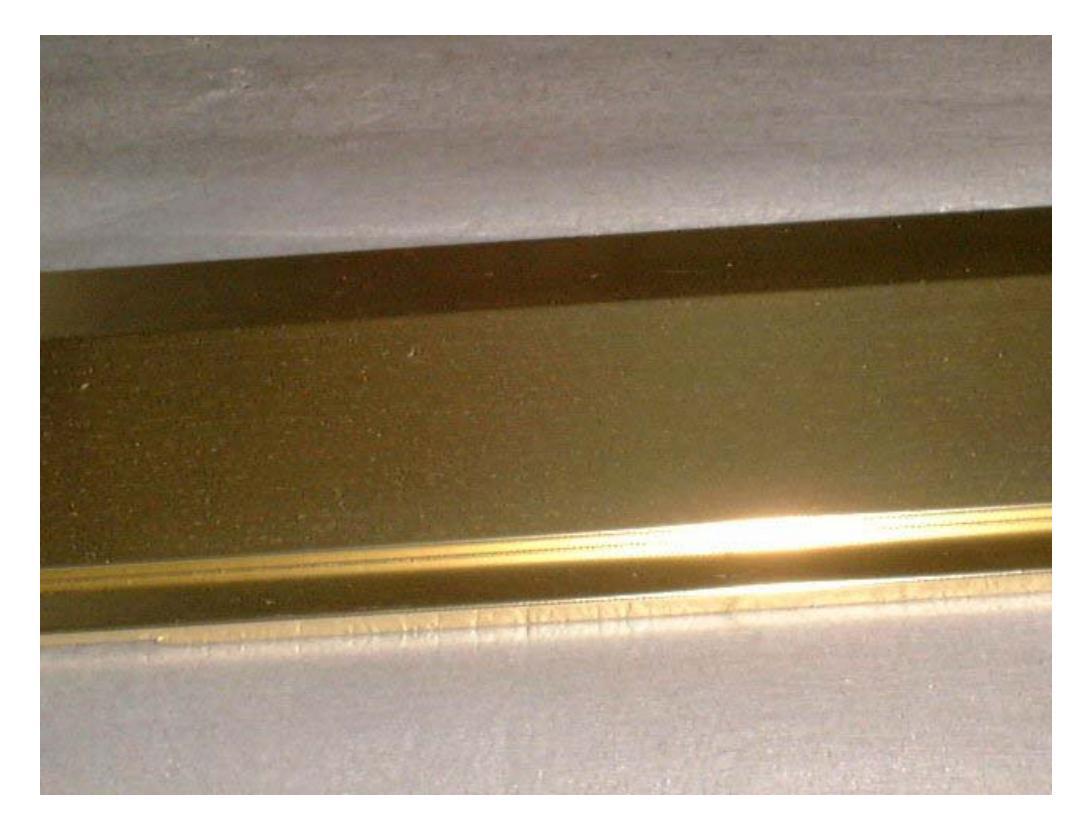
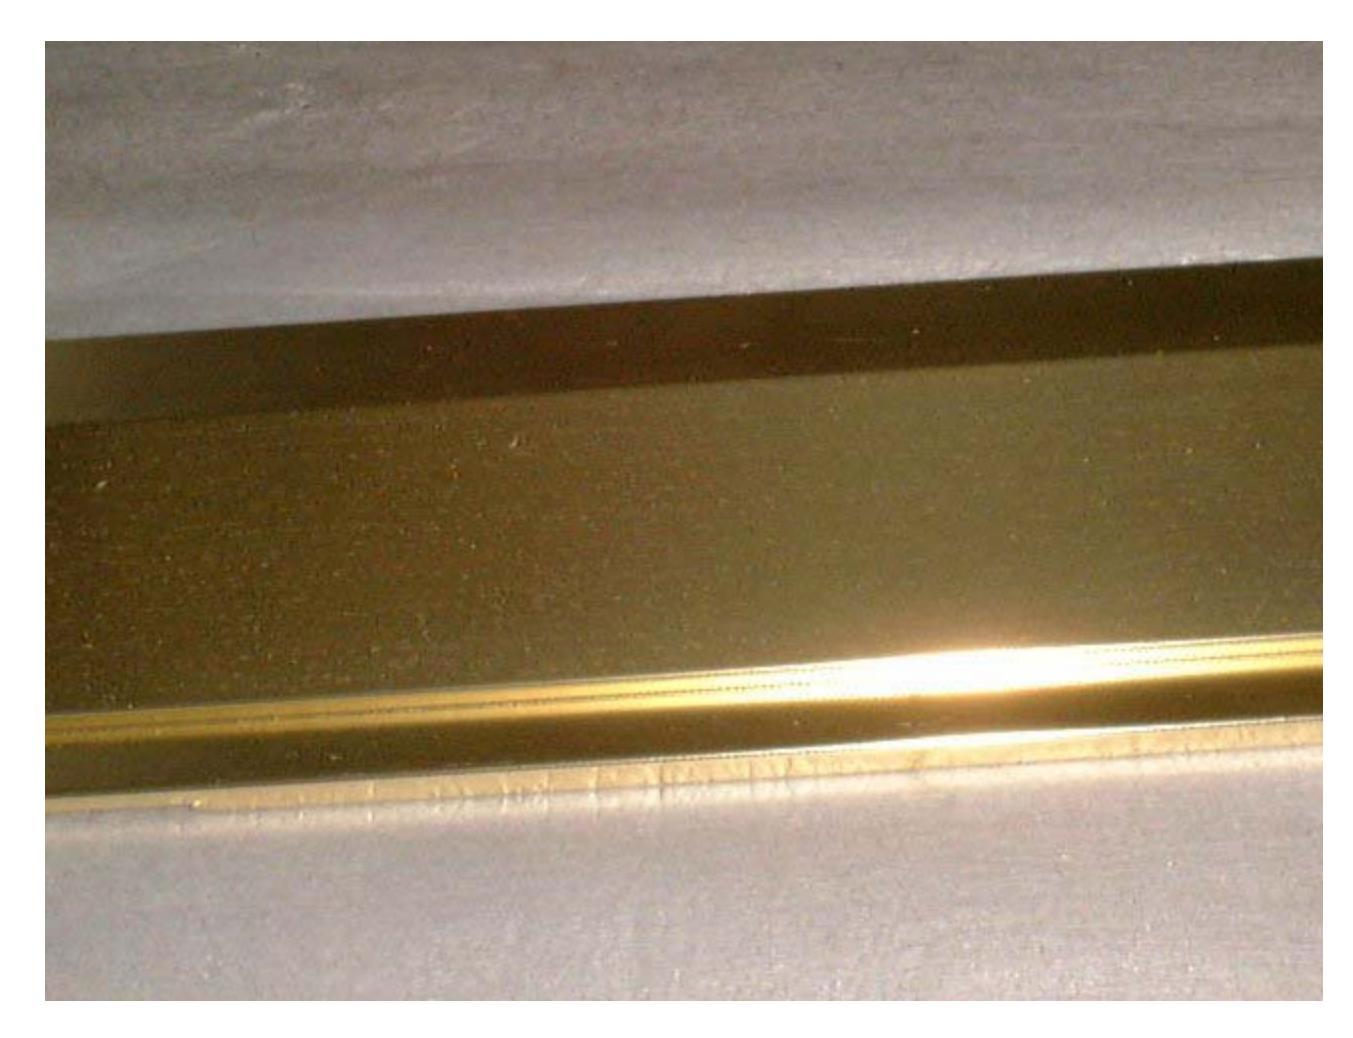
Figure 11. Very fine pitting typical of that due to an imbalance in a chemical brightening solution.

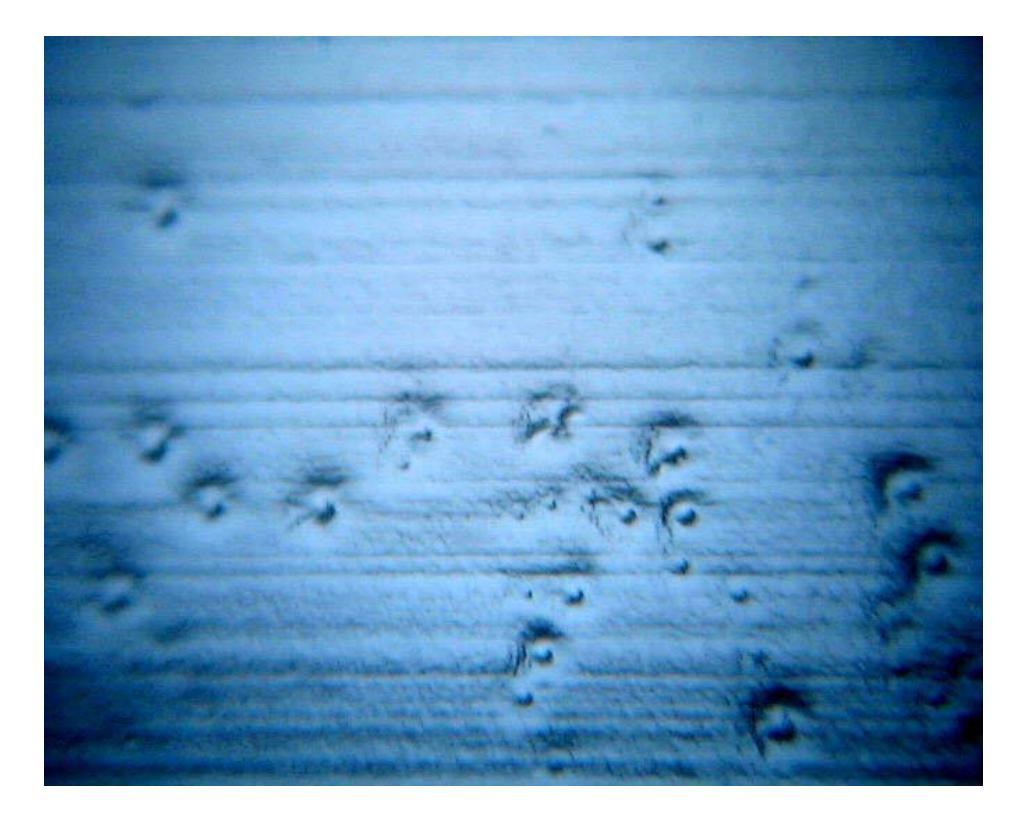
The geometry of the `castle and moat' defect is usually clearly visible under a microscope and a typical example is shown in Figure 12. Figure 13 illustrates the appearance of the same defect when viewed by the naked eye.

Figure 12. Pitting of the 'castle and moat' type. x 20

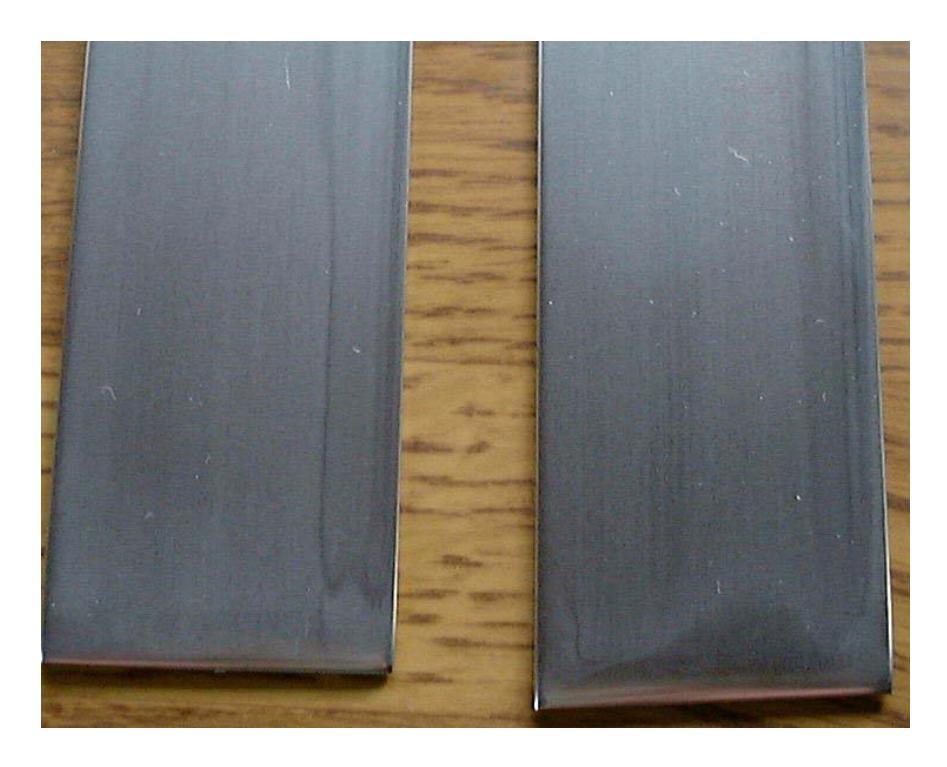
Figure 19. Example of shell zone segregational streaking after stripping the original anodic film, taper polishing the affected surface and re-etching and anodizing.

Special casting technology is available to reduce the ingot shell zone to a minimum. In the case of extrusions, any die design features that can influence metal flow during the extrusion process may increase or decrease the chances of the segregated layer being at or just under the extruded surface.

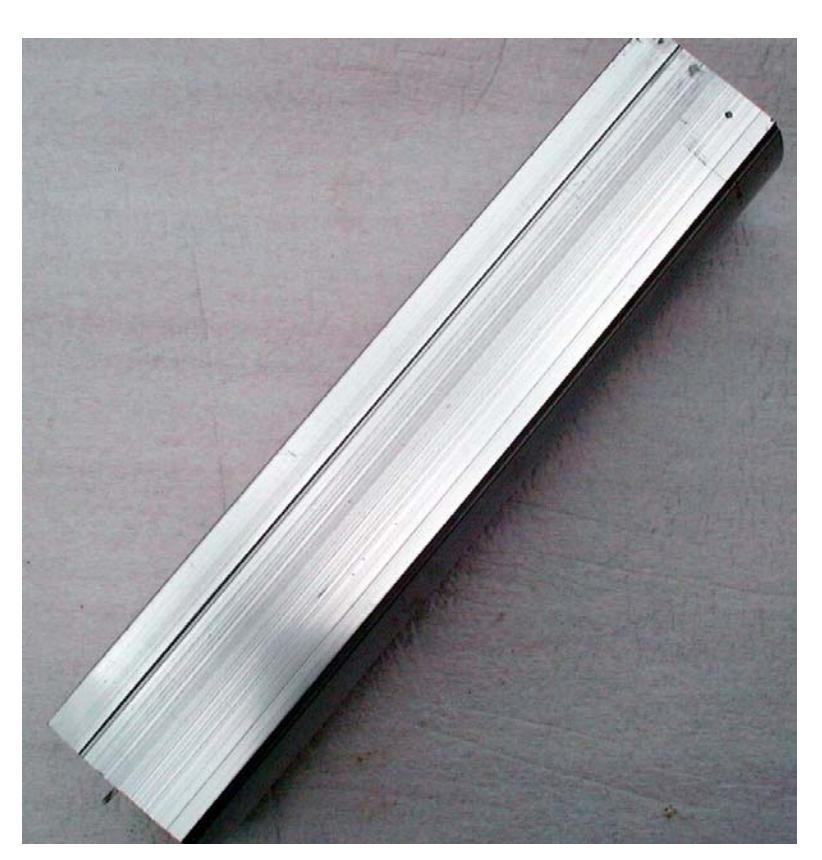
Figure 23 (right). Severe die lines showing up as darker streaks after etching and anodizing.

Usually attention to die design is required to reduce die line intensity including the nitriding of the bearing surface. Should the defect be found to vary in intensity with extrusion speed the problem might be partly due to the metallurgy of the extrusion ingot. The quality of the ingot is usually assessed in terms of its microstructure and its degree of homogenisation.

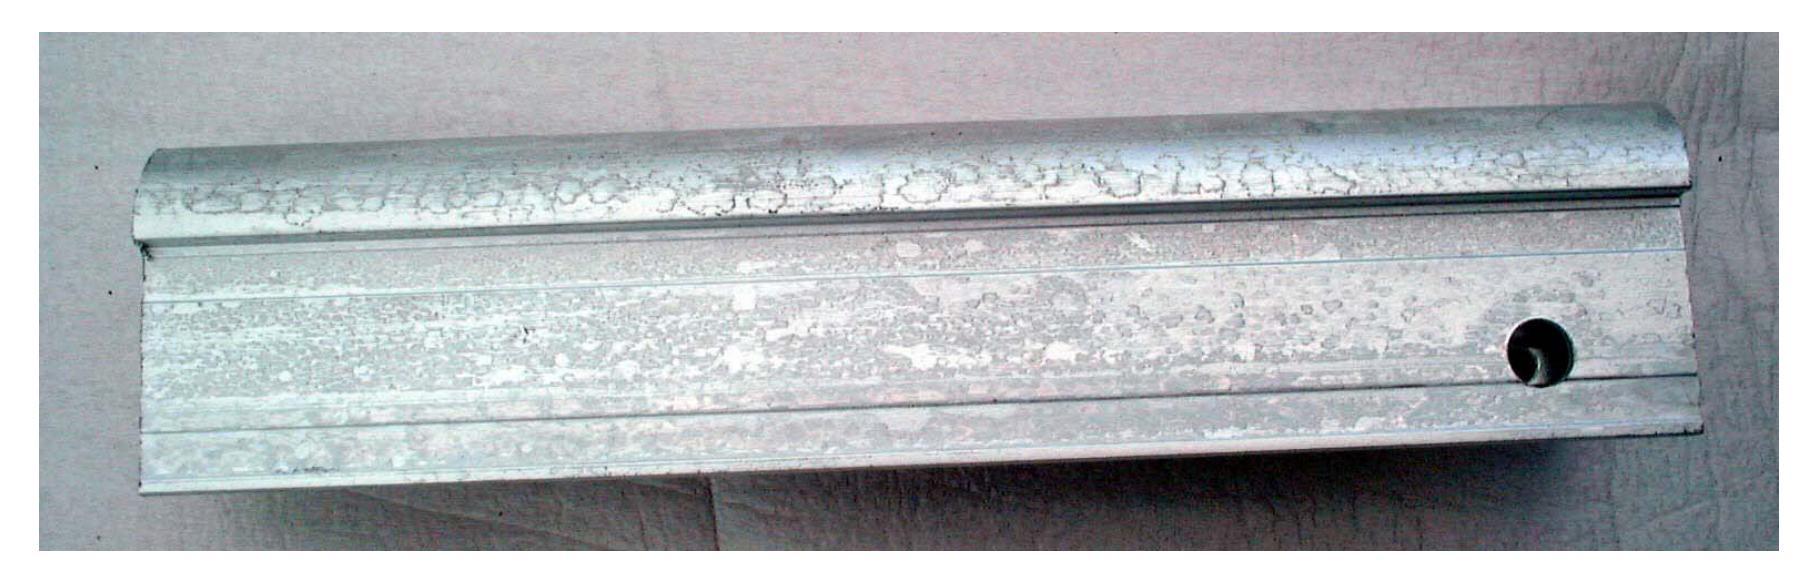
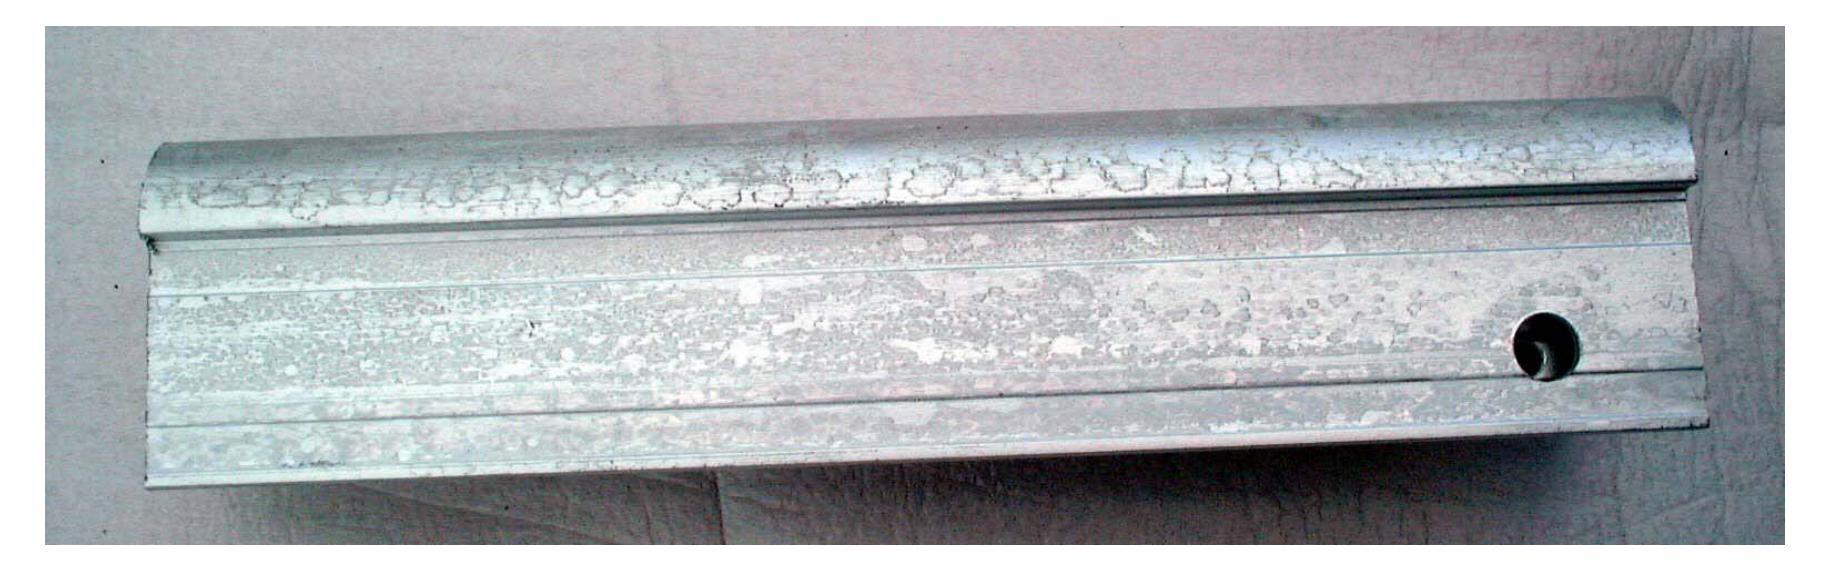
Figure 45. Effect of water staining or inadequate degreasing prior to etching.

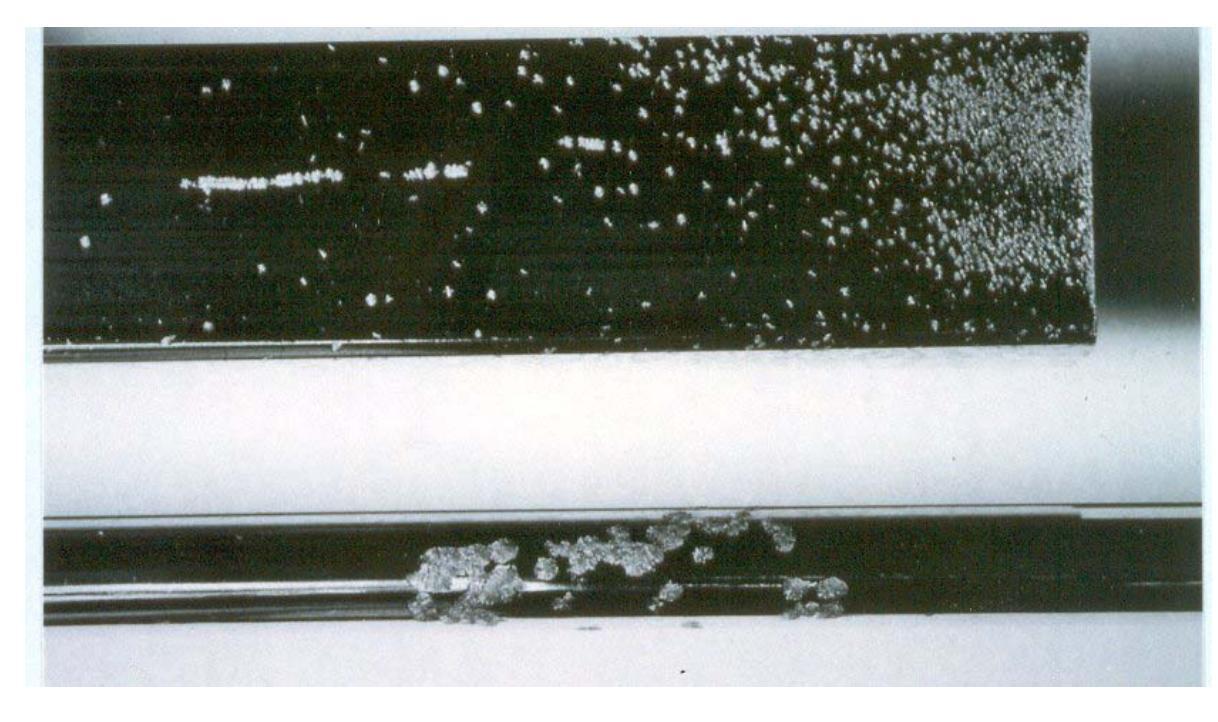
The name, barnacling, has been given to a defect that can occur in chemical brightening solutions containing phosphoric acid. Multi-faceted crystals, about 25µm in height, form on the surface of the brightened part during the brightening process. Typical examples of these crystals are shown in Figure 56. They are in fact crystals of aluminium phosphate and only form when the water content of the brightening solution is too low.

Figure 56. Barnacling on a sample of chemically brightened 6463 alloy.

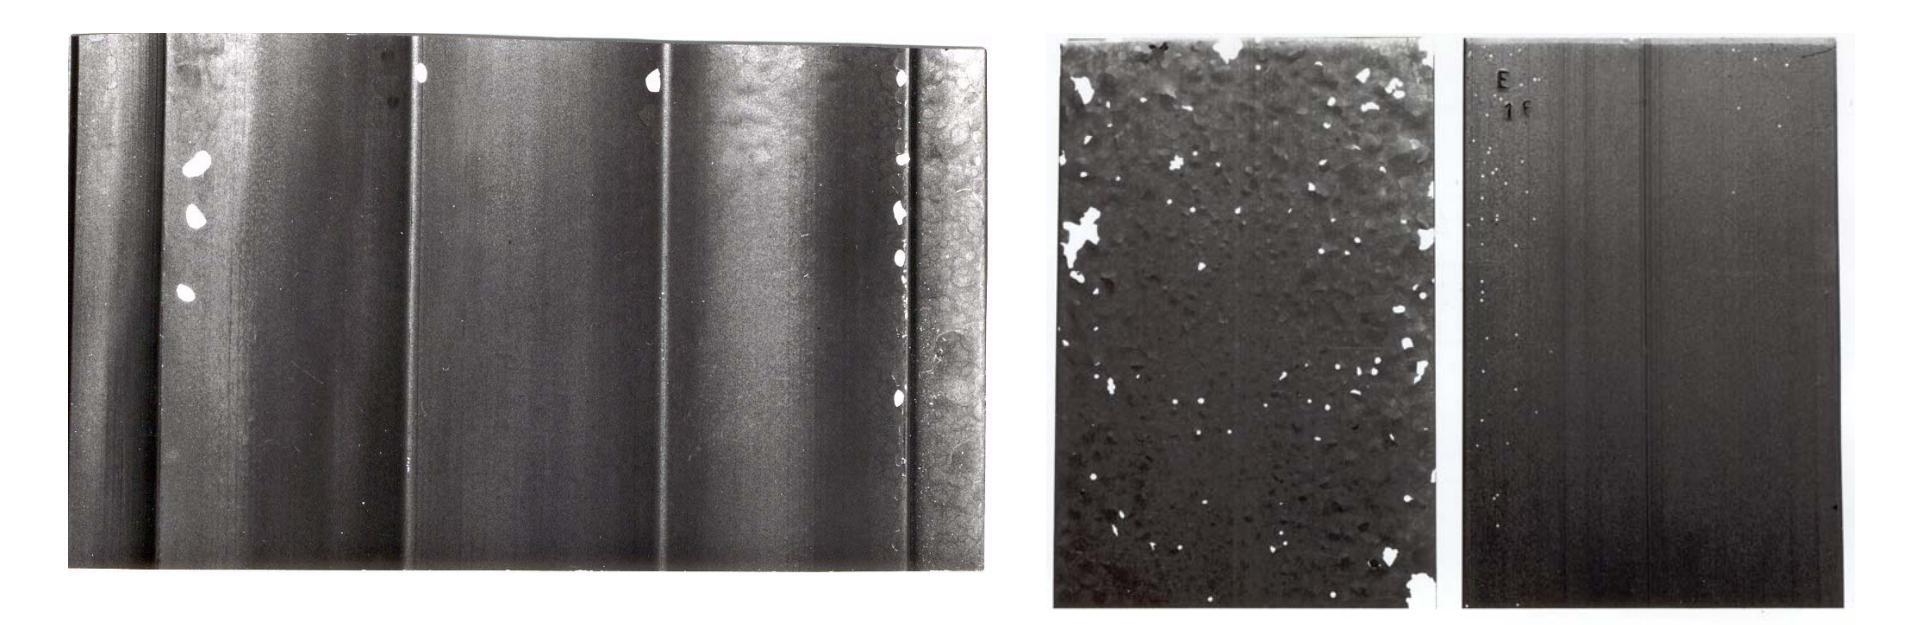
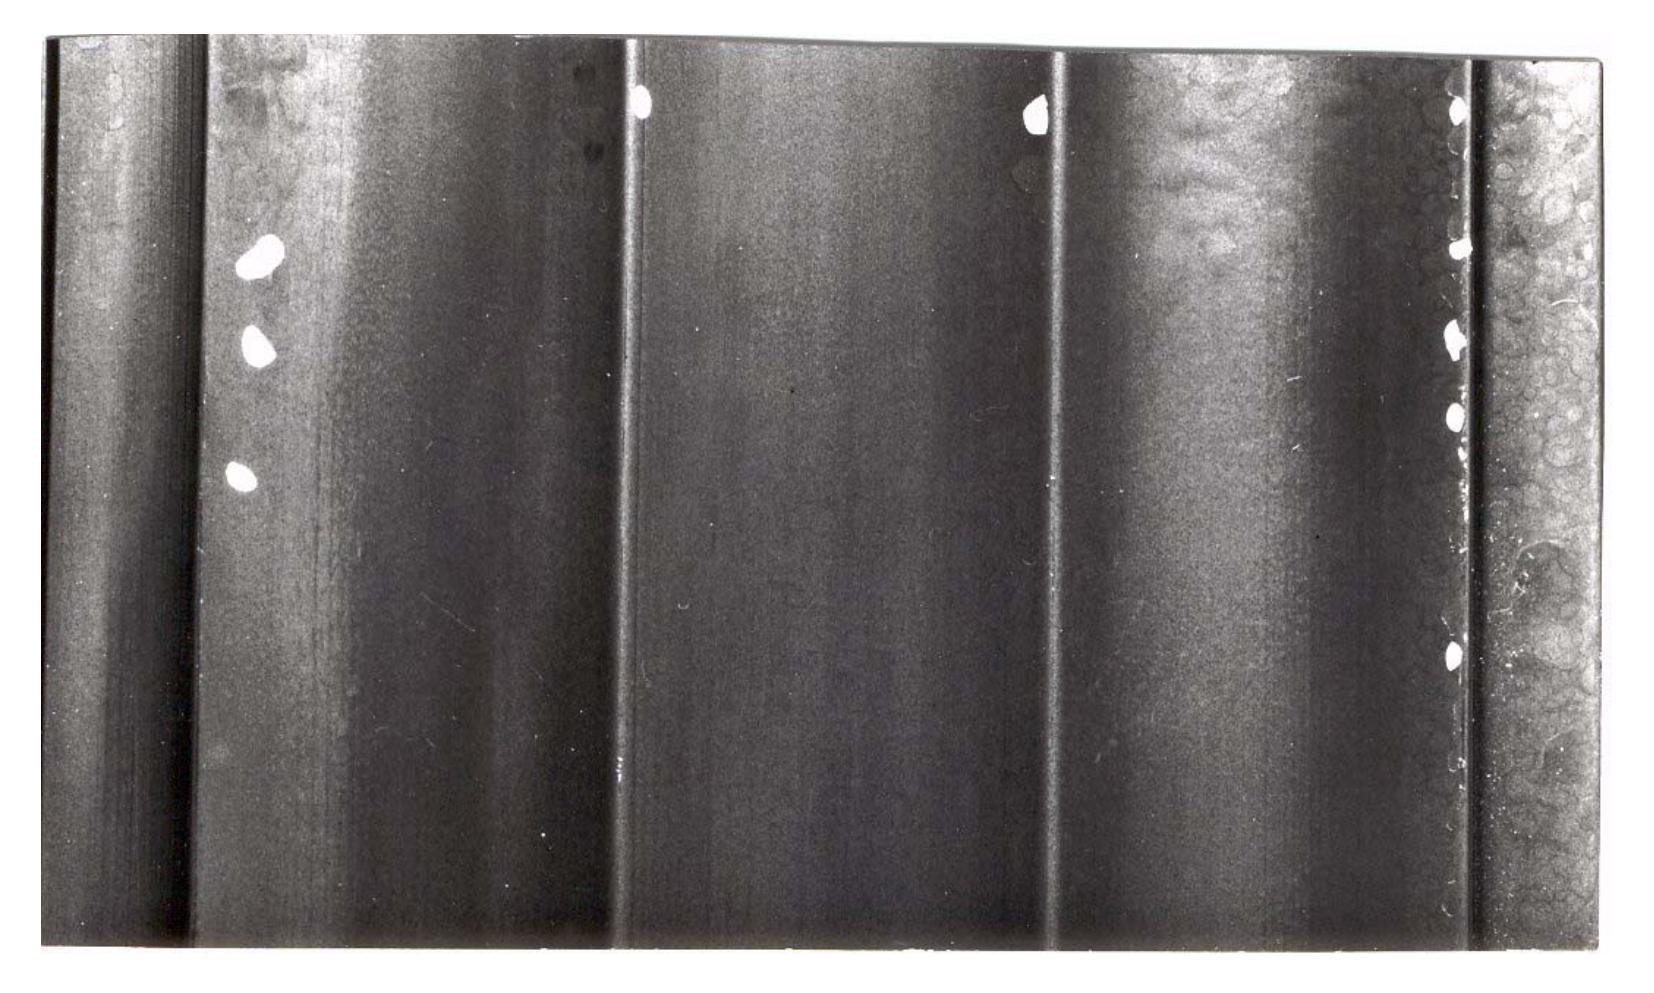
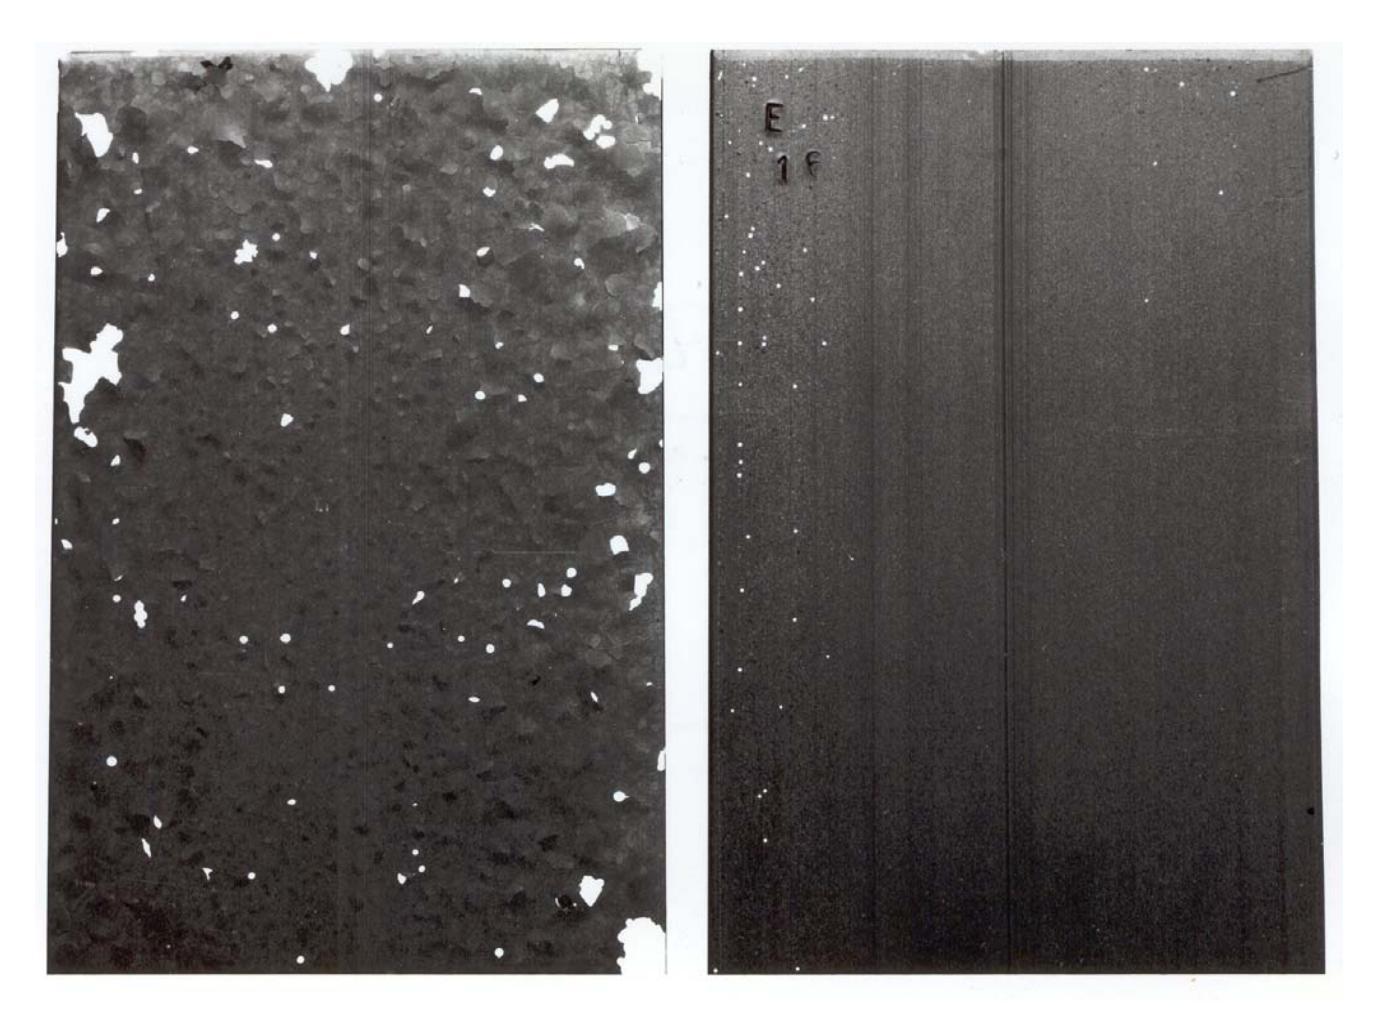
Electrolytically coloured anodic films can be susceptible to spalling. This is a detachment of the anodic film that may occur in the colouring solution or the during the hydrothermal sealing process which follows. Examples of the problem have also been observed in service, although this is very rare and usually only associated with aluminium high-magnesium (2.5% or higher) alloys. The problem is relatively unusual and does not occur when the correct voltage-time programmes and rate of voltage-change, are adhered to. Colouring electrolytes based on nickel and cobalt salts are more prone to this defect than those based on tin salts. Contamination of nickel and cobalt colouring electrolytes with sodium ions can cause spalling as well as difficulty in obtaining dark bronze and black shades. Anything that results in excessive hydrogen evolution at the metal/oxide interface, such as too high a colouring voltage, high sodium content in the colouring electrolyte or high colouring electrolyte temperatures, can produce spalling. Sometimes inclusions in the base metal can cause spalling but they are usually more likely to result in the defects described in sections 2g and 2i. Spalling is quite variable in terms of the size of the areas of detachment as can be seen in Figure 66.

Figure 66. Various forms of spalling on a 6063 electrolytically coloured extrusion caused by colouring at too high a voltage.

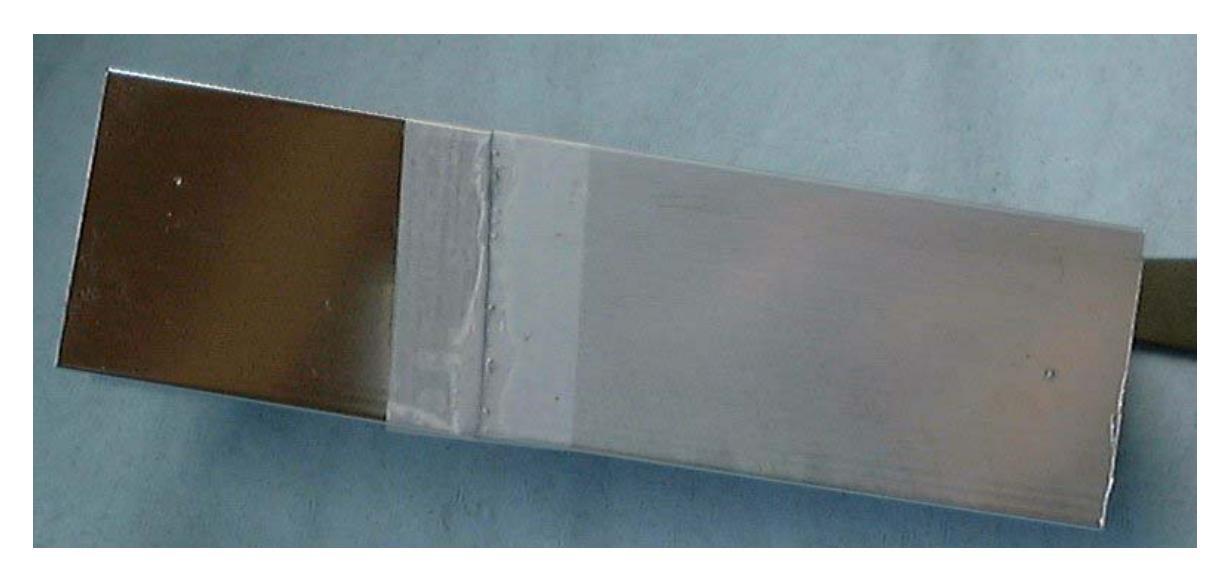
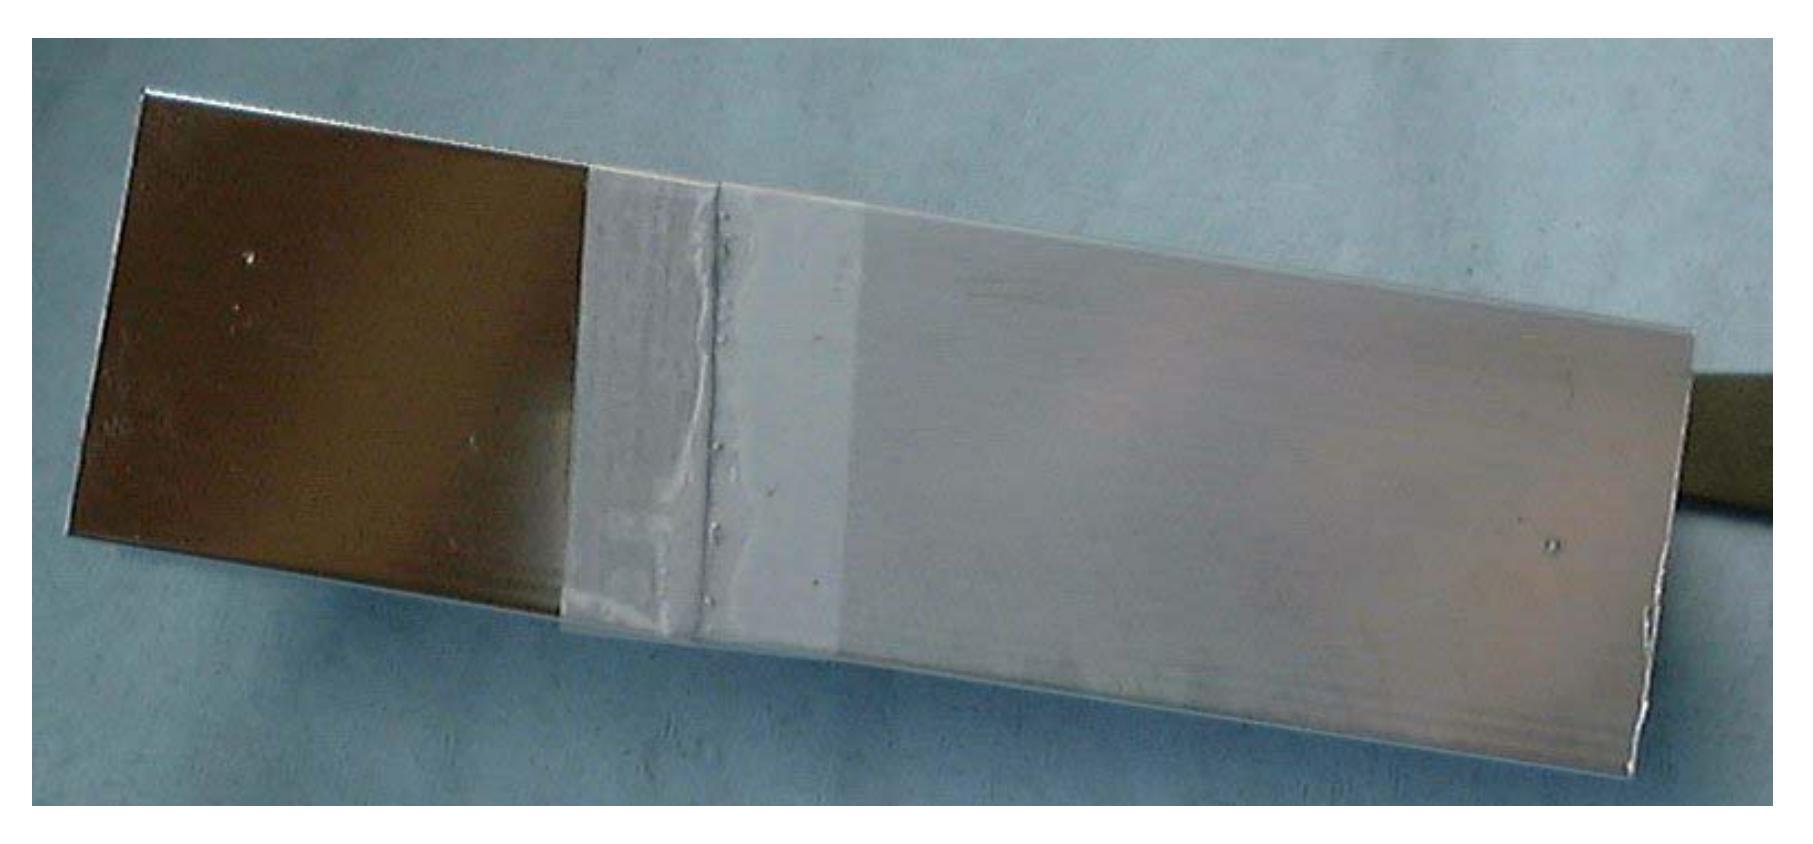
Sometimes an overall dullness of a section may be indicative of a coarse Mg₂Si precipitate in the 6063 or 6463 alloy being brightened, or it may be due to a low nitric acid content in the brightener or even a thick anodized coating. The latter explanation can most easily be confirmed or eliminated by measuring the film thickness. Stripping the film and reprocessing under optimum conditions is one method of determining whether the problem is metallurgical or due to the brightening process. Such an example is illustrated in Figure 74 where the satisfactory result on reprocessing suggested that it was the brightening process that was at fault. In such cases it is usually the nitric acid content of the brightener that is low, although the temperature, if too low, may have a similar effect.

Figure 74. Example of bright trim section showing an overall dull finish before reprocessing (to right of tape) and a satisfactory finish after reprocessing (to the left of the tape).

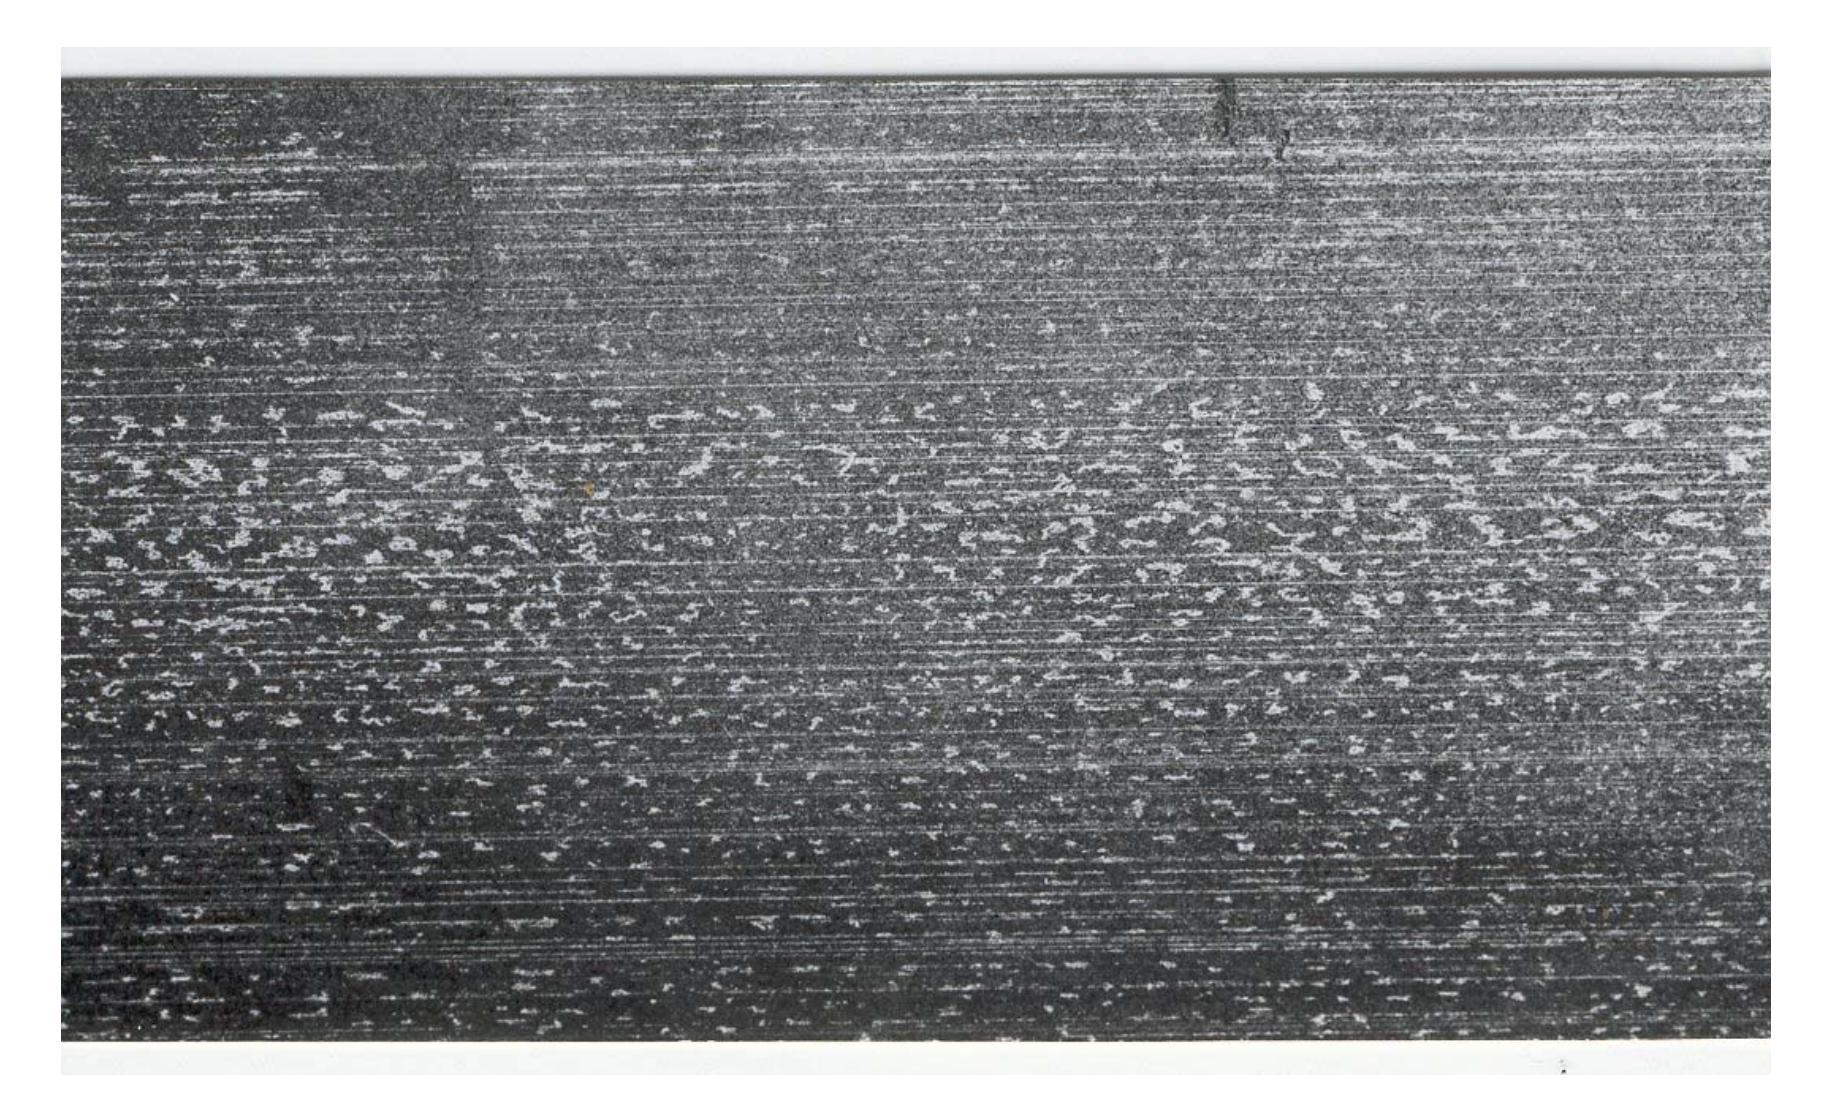
Where the pitting is found only on certain faces of the sample, perhaps just a single face, and a sharp demarcation exists between the pitted area and a satisfactory area, the problem is probably due to corrosive media attacking exposed faces of the sample. A sharp demarcation line between the defect area and a normal area suggests shielding of the affected part by other parts or perhaps one face having been protected by lying on a shelf in storage (face-up, face-down). Pits often tend to run along die lines on extrusions where any natural protective oxide film is at its weakest (Figure 1). This is commonly observed with atmospheric

corrosion of mill finish extrusions, particularly air quenched 6063 type extrusions, where the presence of a mixed magnesium oxide - aluminium oxide film on the surface, facilitates and accelerates the corrosion process. This type

of corrosion is not readily visible on the mill finish sample, but is revealed by an etching pre-treatment, and can be seen immediately after the etching stage. It is often not detected until the final inspection of an anodized and sealed product. The pitting may only be on one or two faces of an extrusion depending upon its shape and how it has been stored.

Figure 1. Typical atmospheric corrosion revealed by etching and anodizing.

This type of corrosion cannot be removed by reprocessing. The only remedial action is to strip off the anodic film and then mechanically linish the surface to remove the pits. This is practically impossible on complex shapes and it is often more economic to re-extruded the alloy and ensure that it is handled and stored correctly prior to etching and anodizing.
