The Identification and Prevention of Defects on Anodized Aluminium Parts

by Ted Short, Aluminium Finishing Consultant

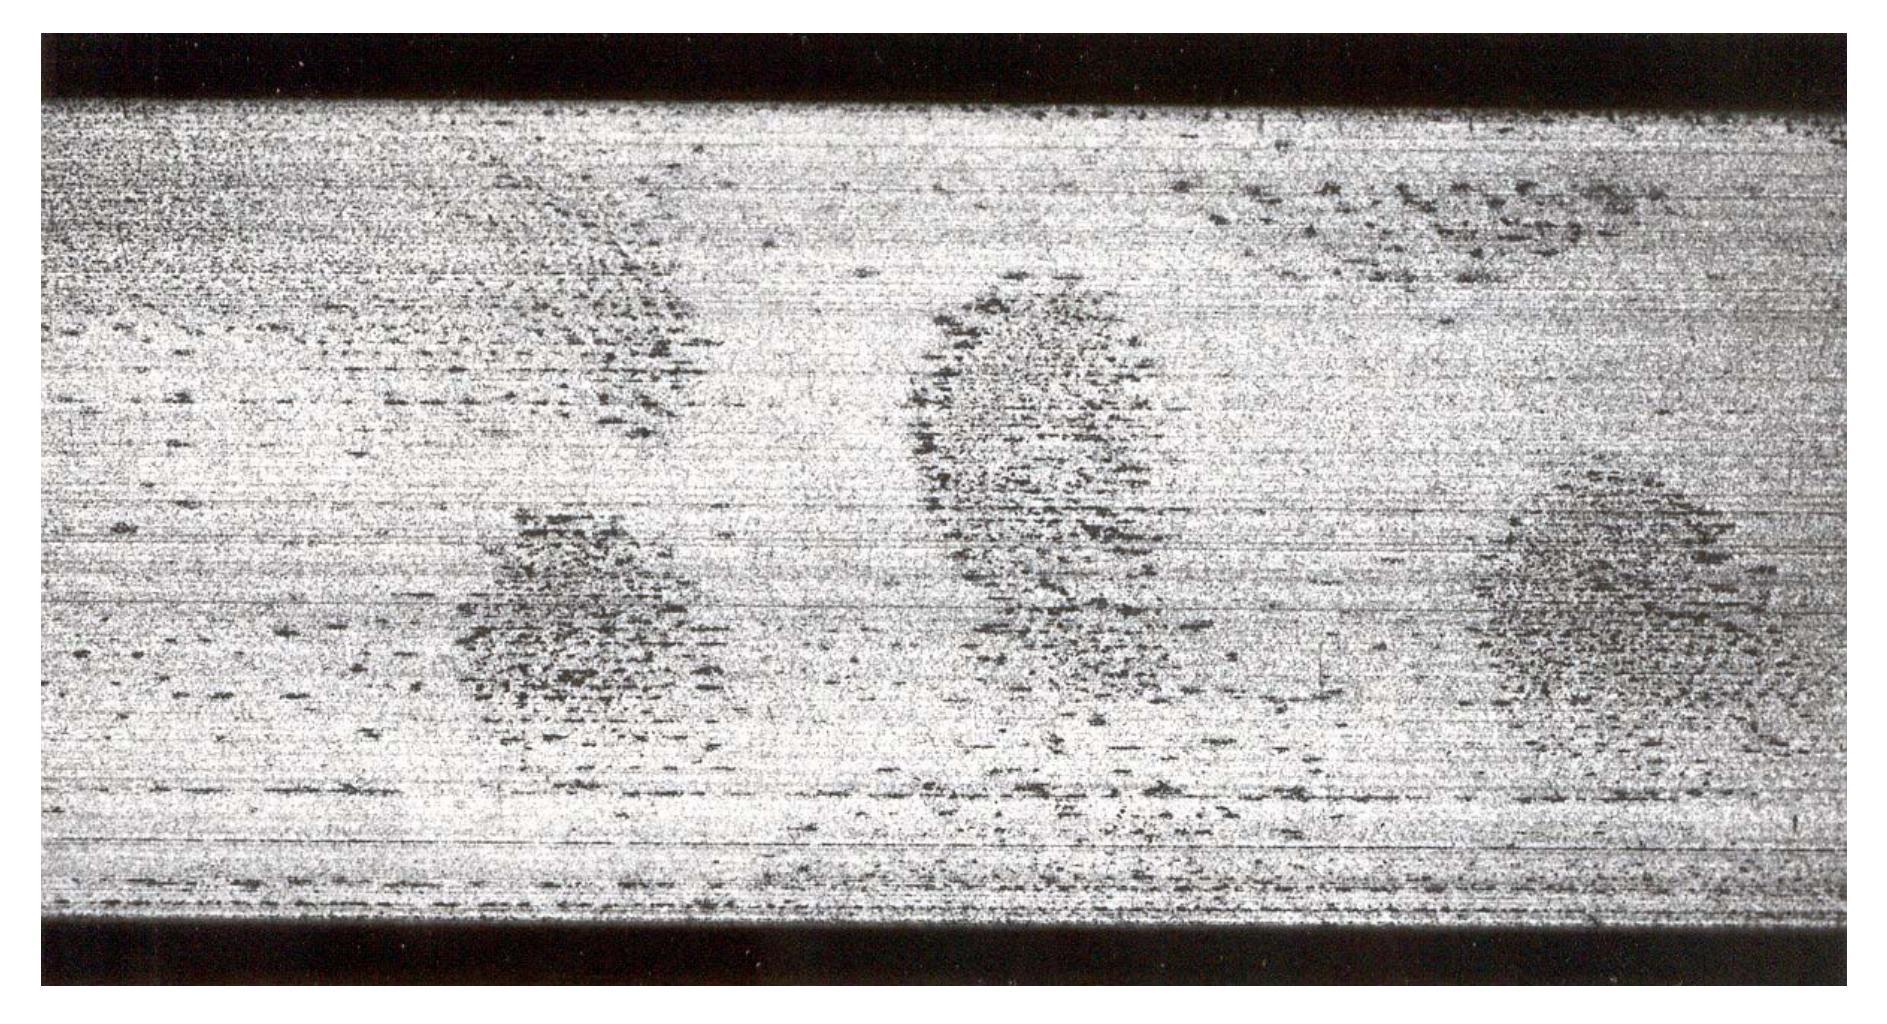
A pitting pattern having a distinct finger print shape is characteristic of finger print corrosion (Figure 2). (also known as finger-marking). This occurs due to handling, mainly of 6000-series aluminium alloys, after extrusion and before anodizing, without using gloves. Perspiration is acidic and contains chloride ions and removes the magnesia film present on the 'as extruded' 6063 extrusions resulting in rapid localised corrosion of the aluminium substrate. Again, it is not normally visible at the mill finish stage but is enhanced by the etching and anodizing processes. It is always recommended that cotton gloves be worn when handling 'mill finish' aluminium. Similar pitting may occur on aluminiumcopper alloy extrusions sheet or plate due to the reactive nature of this alloy.

Figure 2. Finger print corrosion on 6063 extrusion revealed by etching and anodizing.

As with the previous problem, this type of corrosion cannot be removed by reprocessing. The only remedial action is to strip off the anodic film and then mechanically linish the surface to remove the pitting. This is practically impossible on complex shapes and it is often more economic to re-extruded the job and ensure that it is handled and stored correctly prior to etching and anodizing.

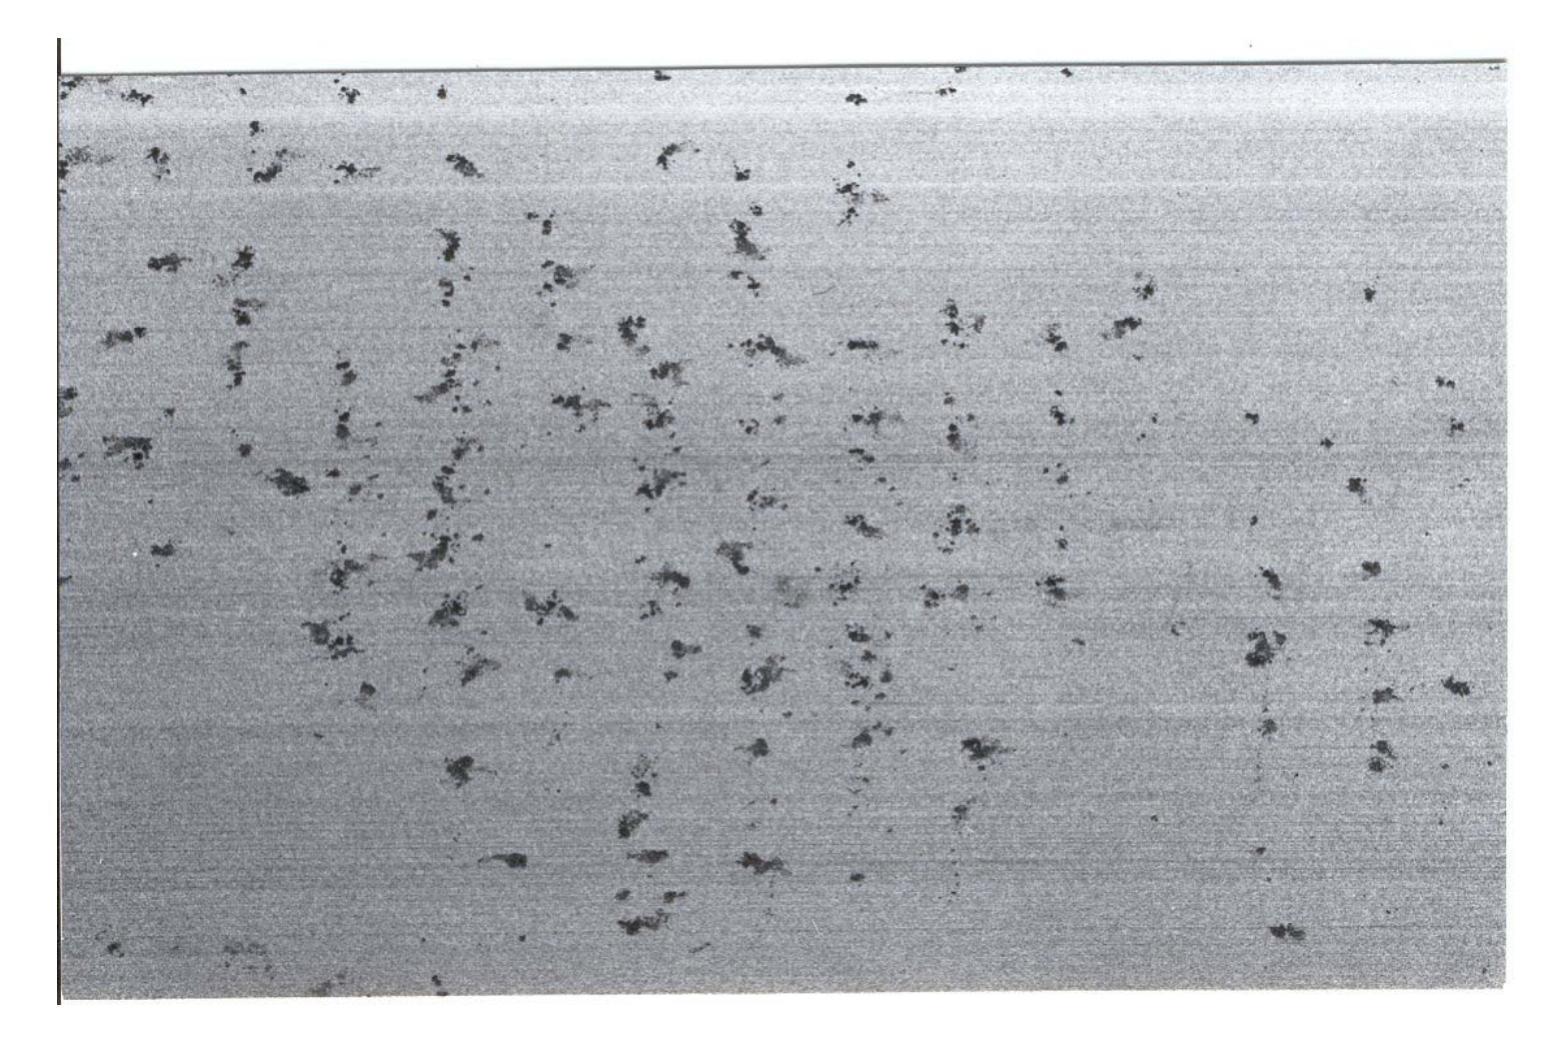
Figure 3. Corrugated cardboard corrosion

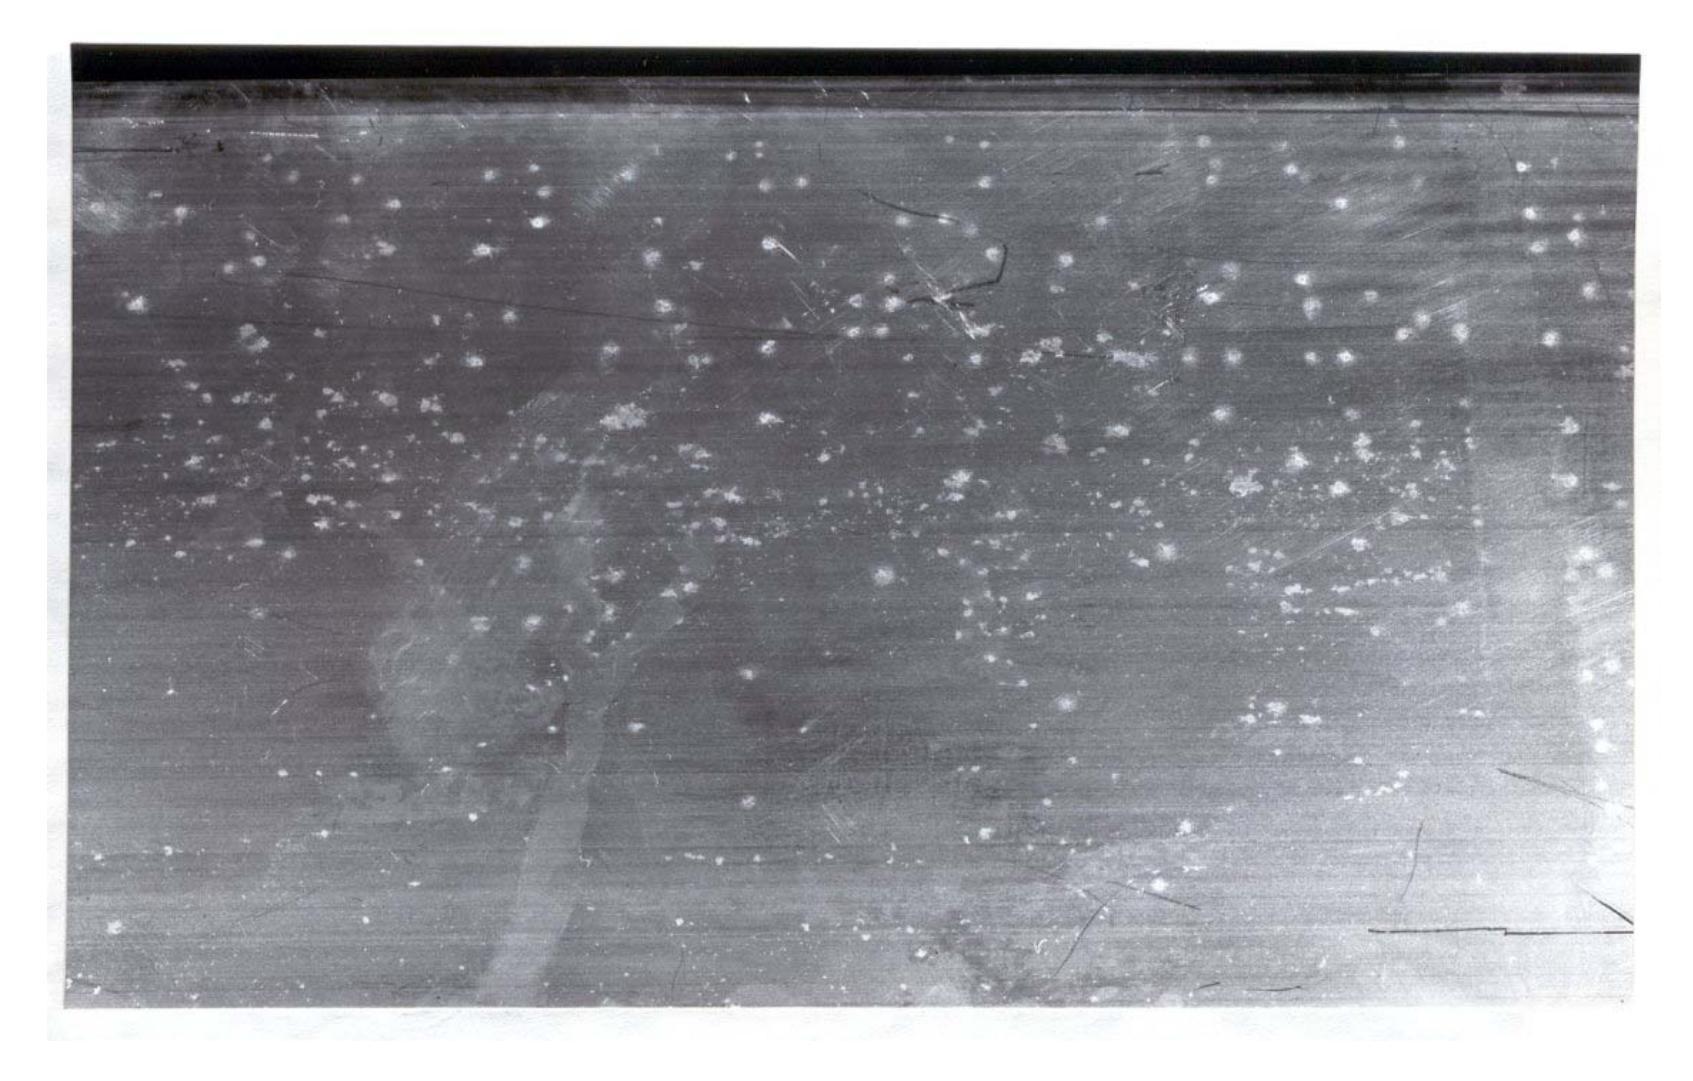
Figure 4. Paper corrosion

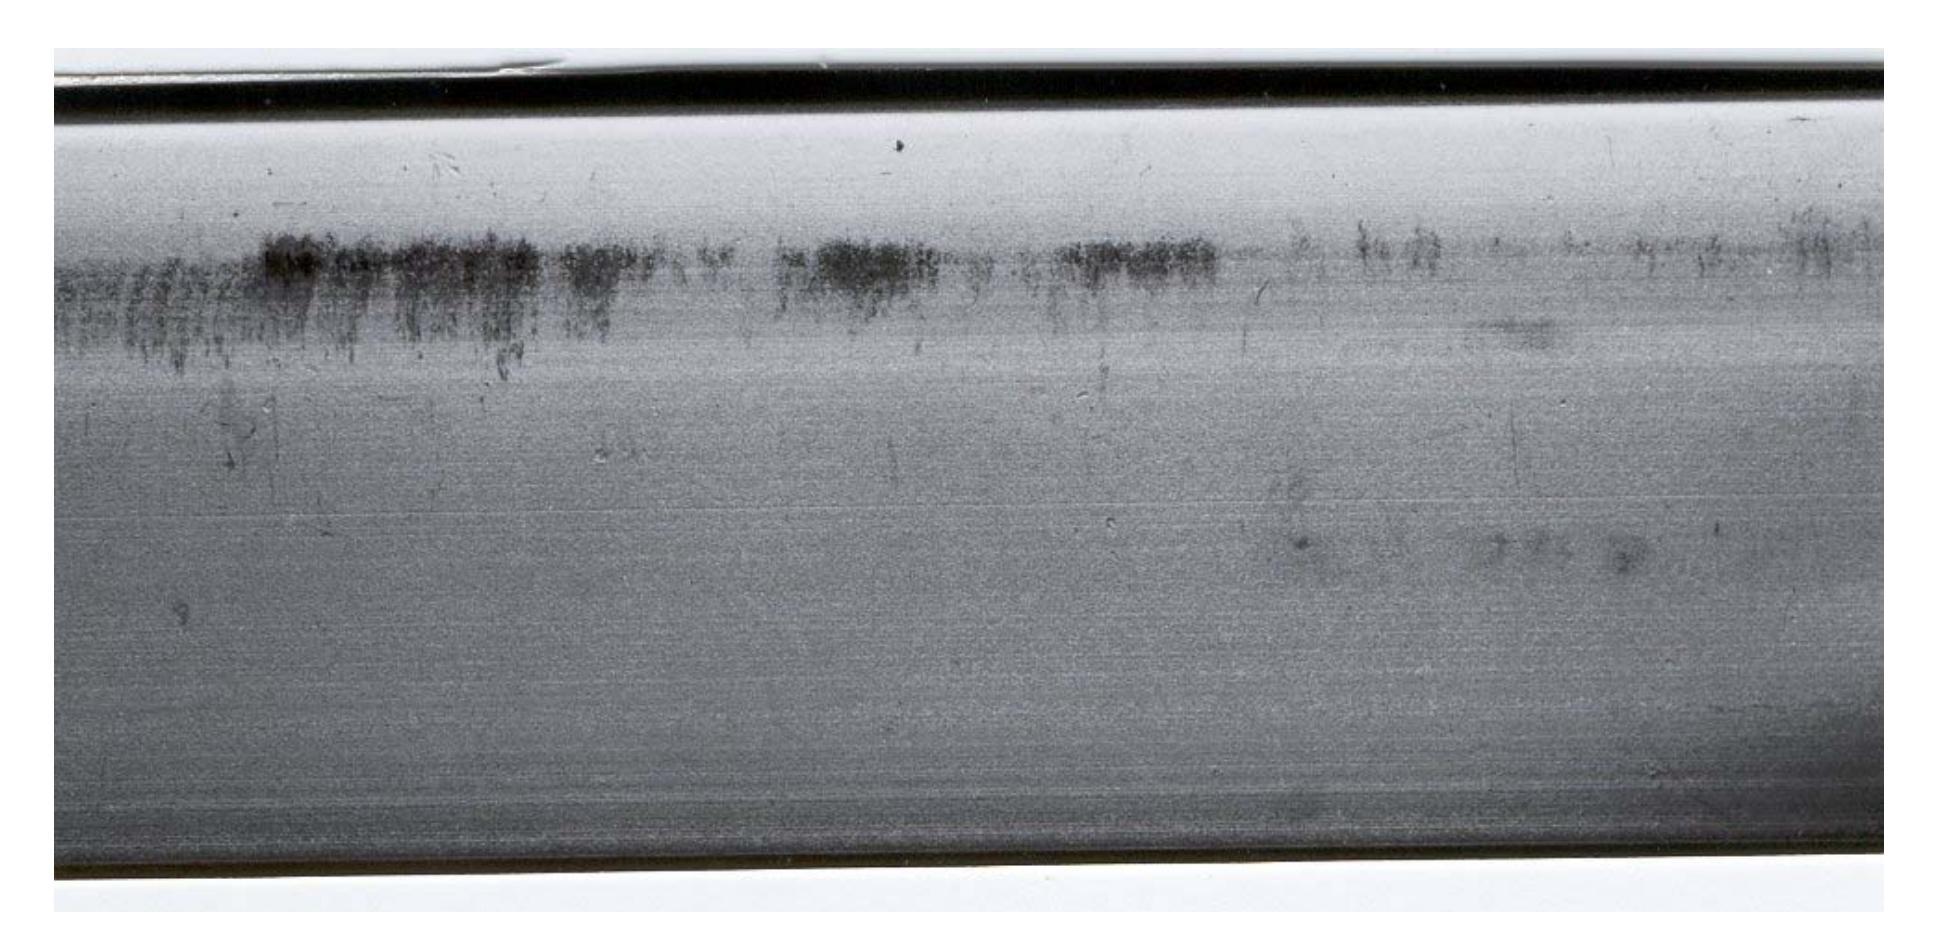
Figure 5. Appearance of fretting corrosion after anodizing.

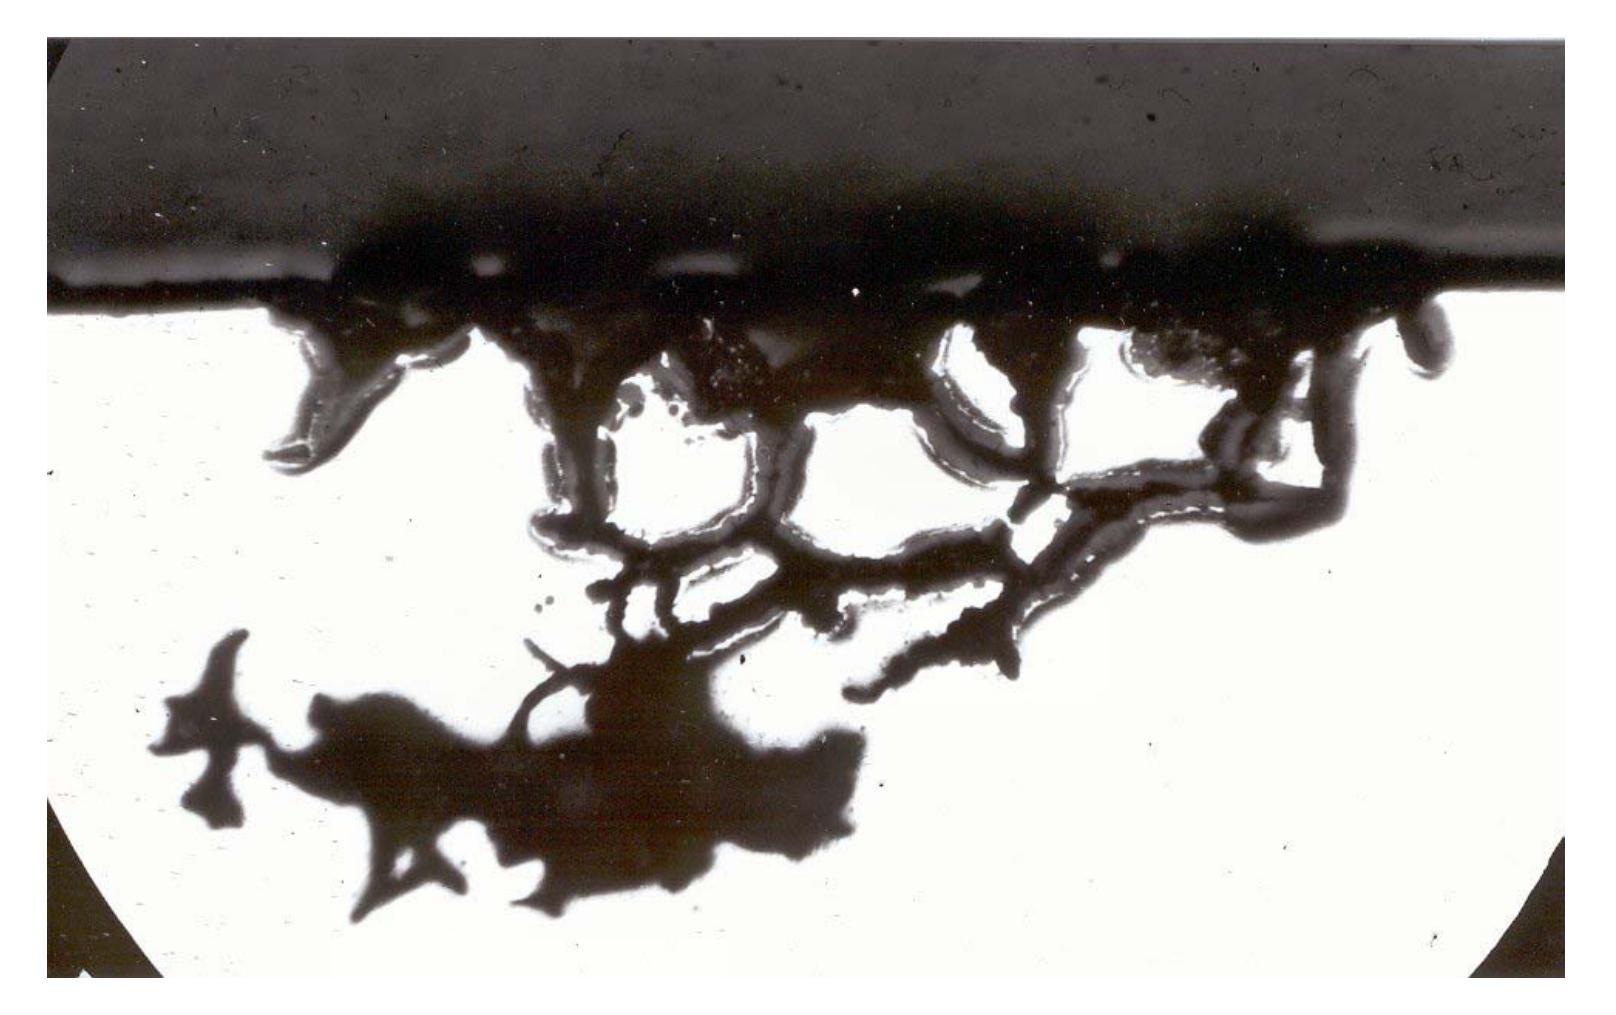
Figure 6. Intergranular attack typical of acid corrosion. x 200

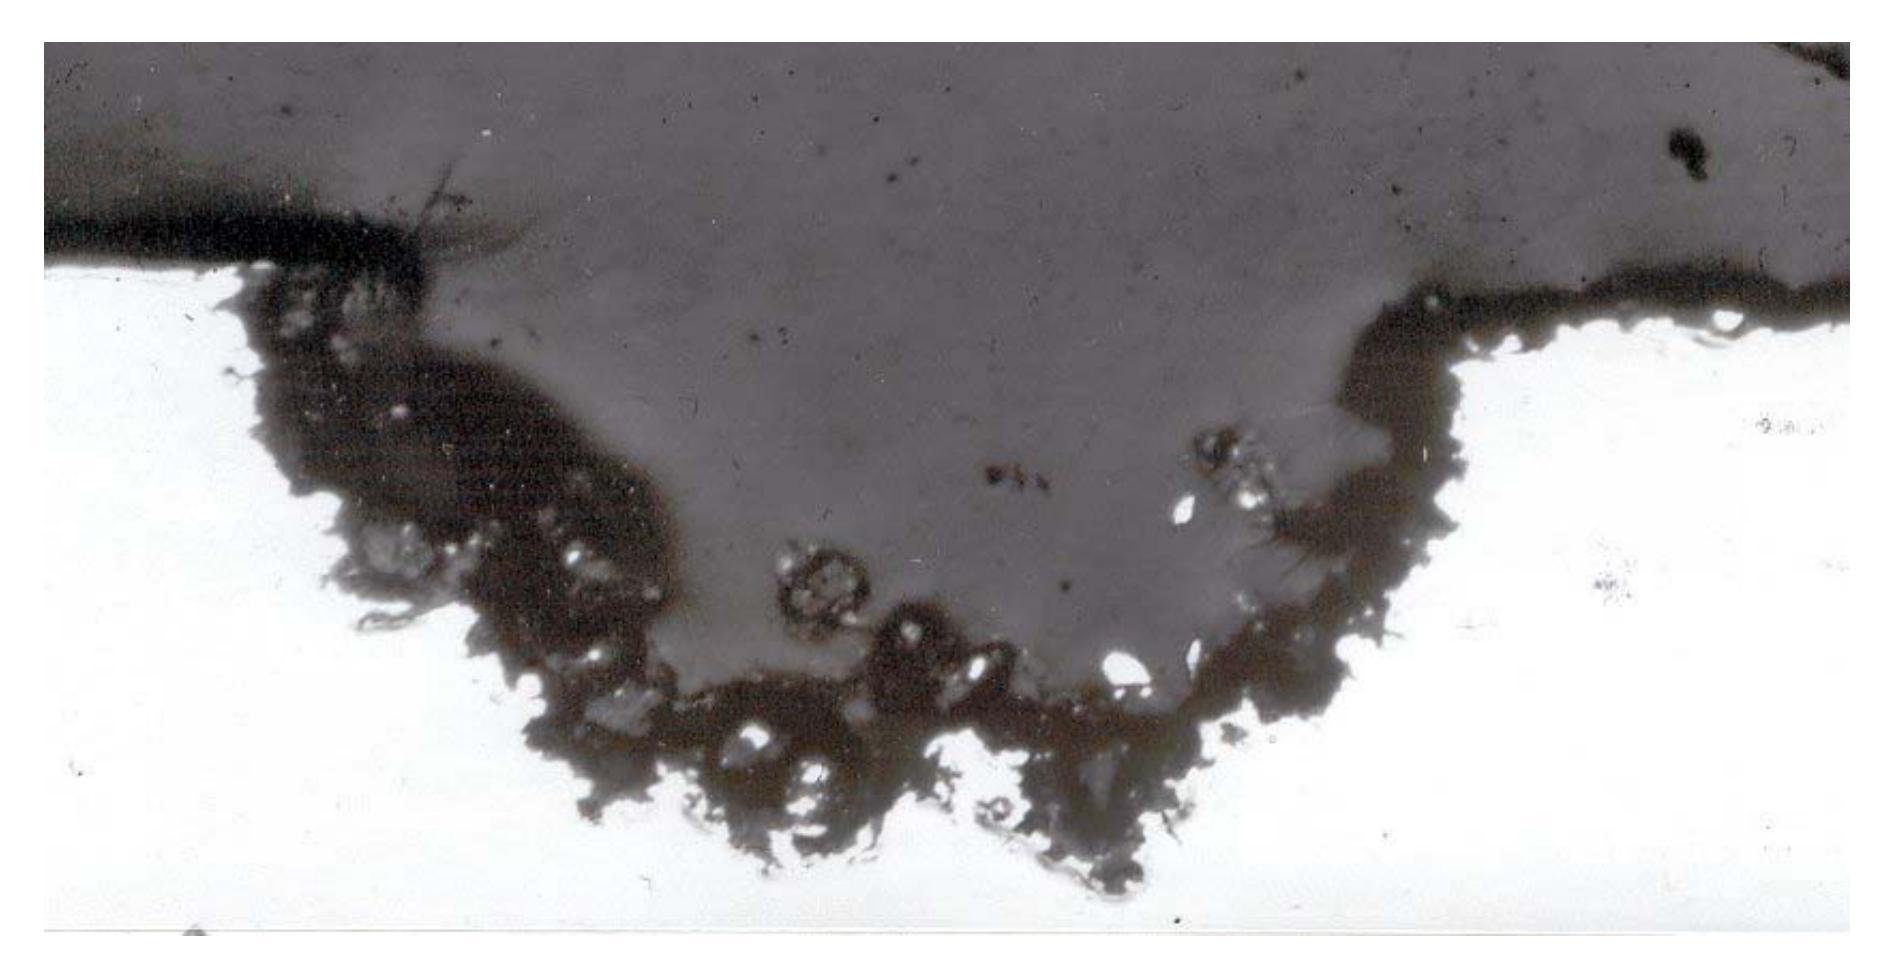
Figure 7. Rounded pit typical of alkali corrosion. x 200

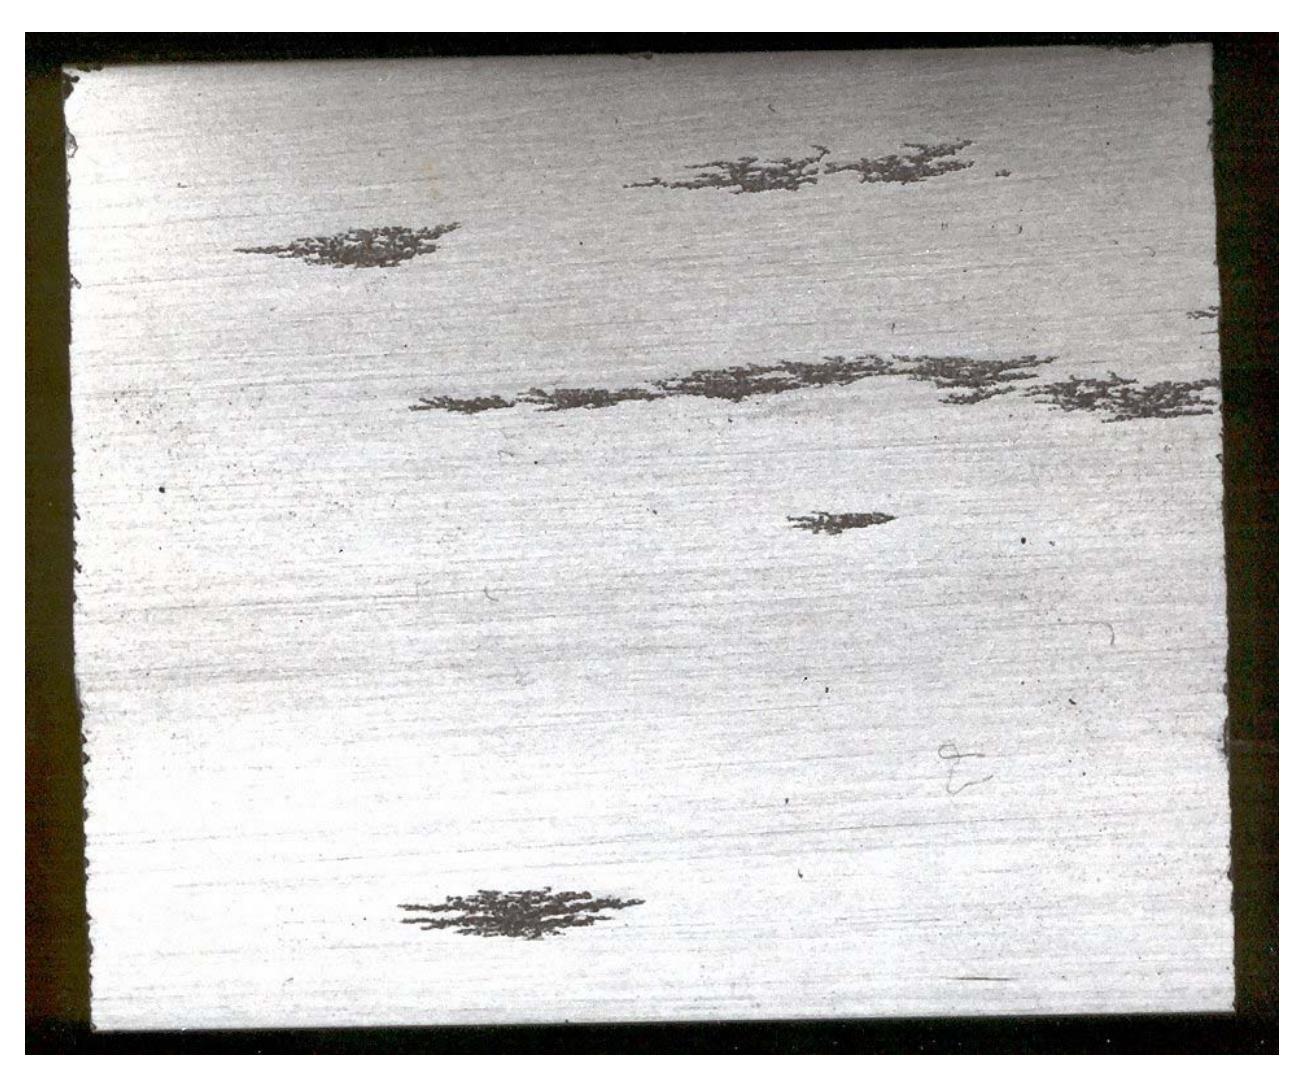
Figure 10. Rinse water corrosion having very shallow filiform type structure.

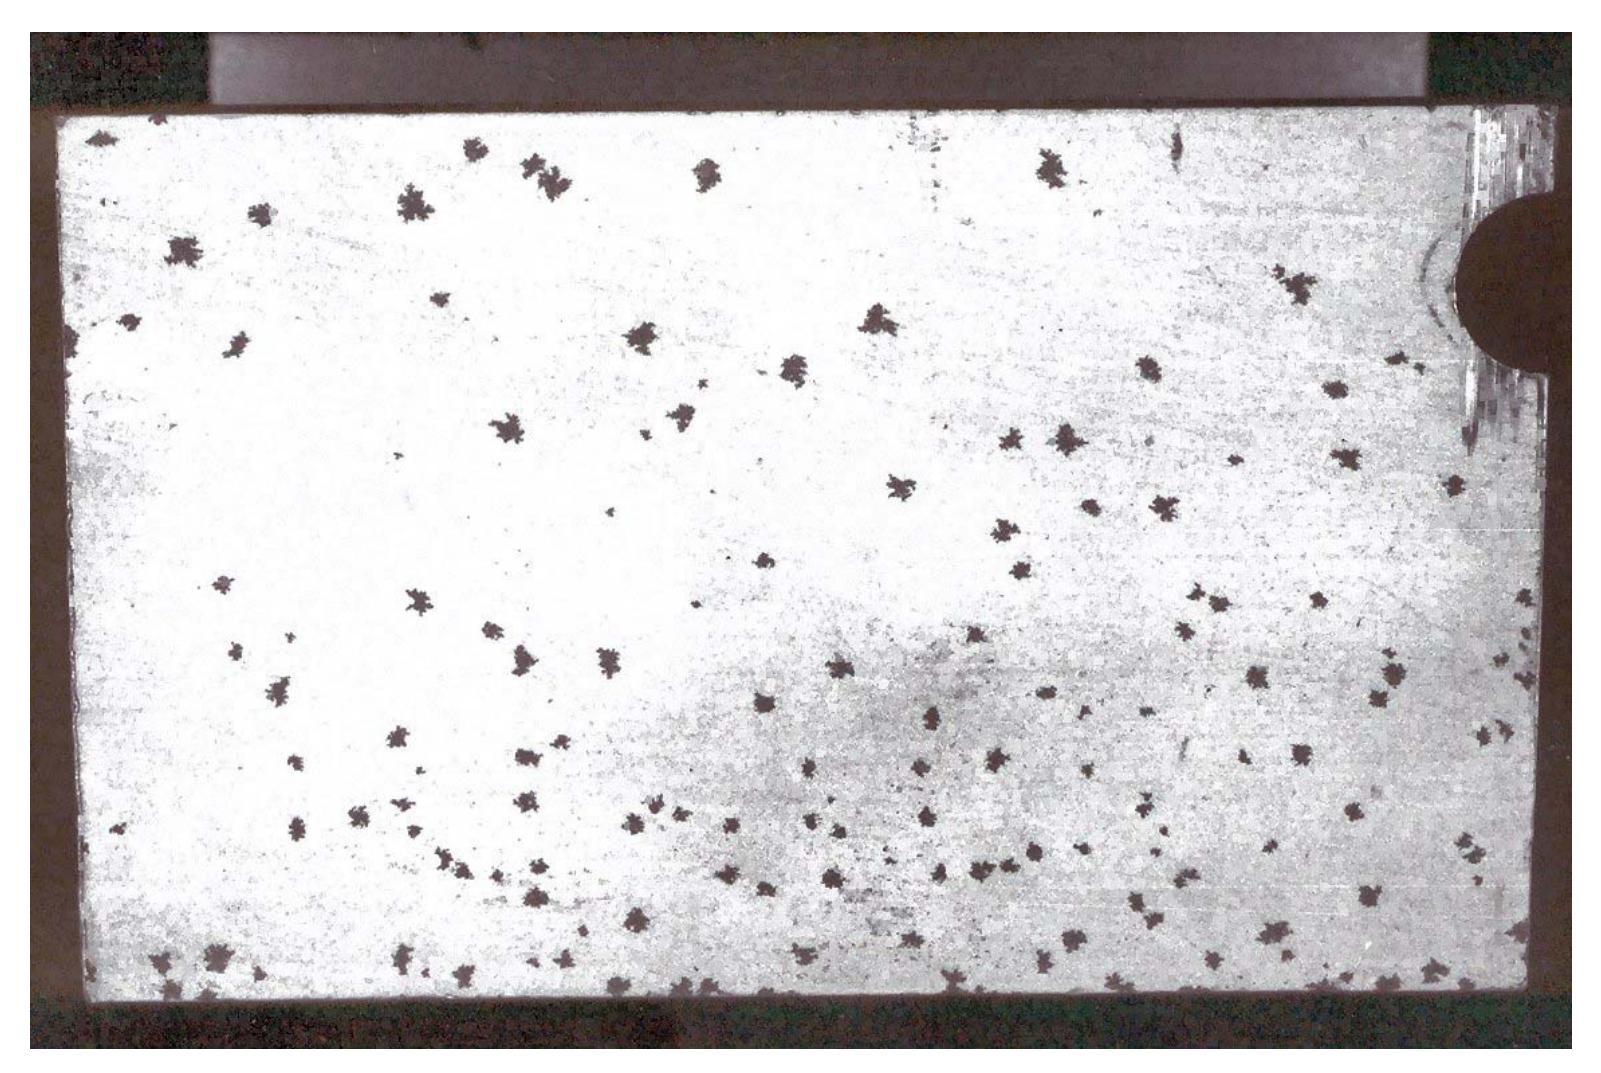
Figure 14. Pitting caused by chloride in a sulphuric acid anodizing electrolyte.

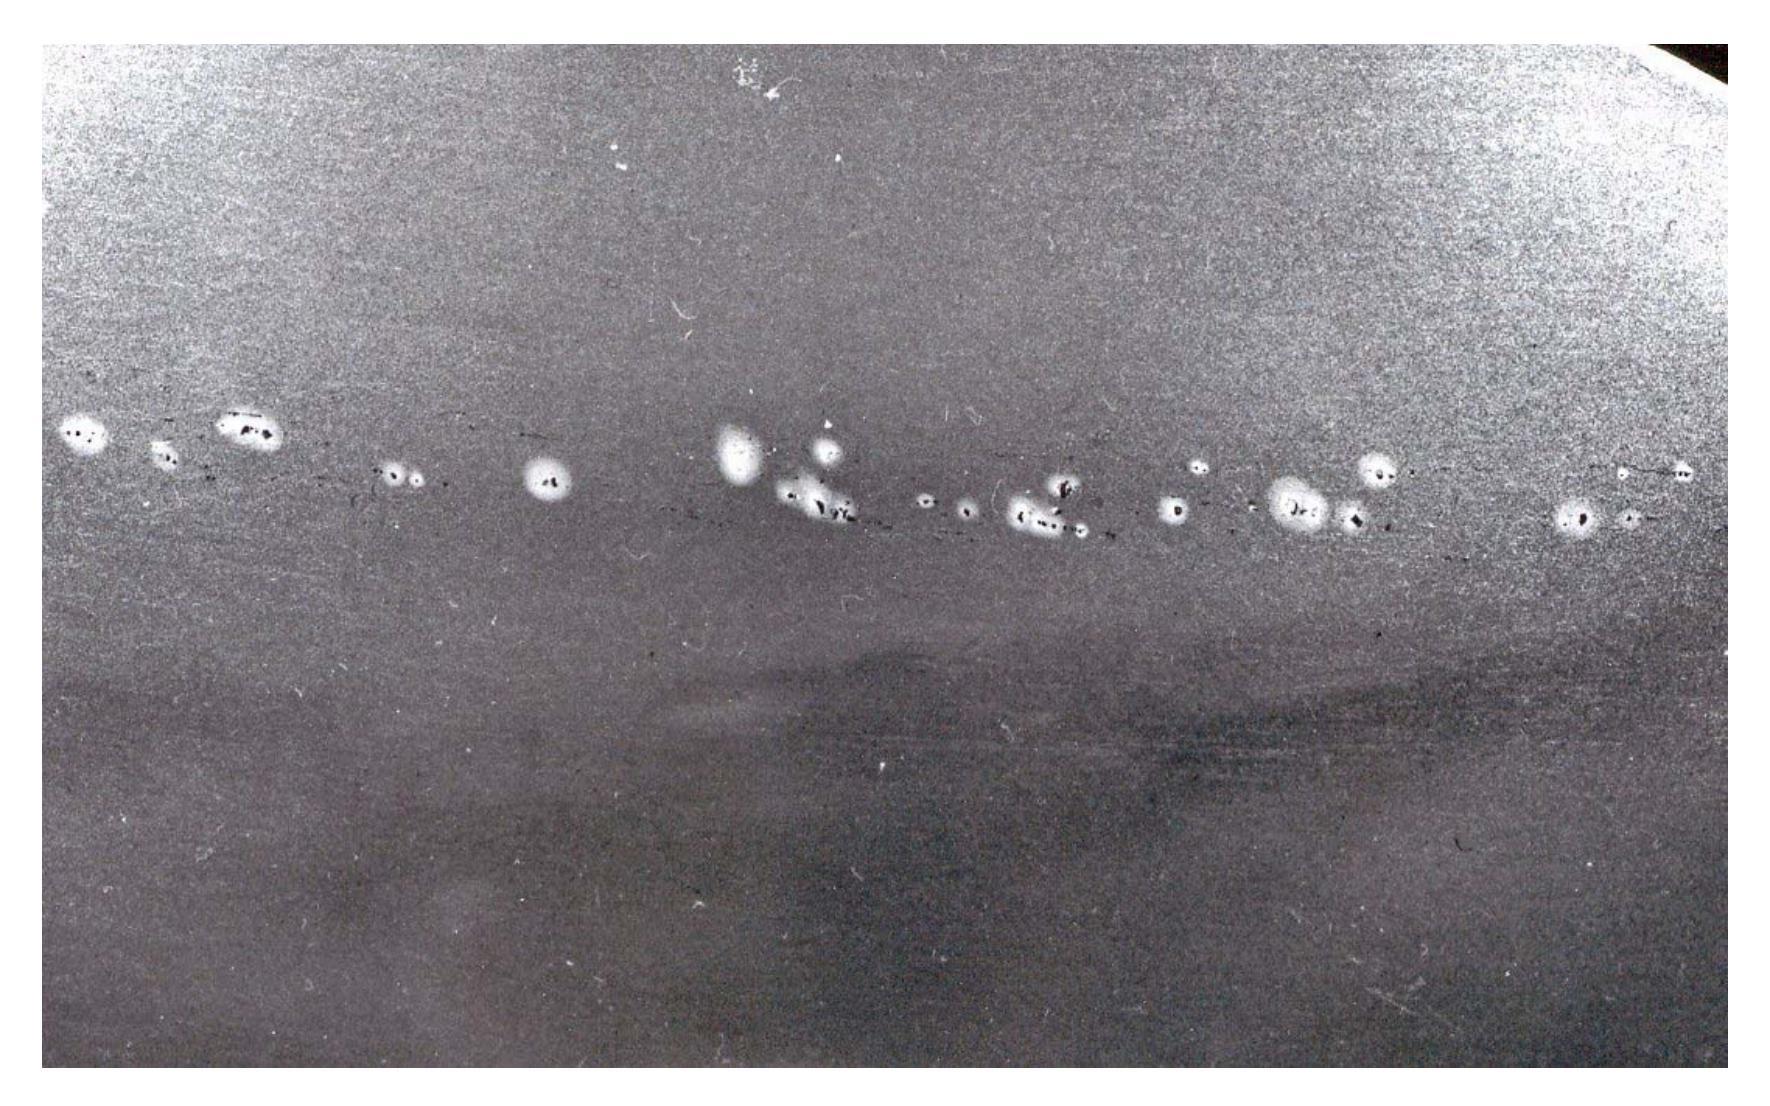
Figure 15. Pitting due to a galvanic cell occurring between the stainless steel tank and the anodized part.

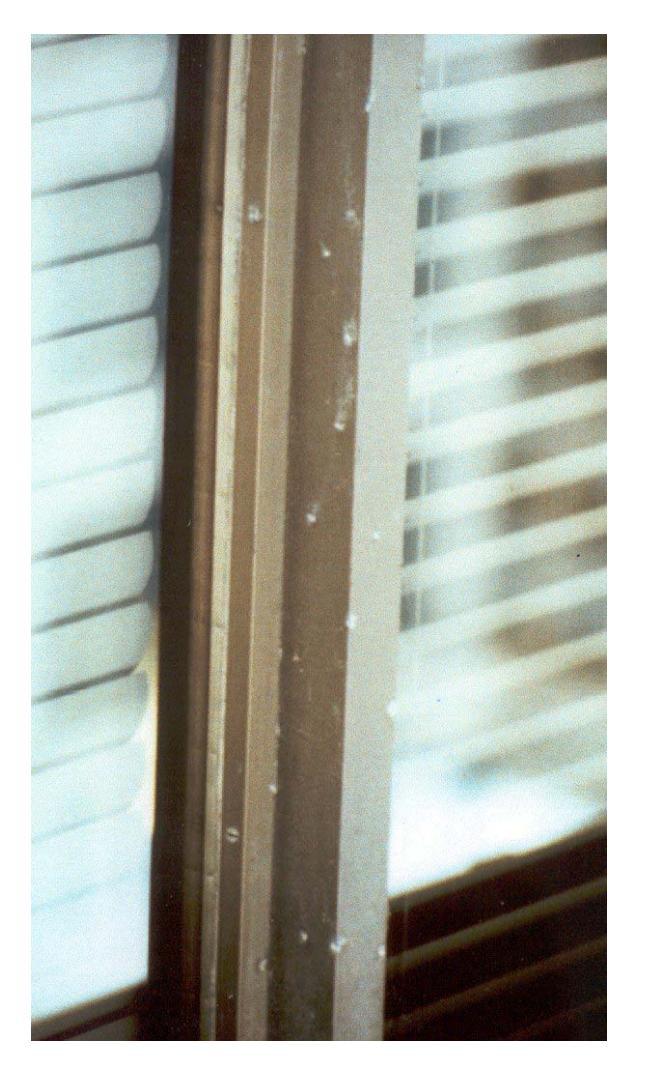
Figure 16. Examples of pitting of anodic films in service due to the film thickness being below specification.

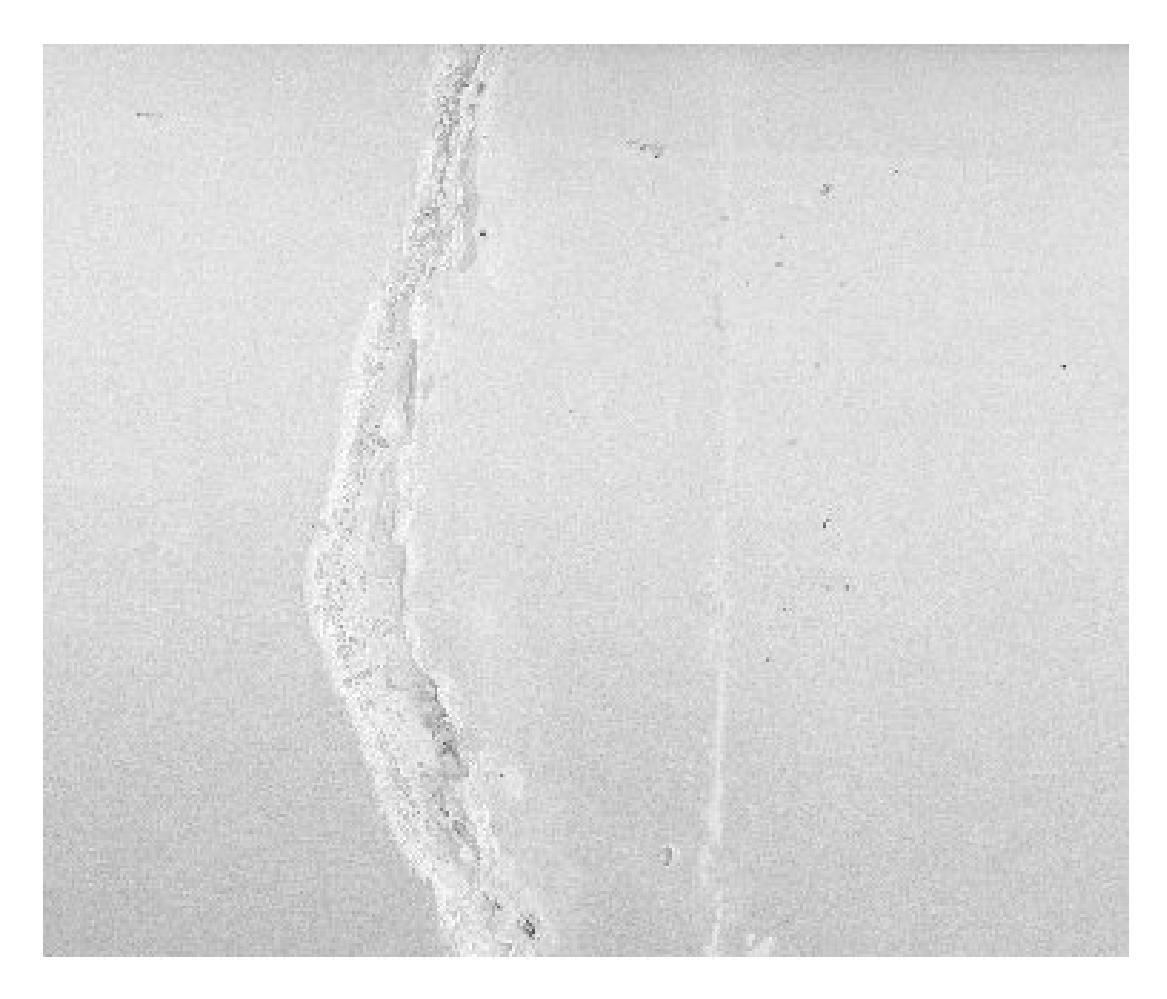
Figure 17. Cement staining on a natural anodized finish.

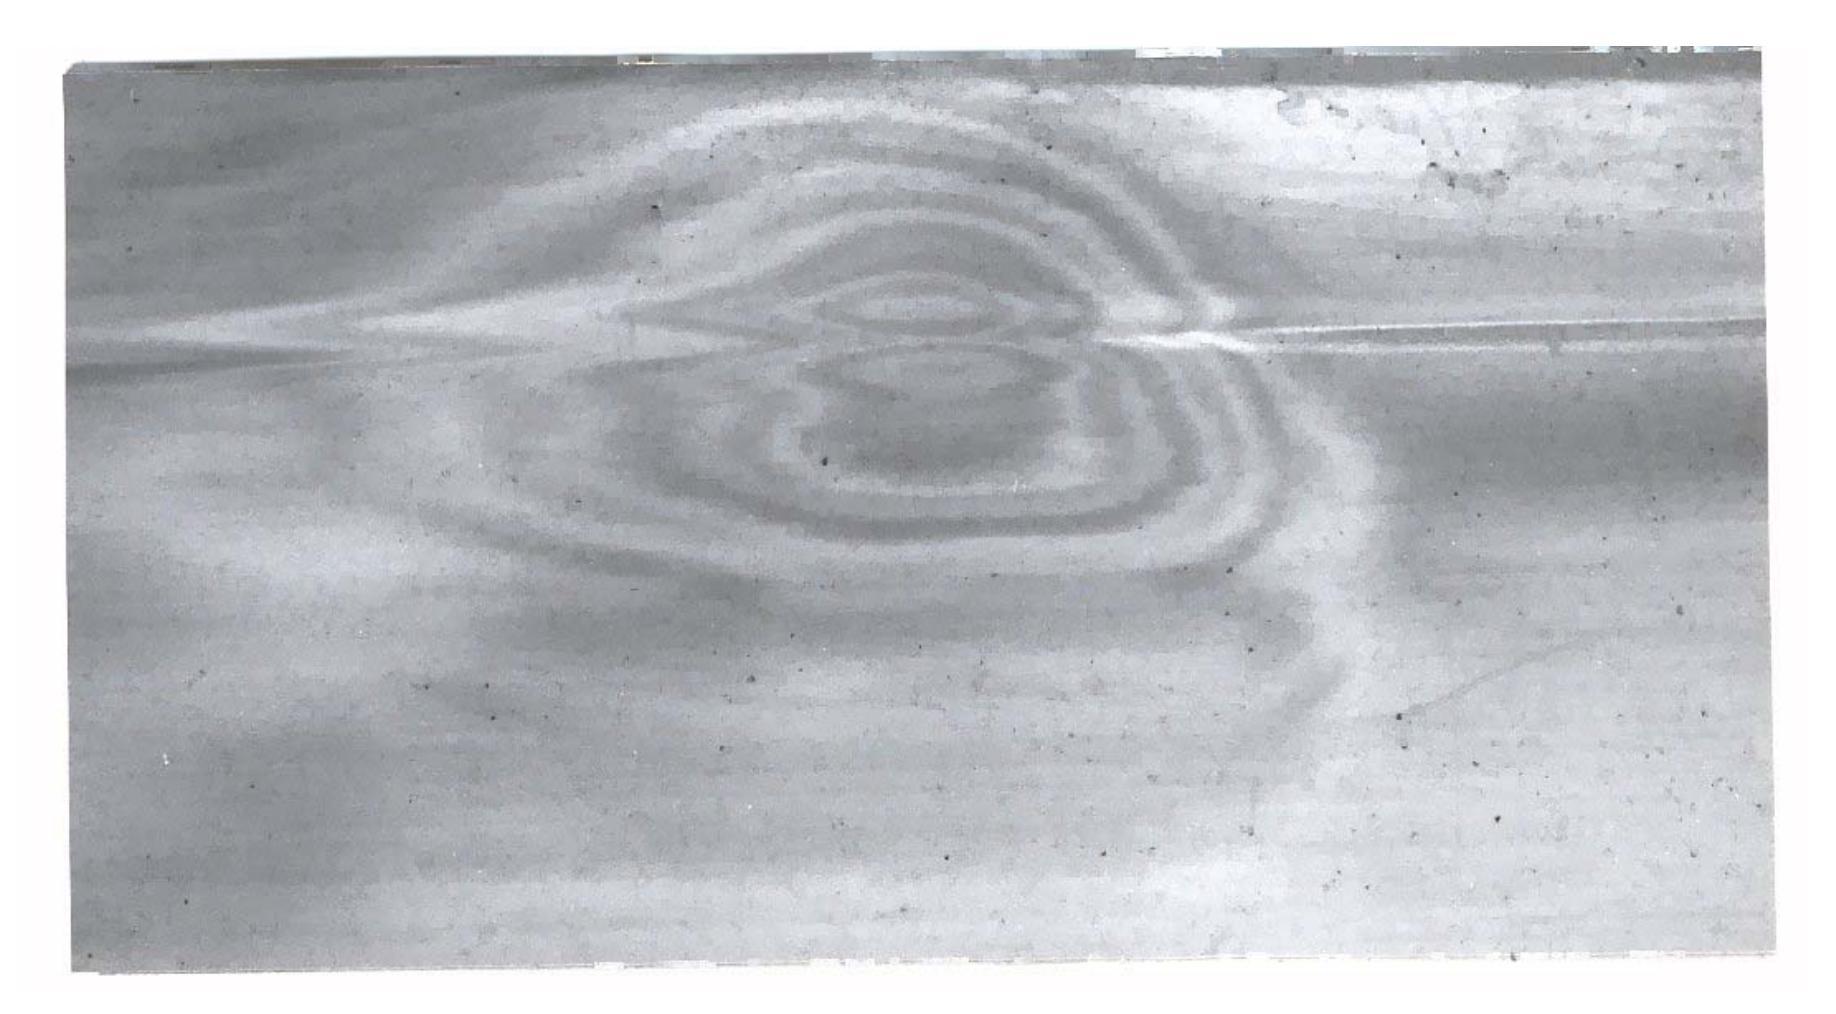
Figure 18. 'Wood grain' effect of ingot segregation on polished and anodized extruded section that was heavily polish to remove a locally severe die line.

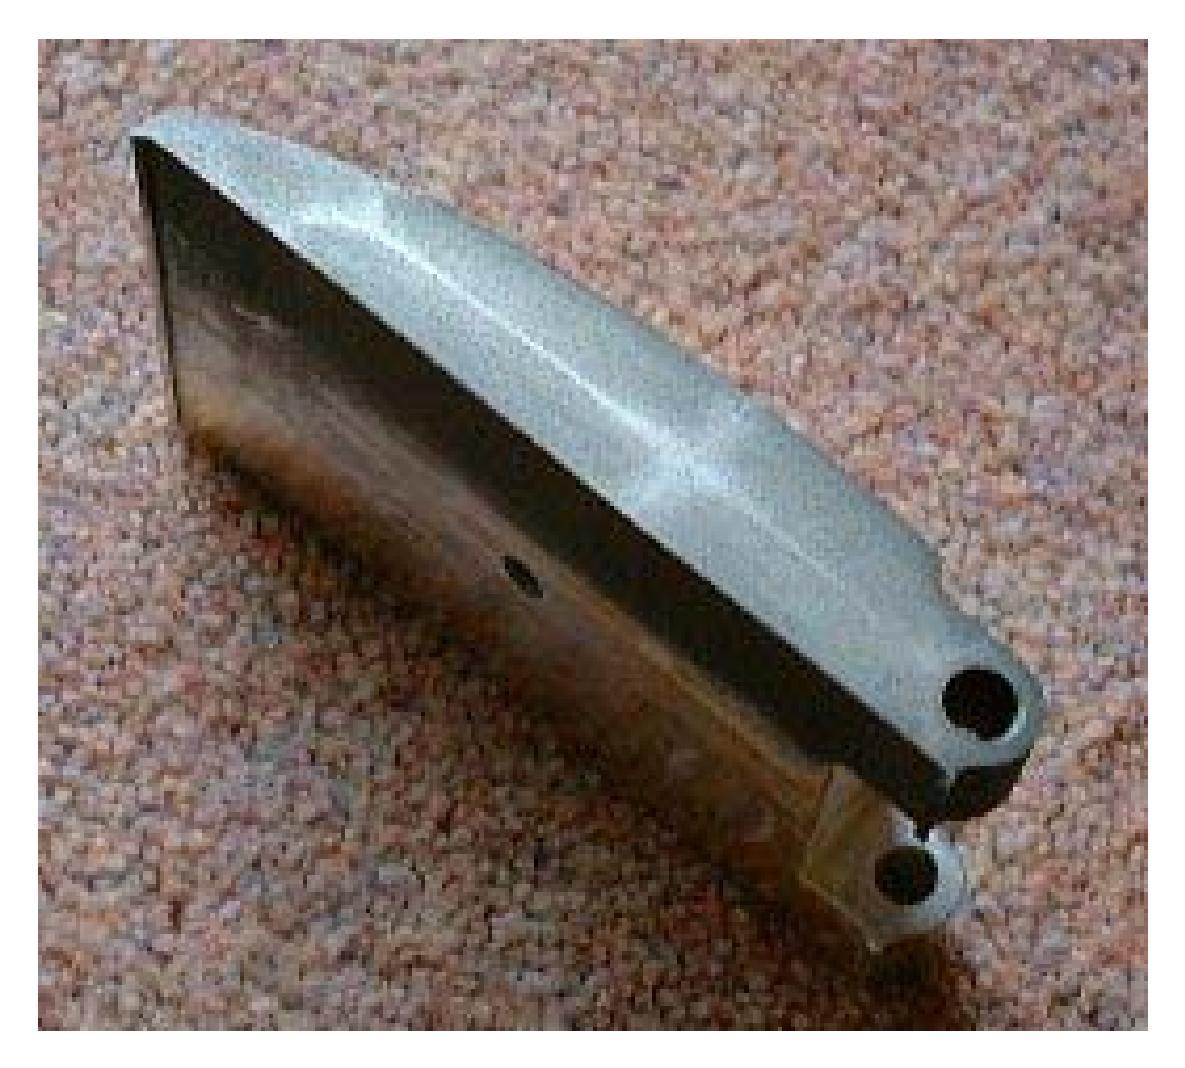
Figure 24. Example metal flow on a hollow extrusion having a small hollow portion at one end of a relatively large solid portion of metal. This may also be part transverse weld/back-end defect. (10 minutes etch in 100g/l NaOH at 60°C.)

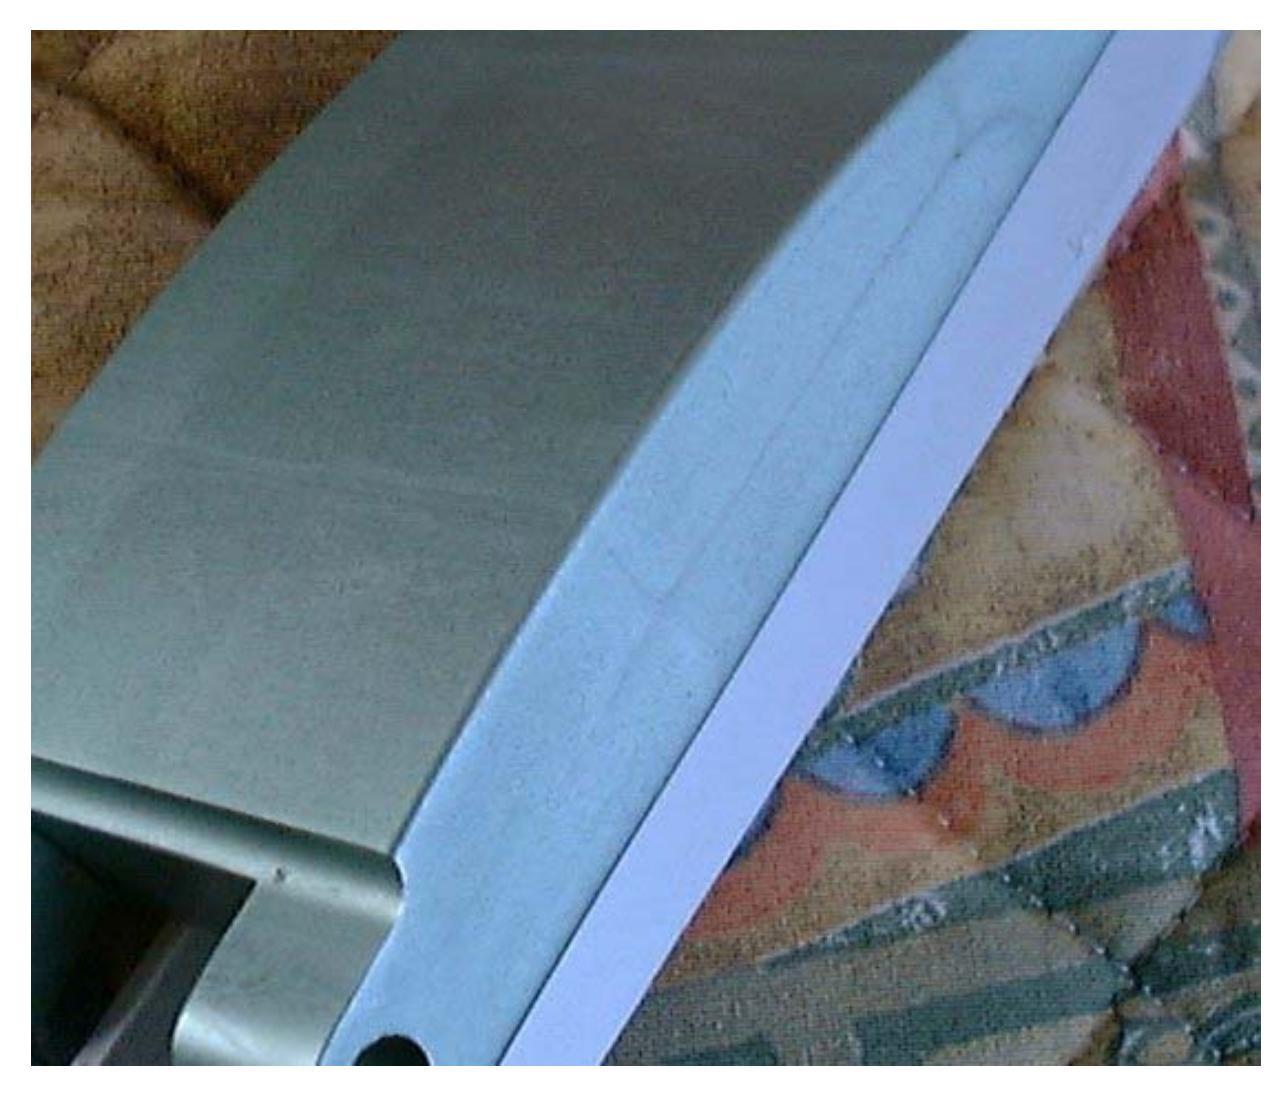
Figure 25. The same sample shows the streaks resulting from the metal flow at the surface of extrusion.
