The Identification and Prevention of Defects on Anodized Aluminium Parts

by Ted Short, Aluminium Finishing Consultant

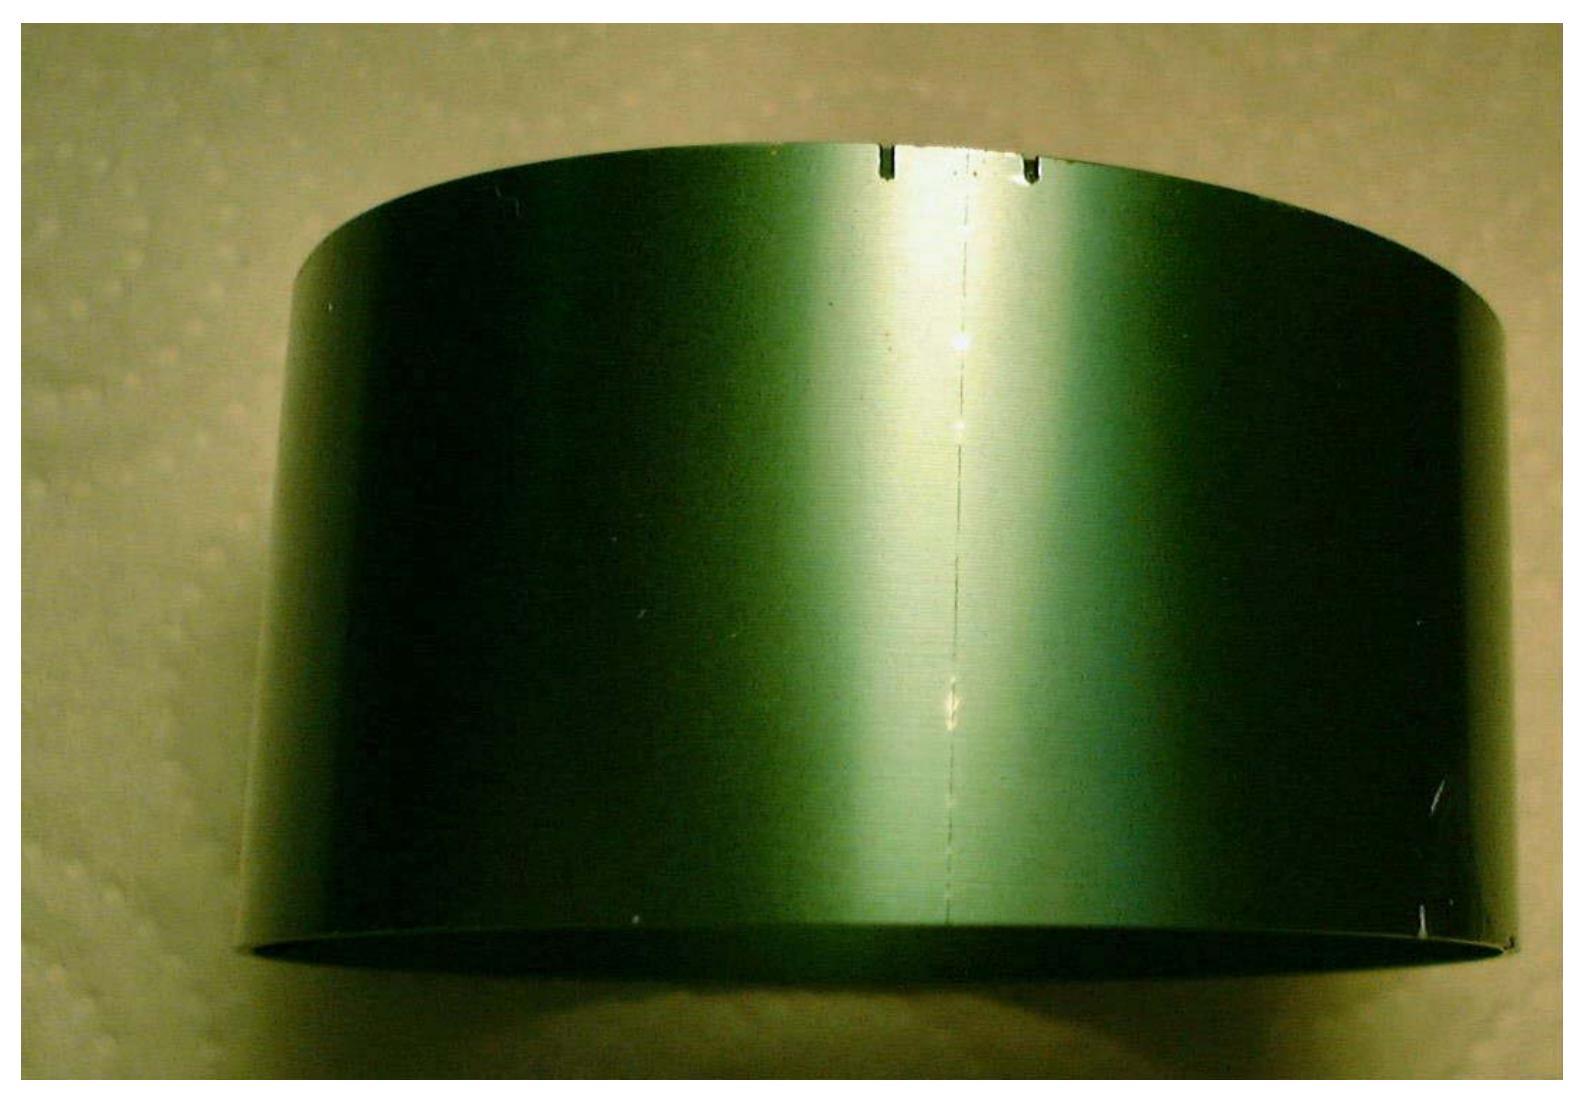
Figure 27. Poor quality weld on extruded tube causing colouring defects when anodized and dyed

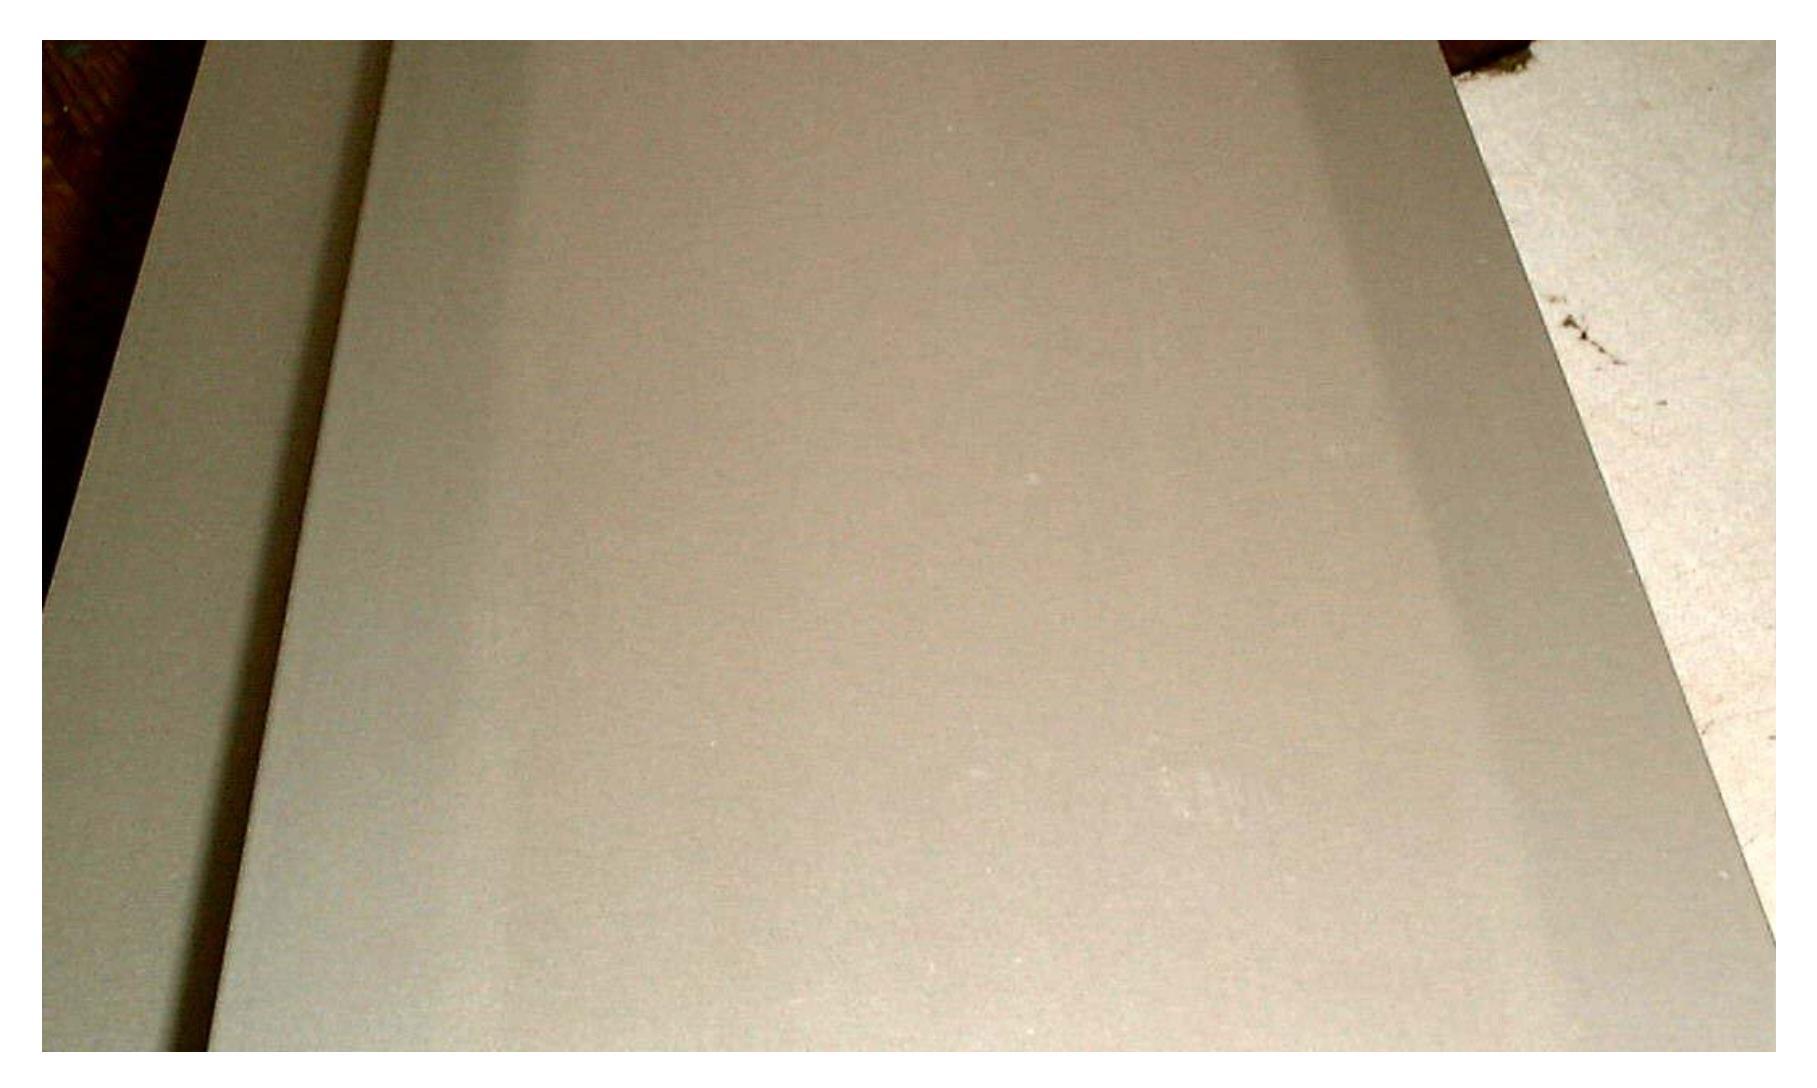
Figure 28. Transverse weld effect on a hollow extrusion after etching and anodizing.

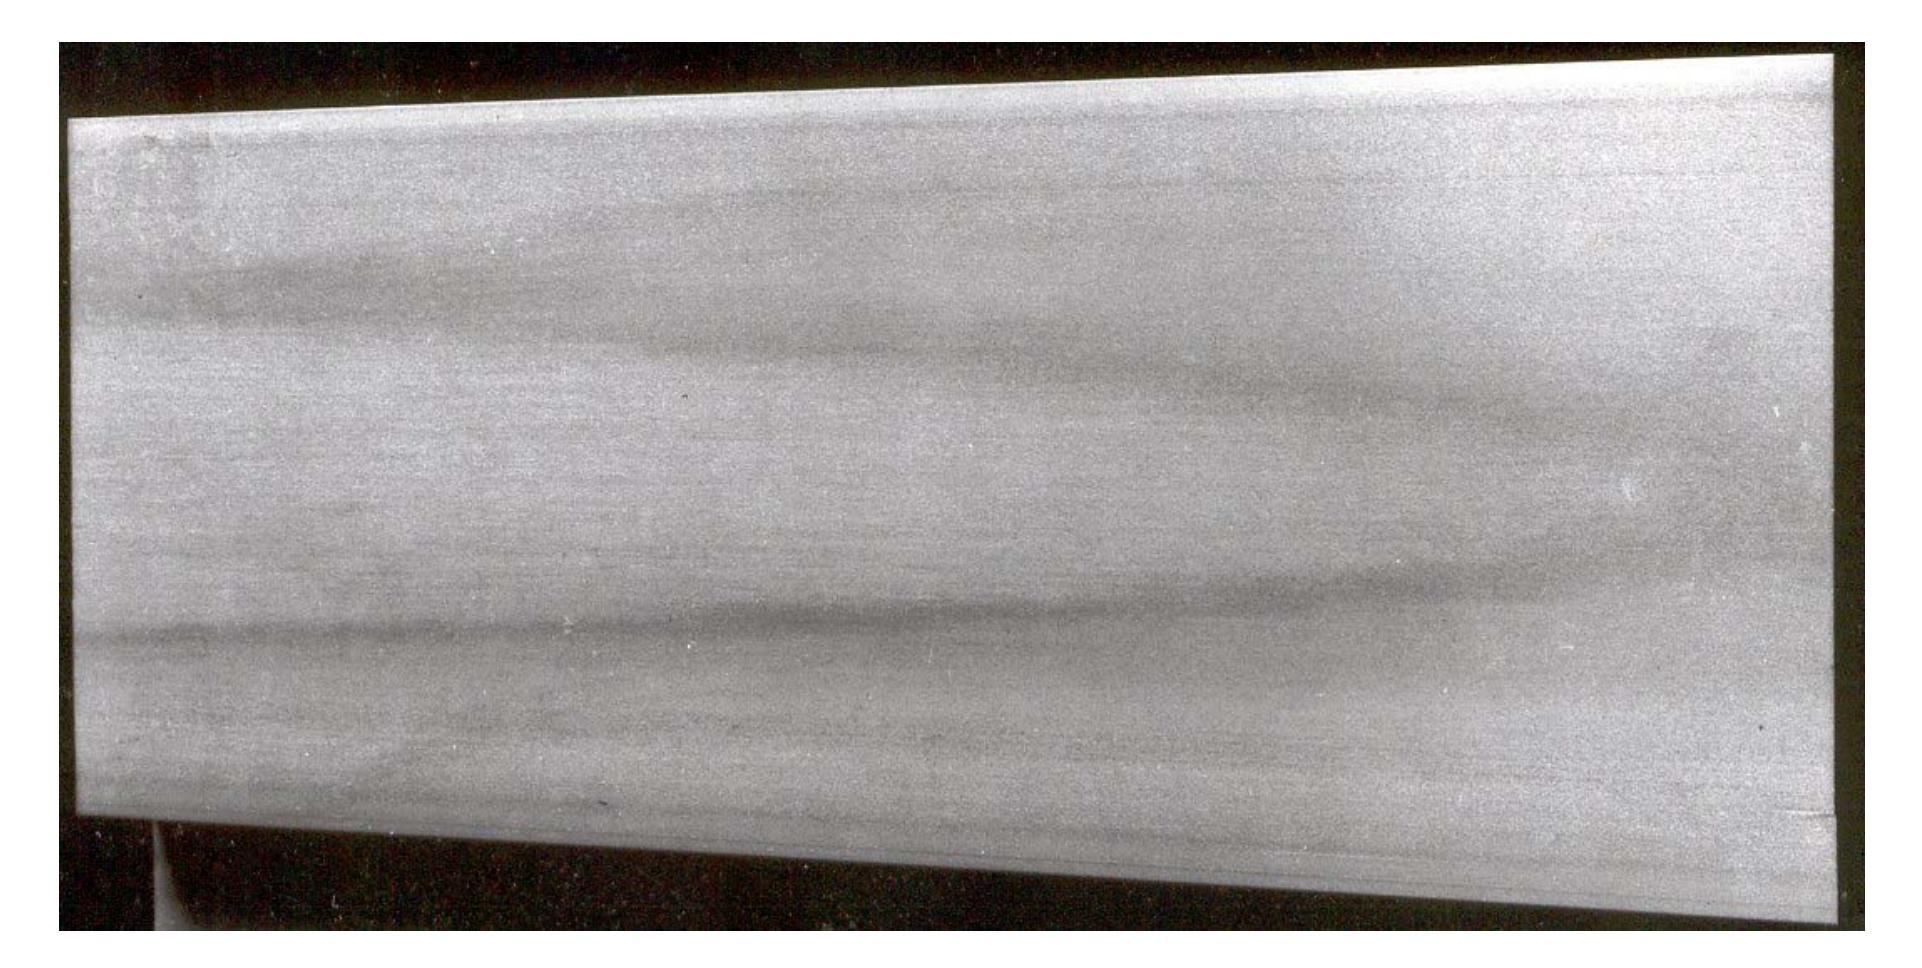
Figure 29. Example of a transverse weld defect at the front end of an extrusion after etching and anodizing.

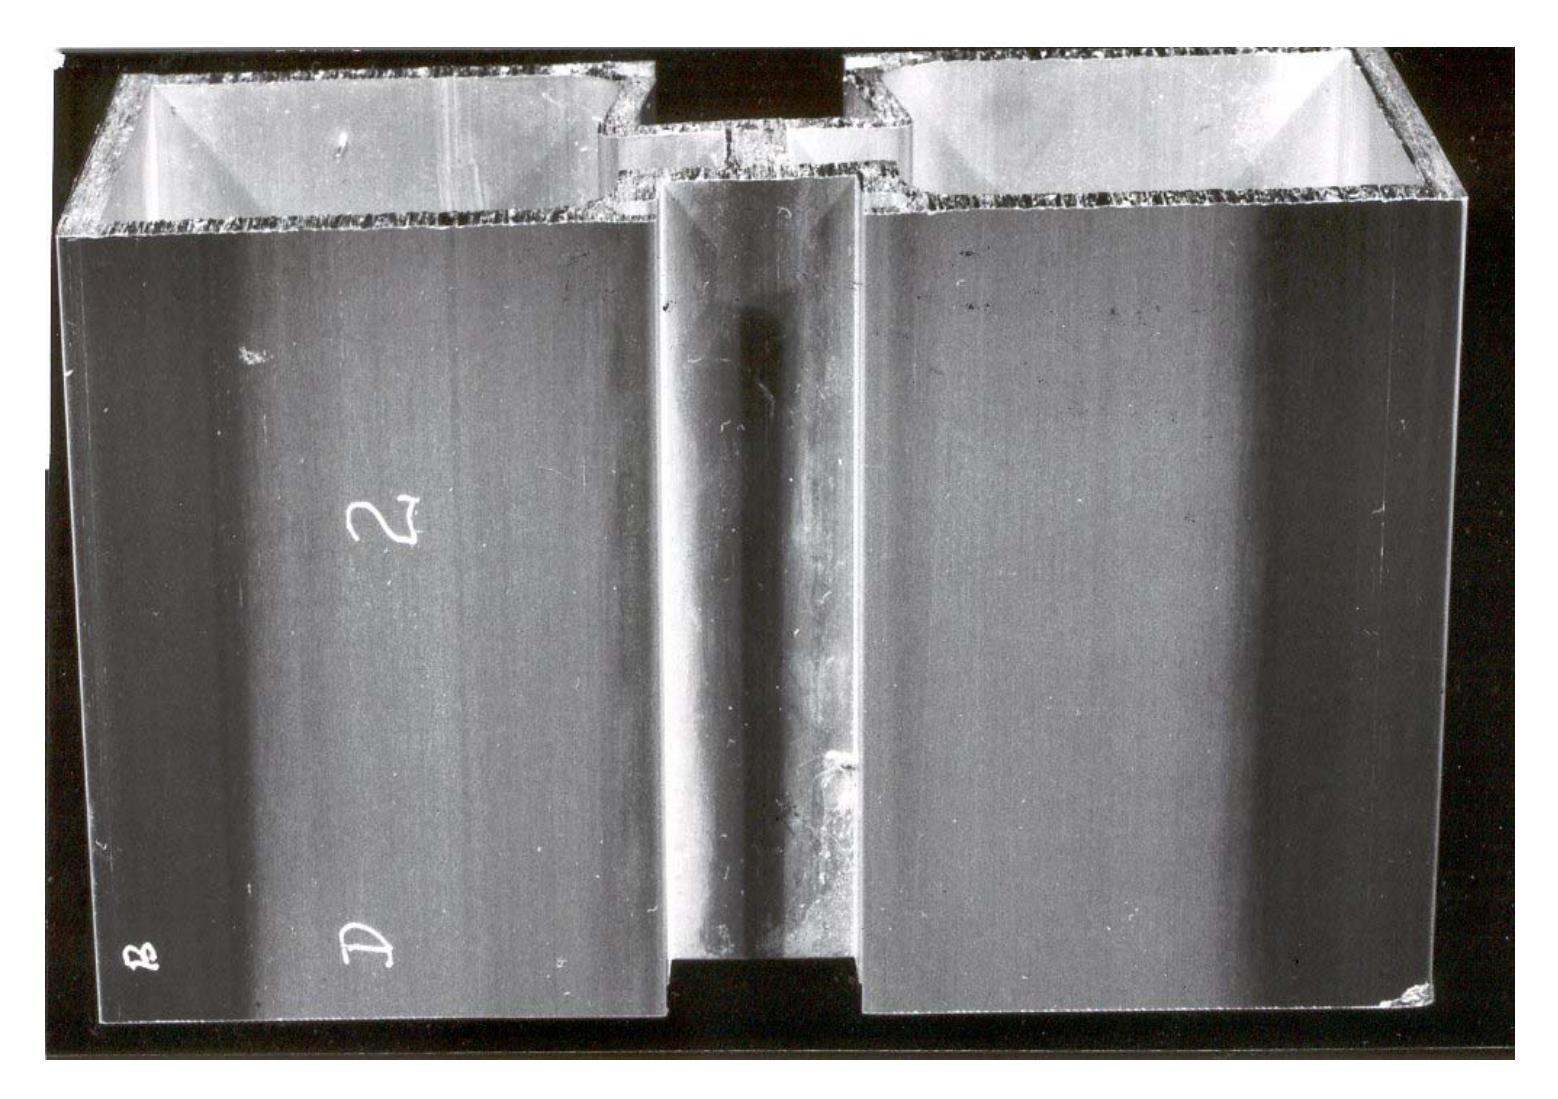
Figure 30. Streaking due to mixing of alloys on a hollow extrusion.

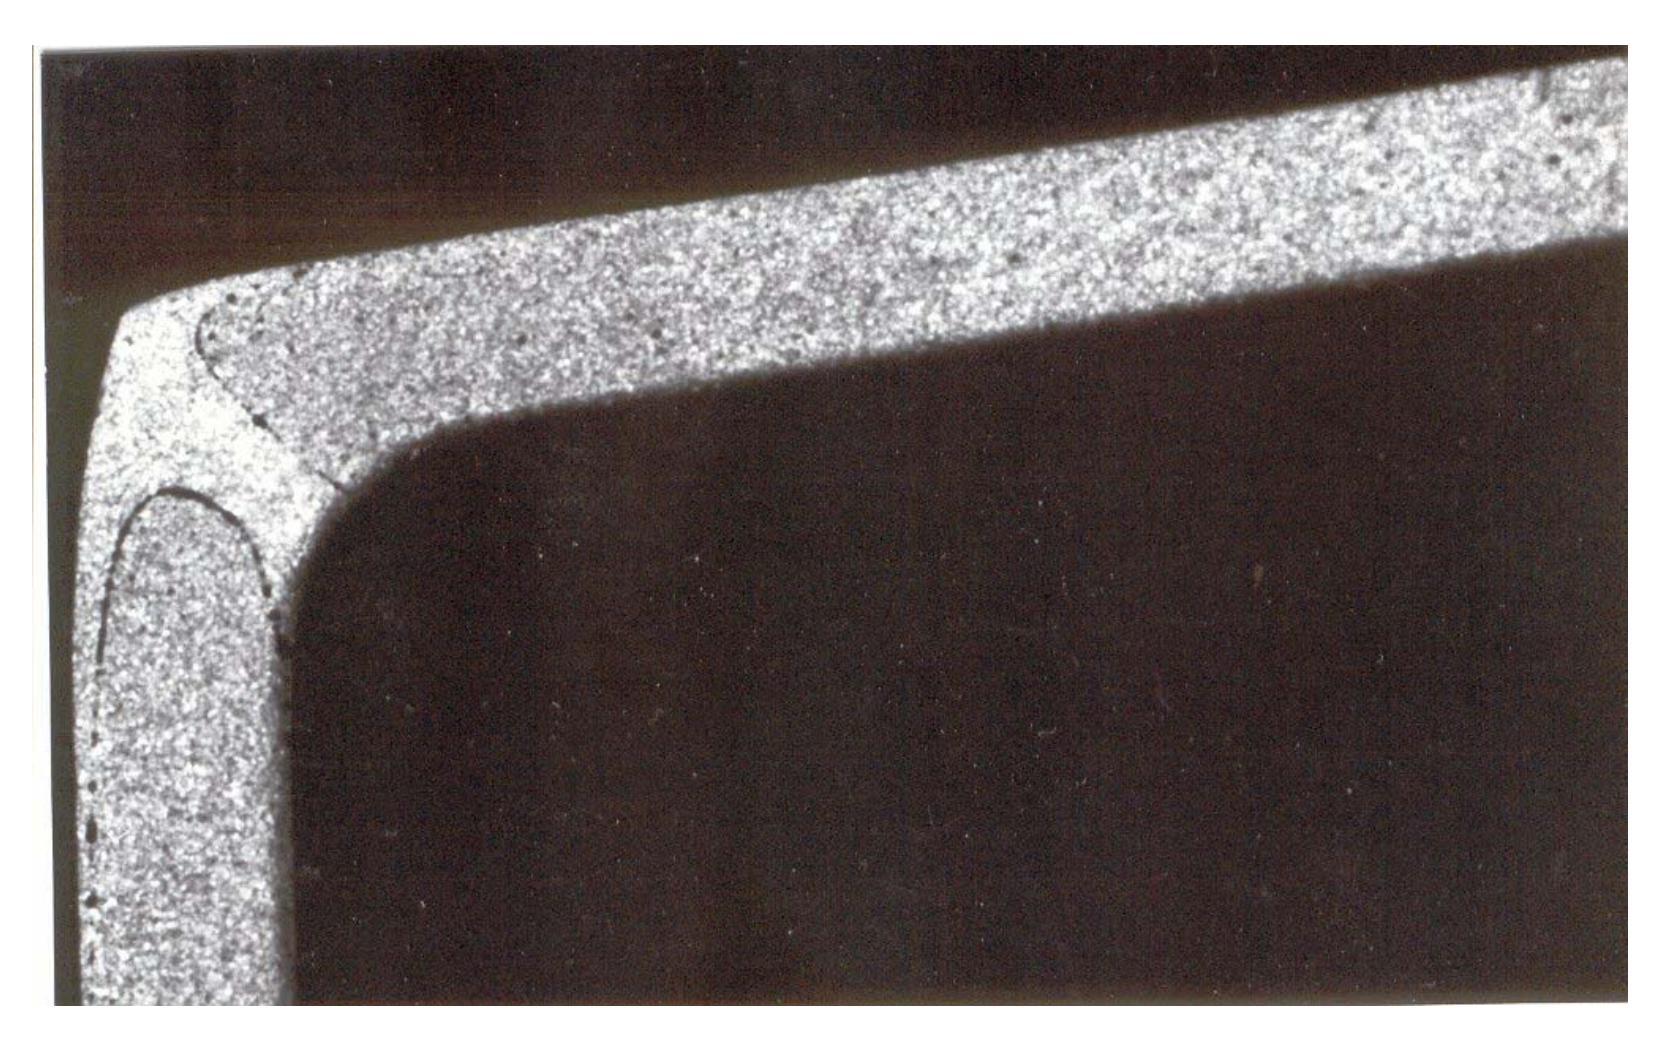
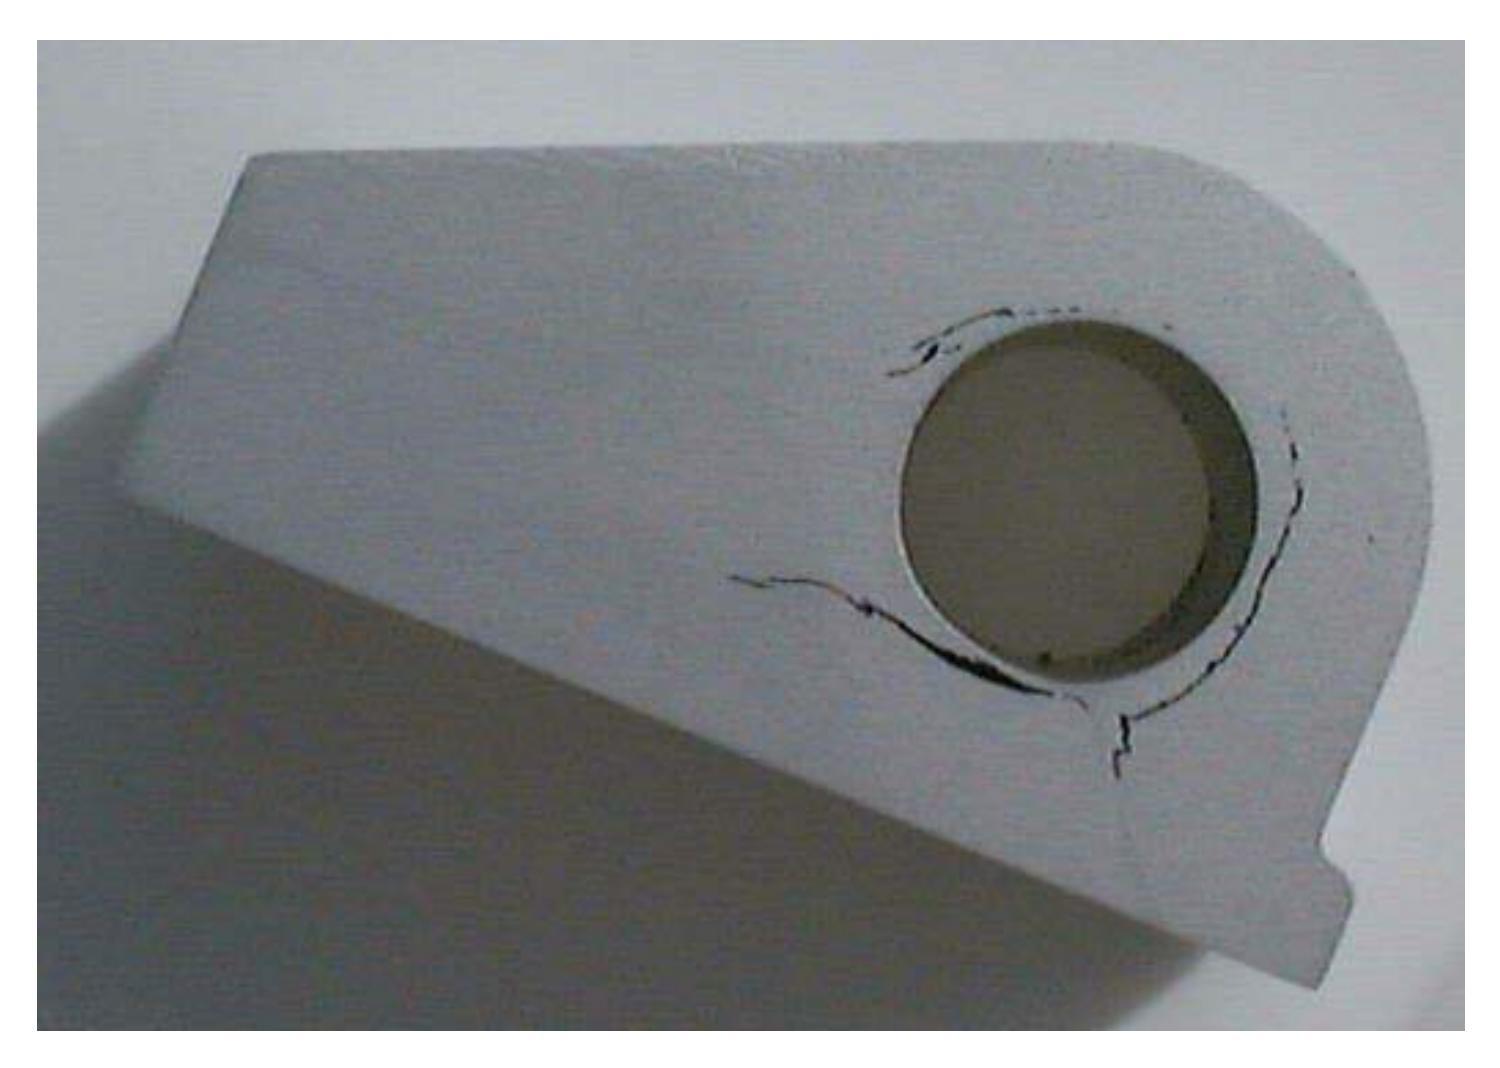
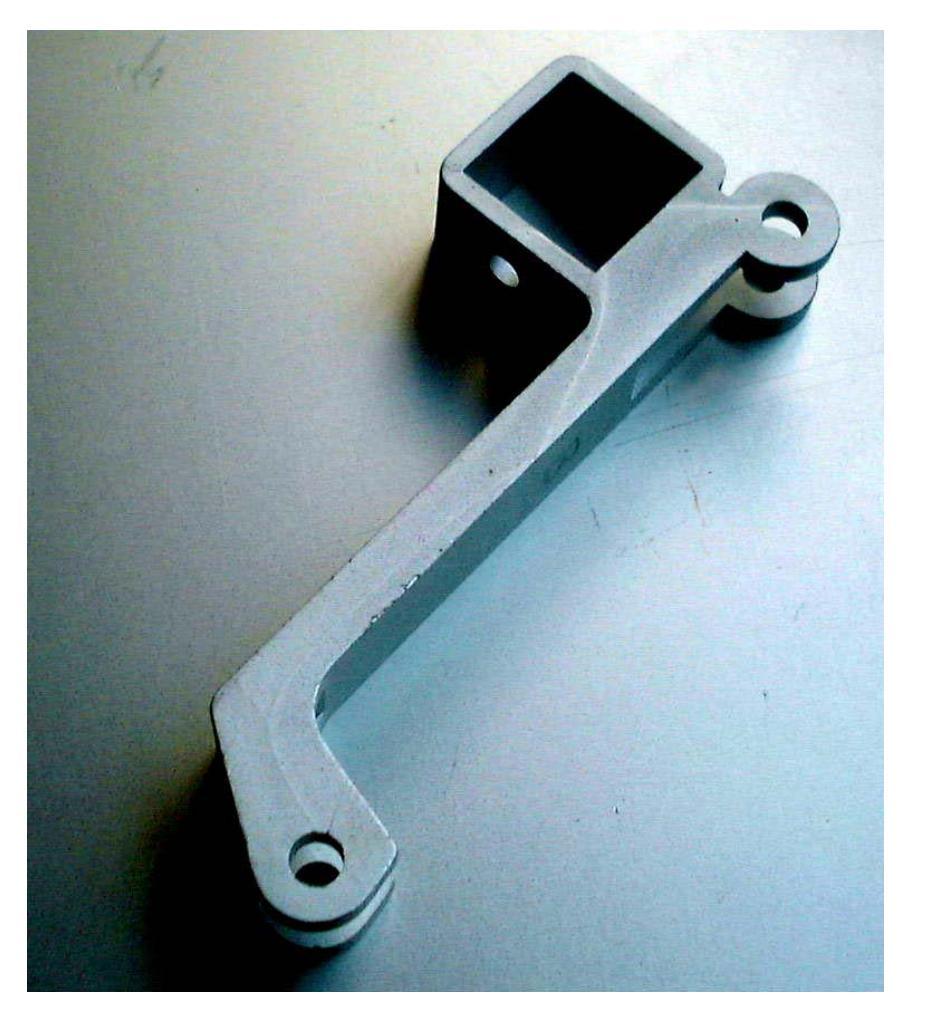
Figure 37. Etched cross sections of extrusions demonstrating back end defects and associated streaking.

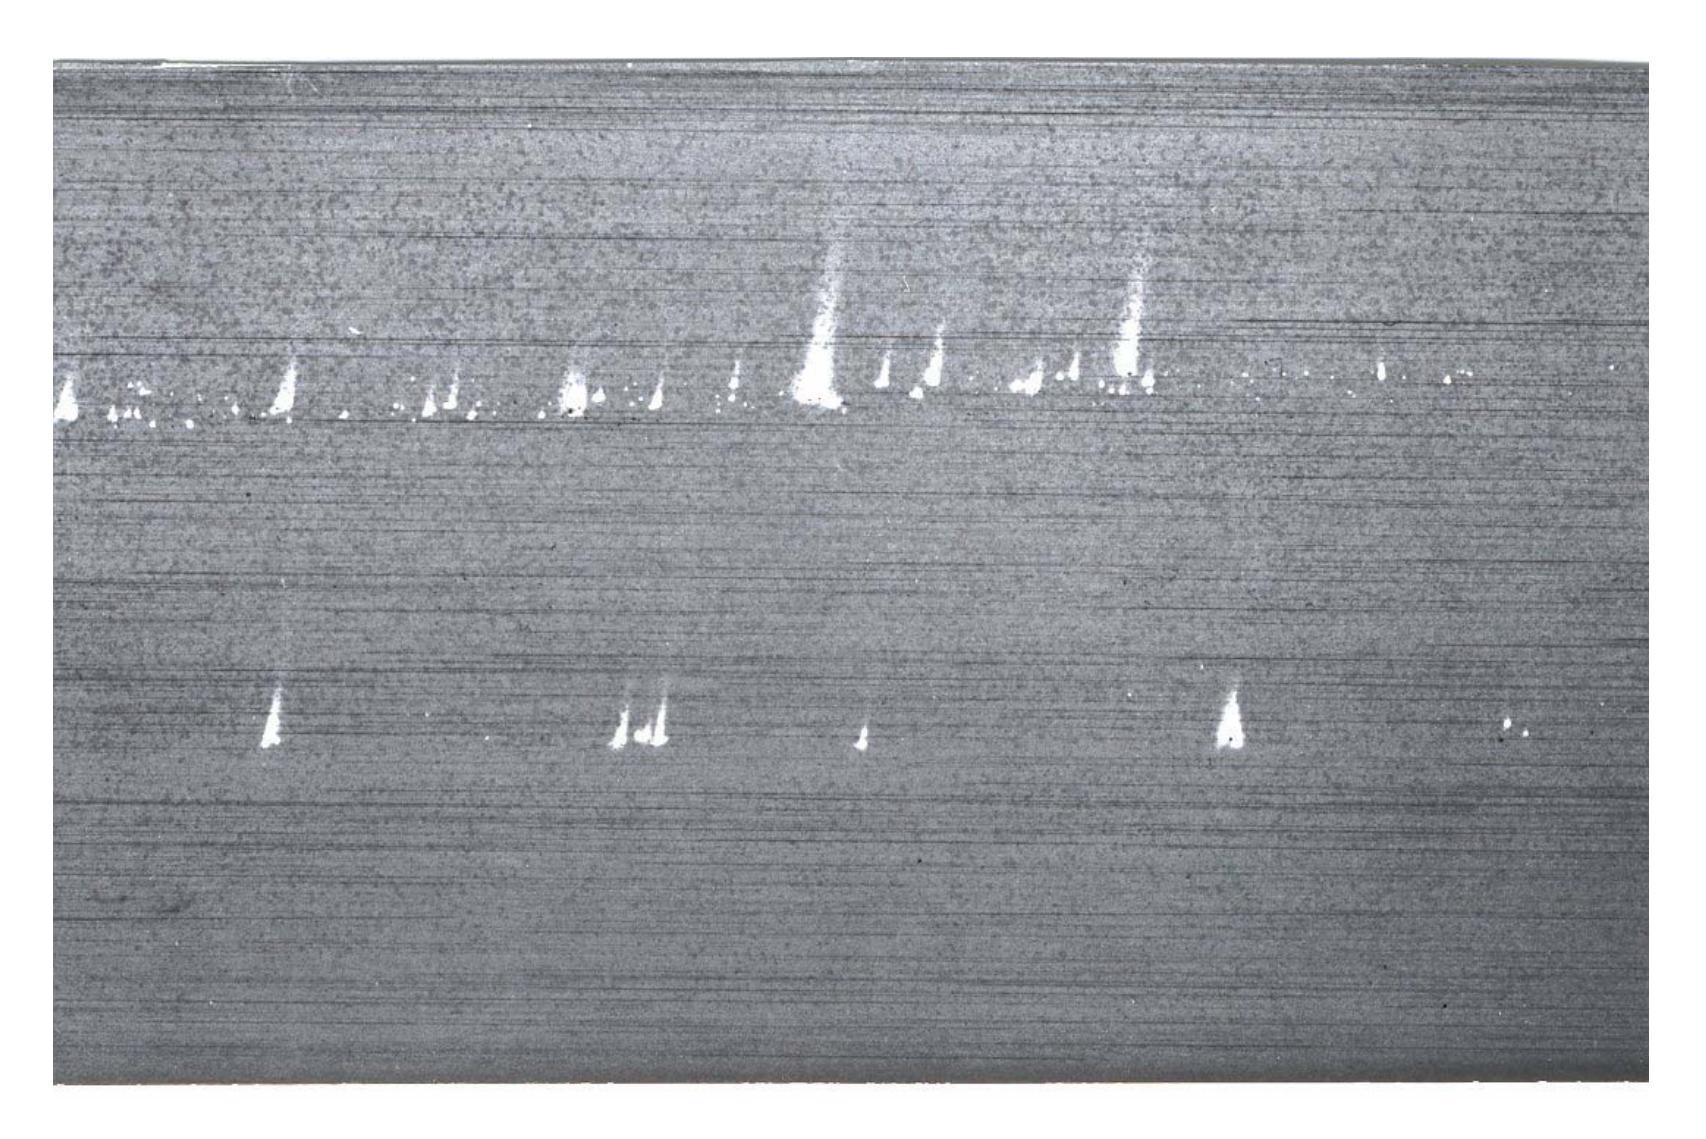
Figure 38. Surface streaking or flecks due to back end defect or transverse weld on an anodized and electrolytically pigmented extrusion.

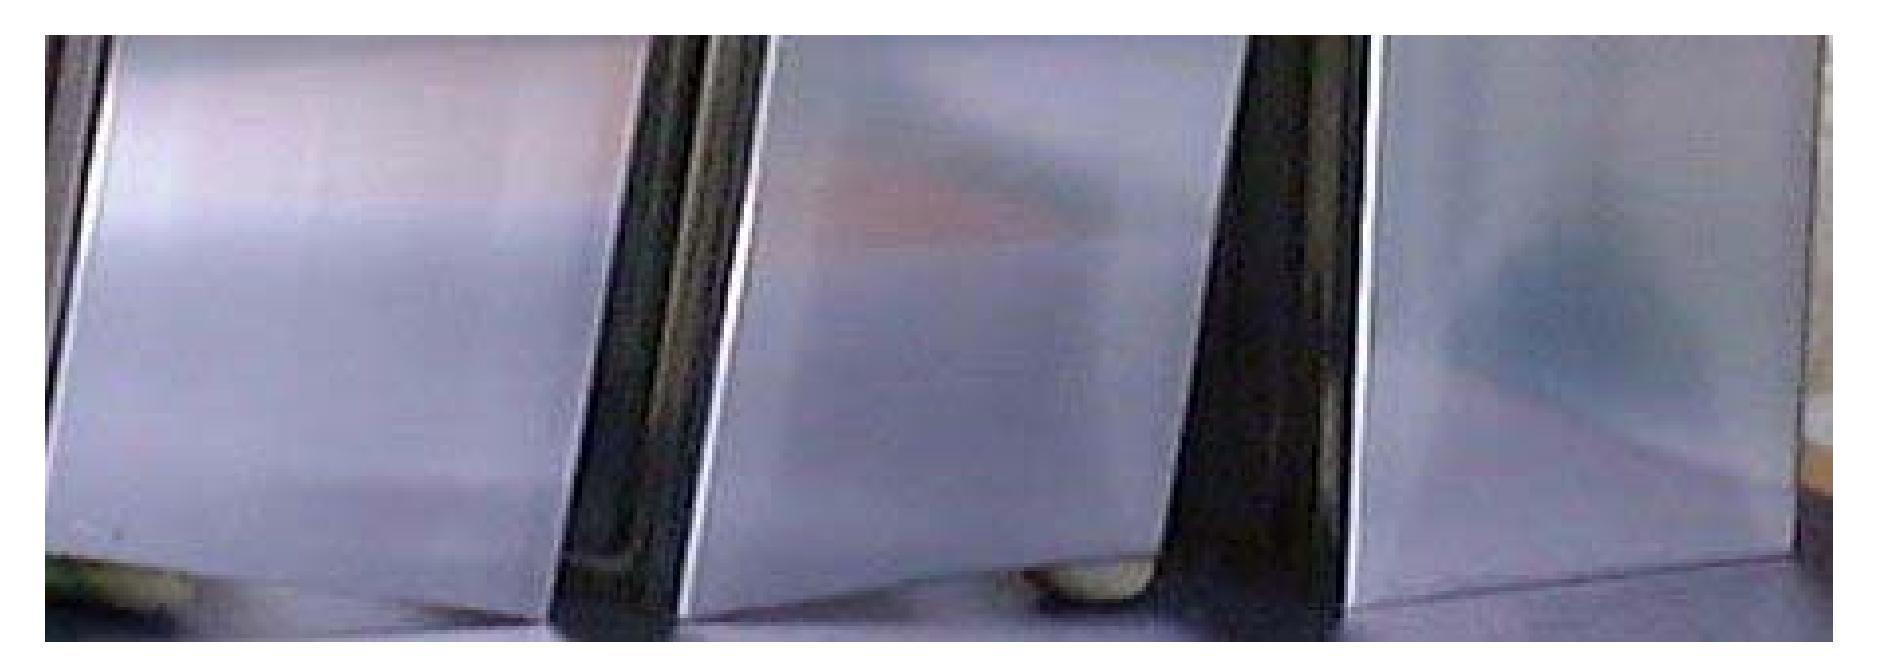
Figure 39. Effect of relatively uniform and taper polishing on the bright band on a polished and anodized extrusion showing a dulling due to a thin segregate layer on the surface near the edges. The heavier the polish the wider is the area of the brighter subsurface material revealed.

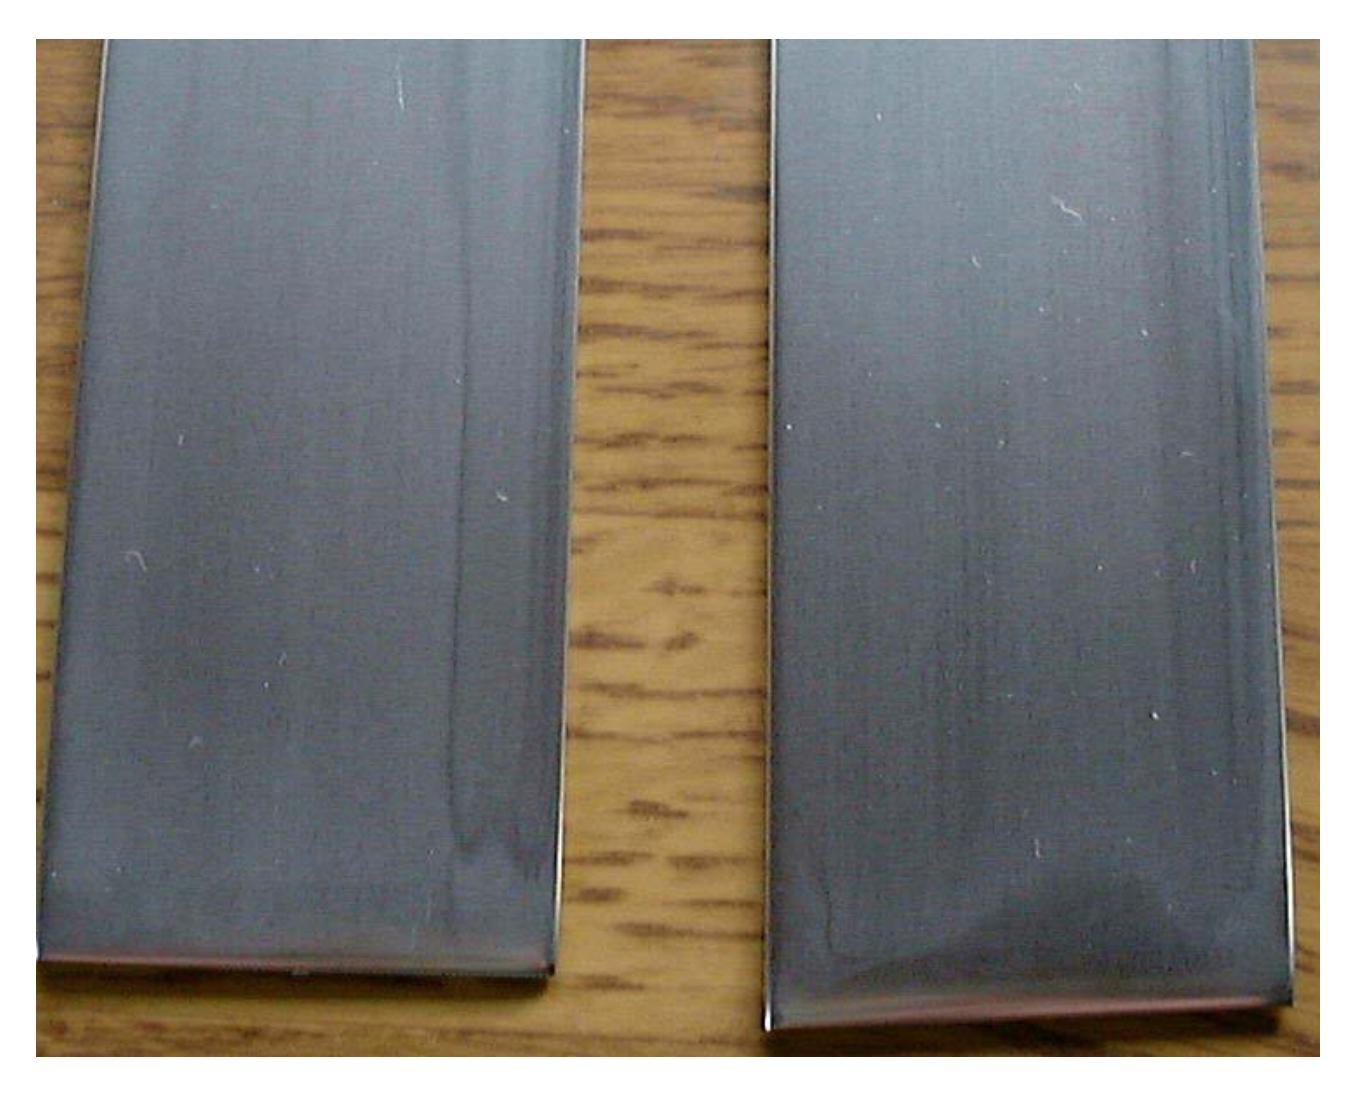
Figure 40. Effect of taper polishing and anodizing a section having segregational streaking or back end defect streaking, upon the position of the streak. The heaviest polishing has been applied towards the bottom of the samples in this picture.

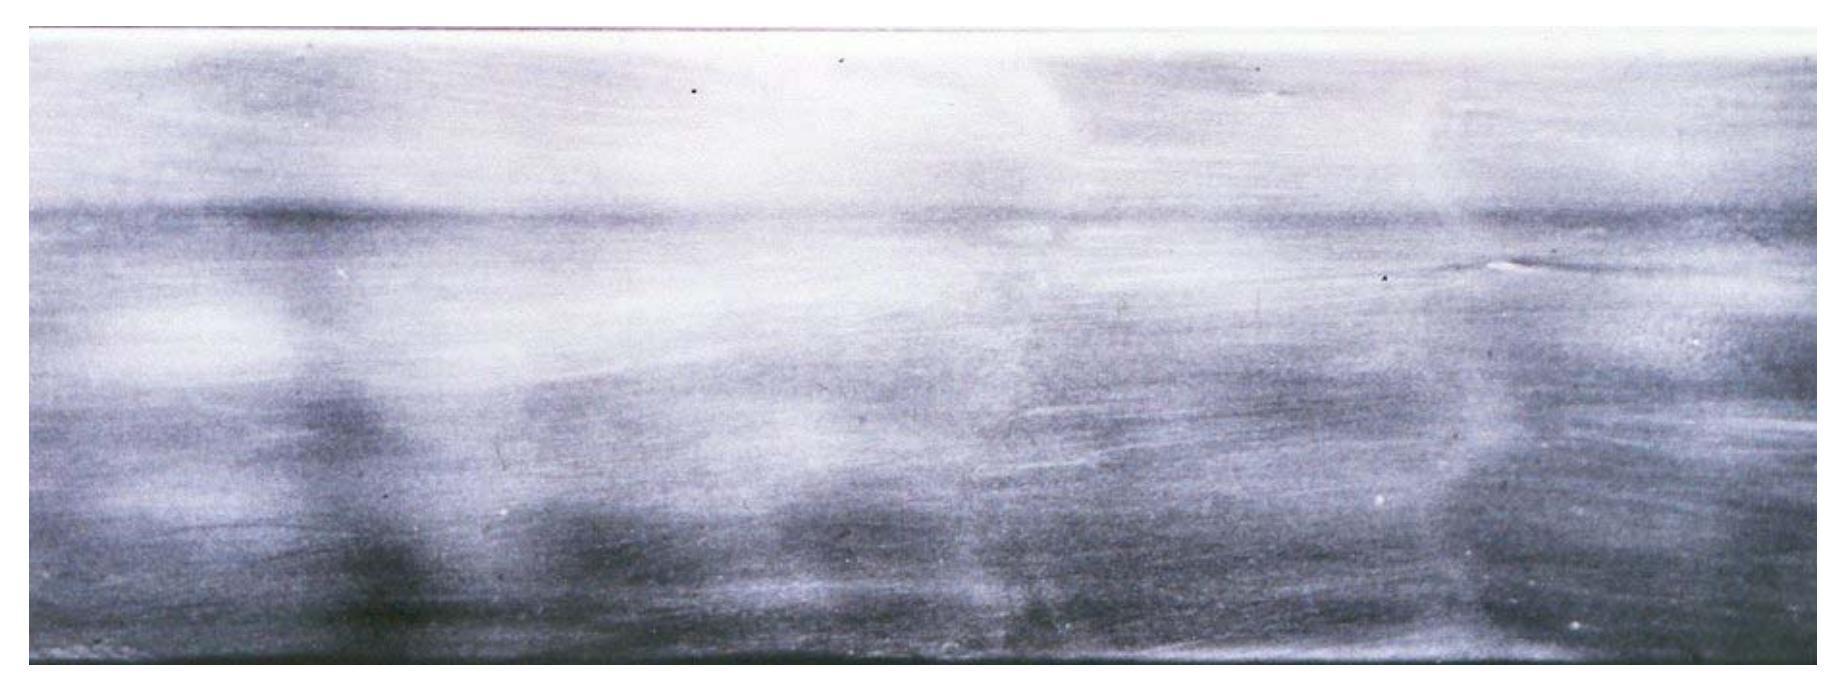
Figure 41. Non-uniform appearance on an etched and anodized extrusion caused by poor mechanical polishing.

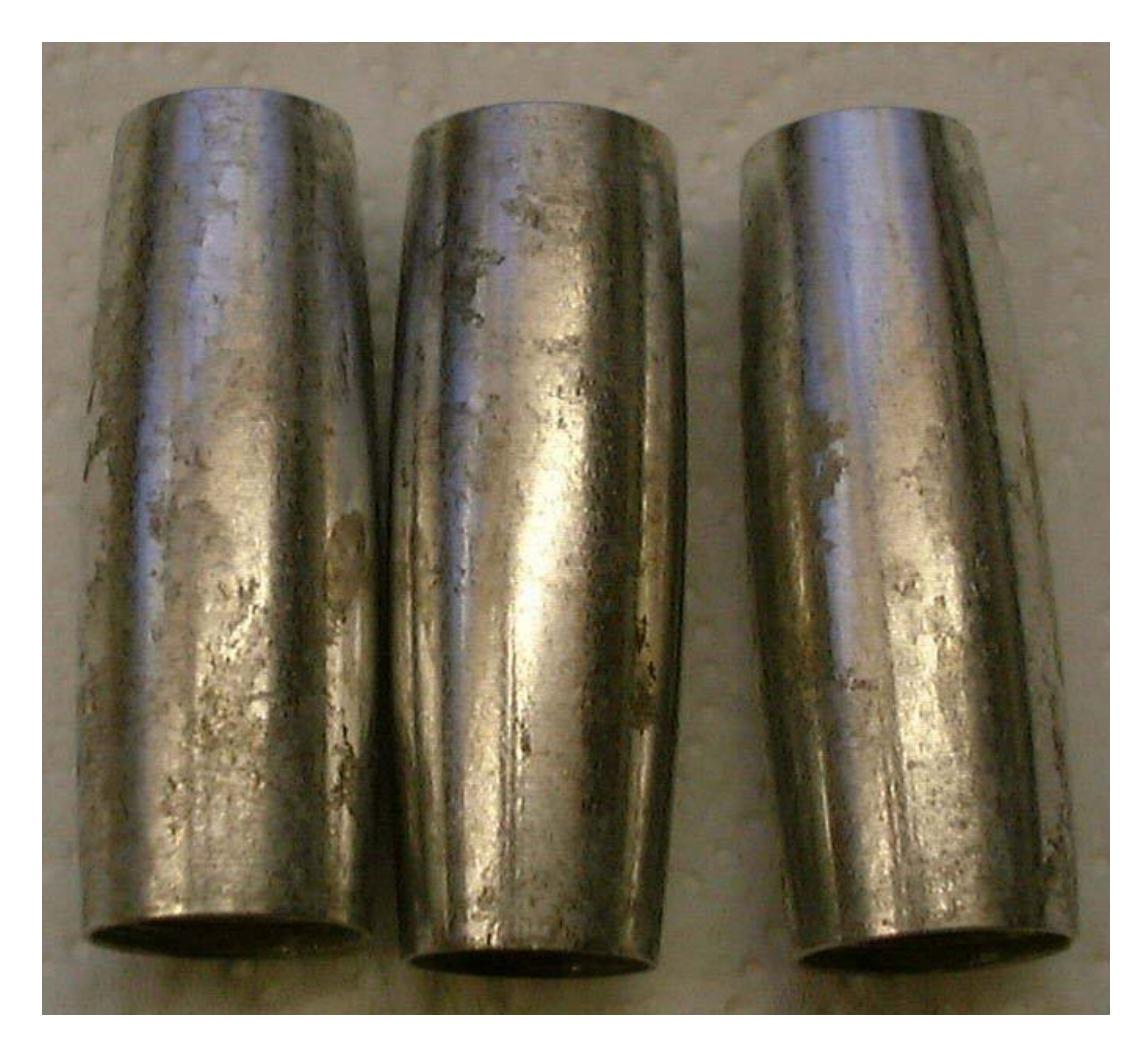
Figure 42. Water staining on samples of machined tube in storage prior to etching and anodizing.

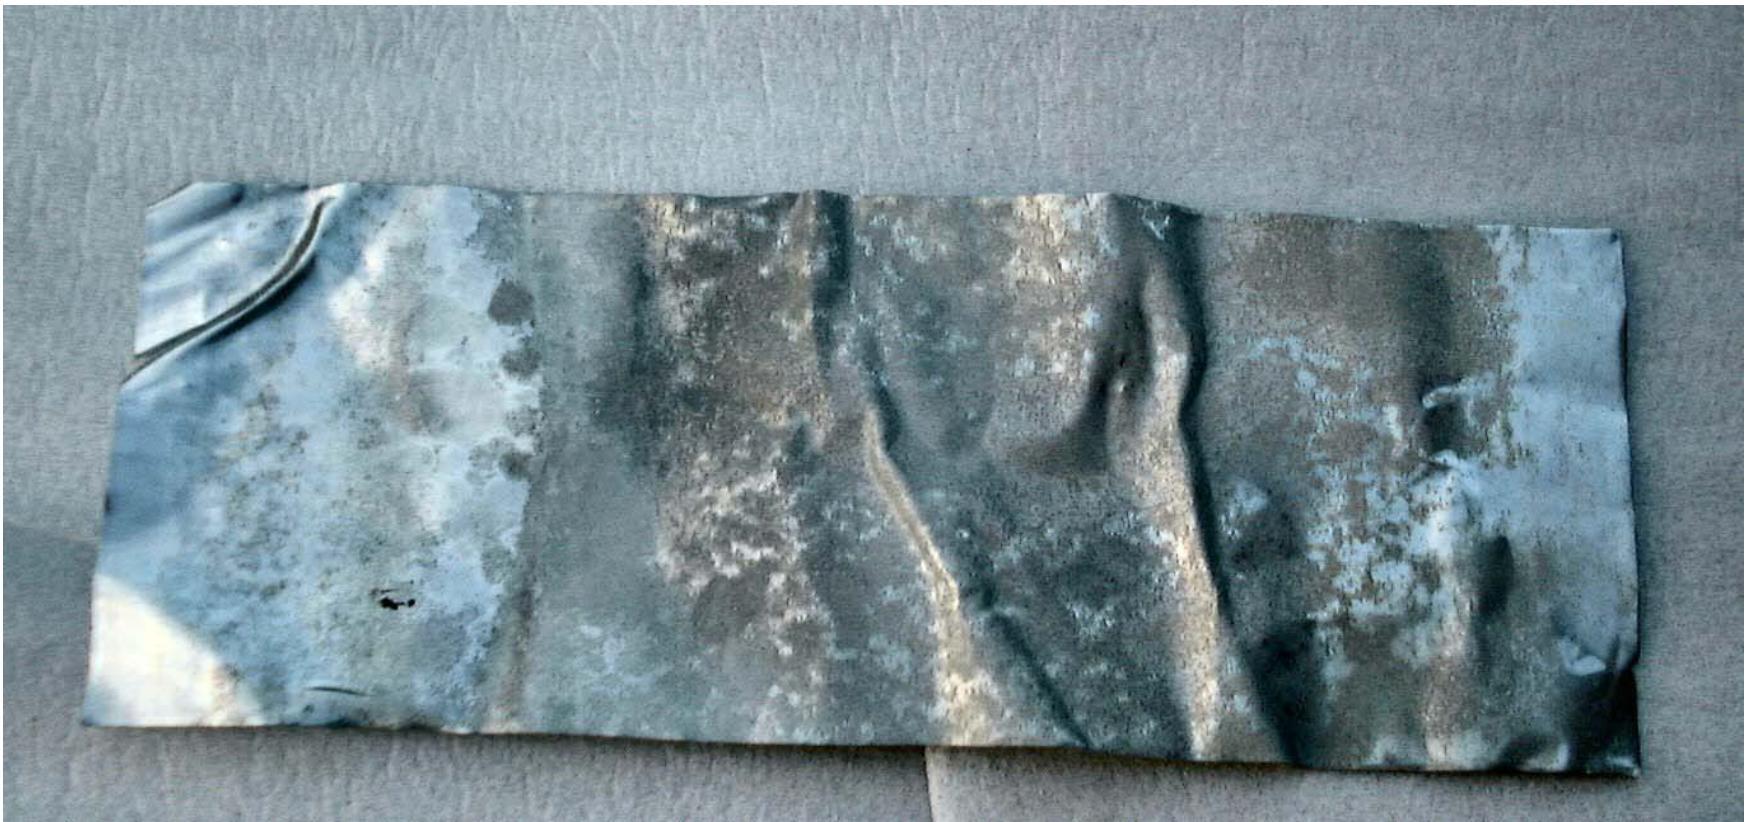
Figure 43. Water staining on aluminium 1050 alloy foil caused by the coiled alloy becoming wet in storage.

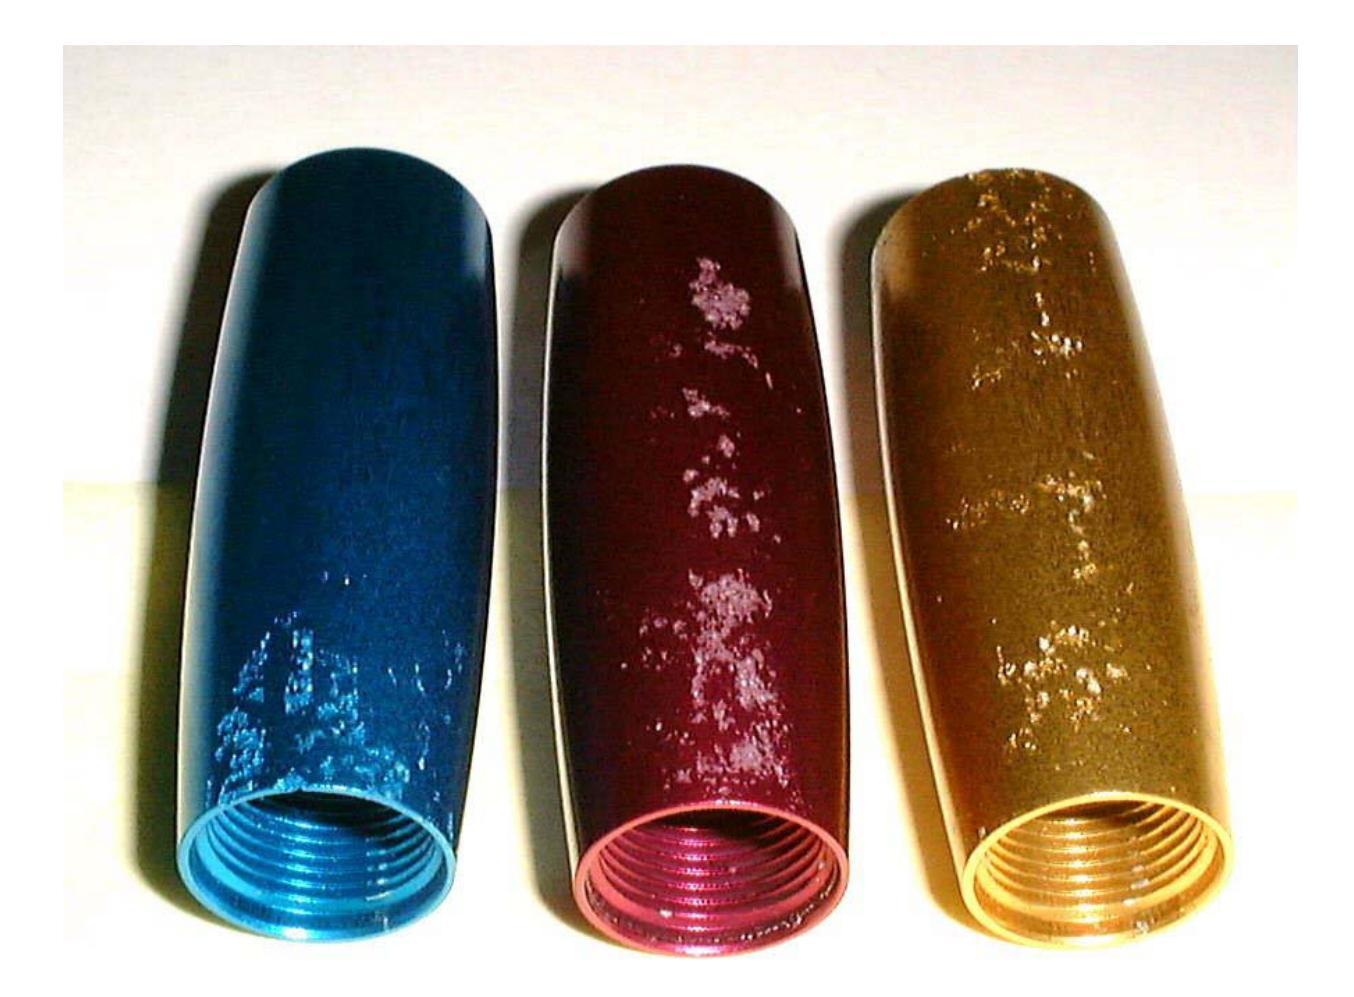
Figure 44. Samples of water stained material from same batch as samples in Figure 29 after brightening anodizing and colouring showing that quite severe corrosion was associated with the water staining
