The Identification and Prevention of Defects on Anodized Aluminium Parts

by Ted Short, Aluminium Finishing Consultant

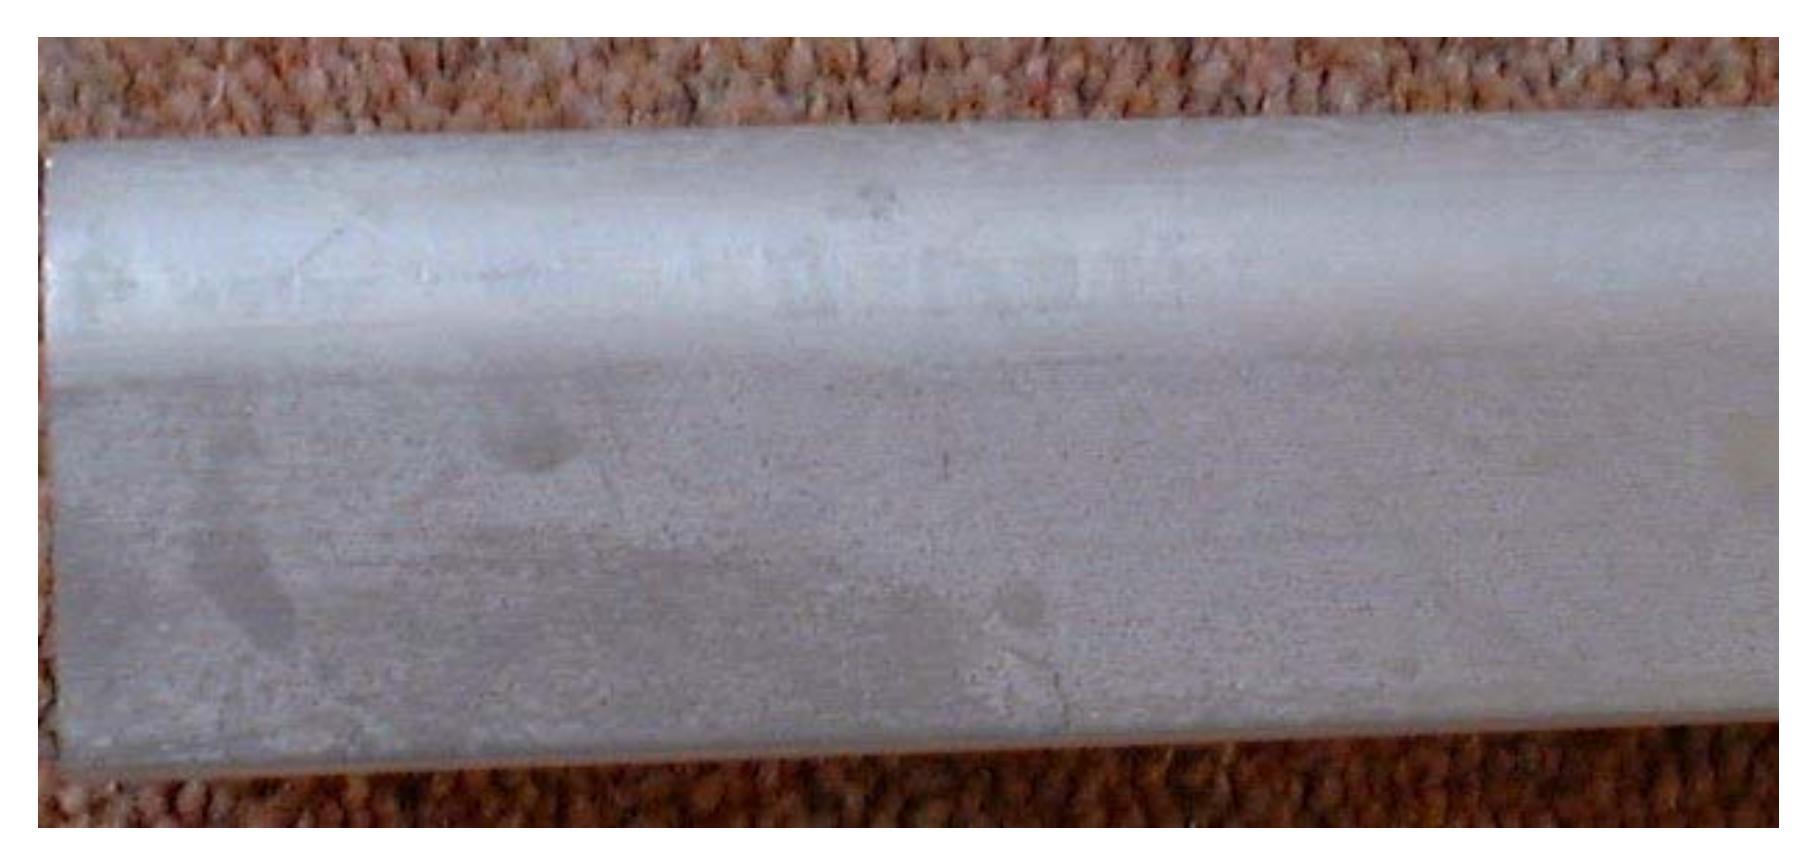
Figure 46. Typical example of 'white etch bloom' on 6063 extrusion.

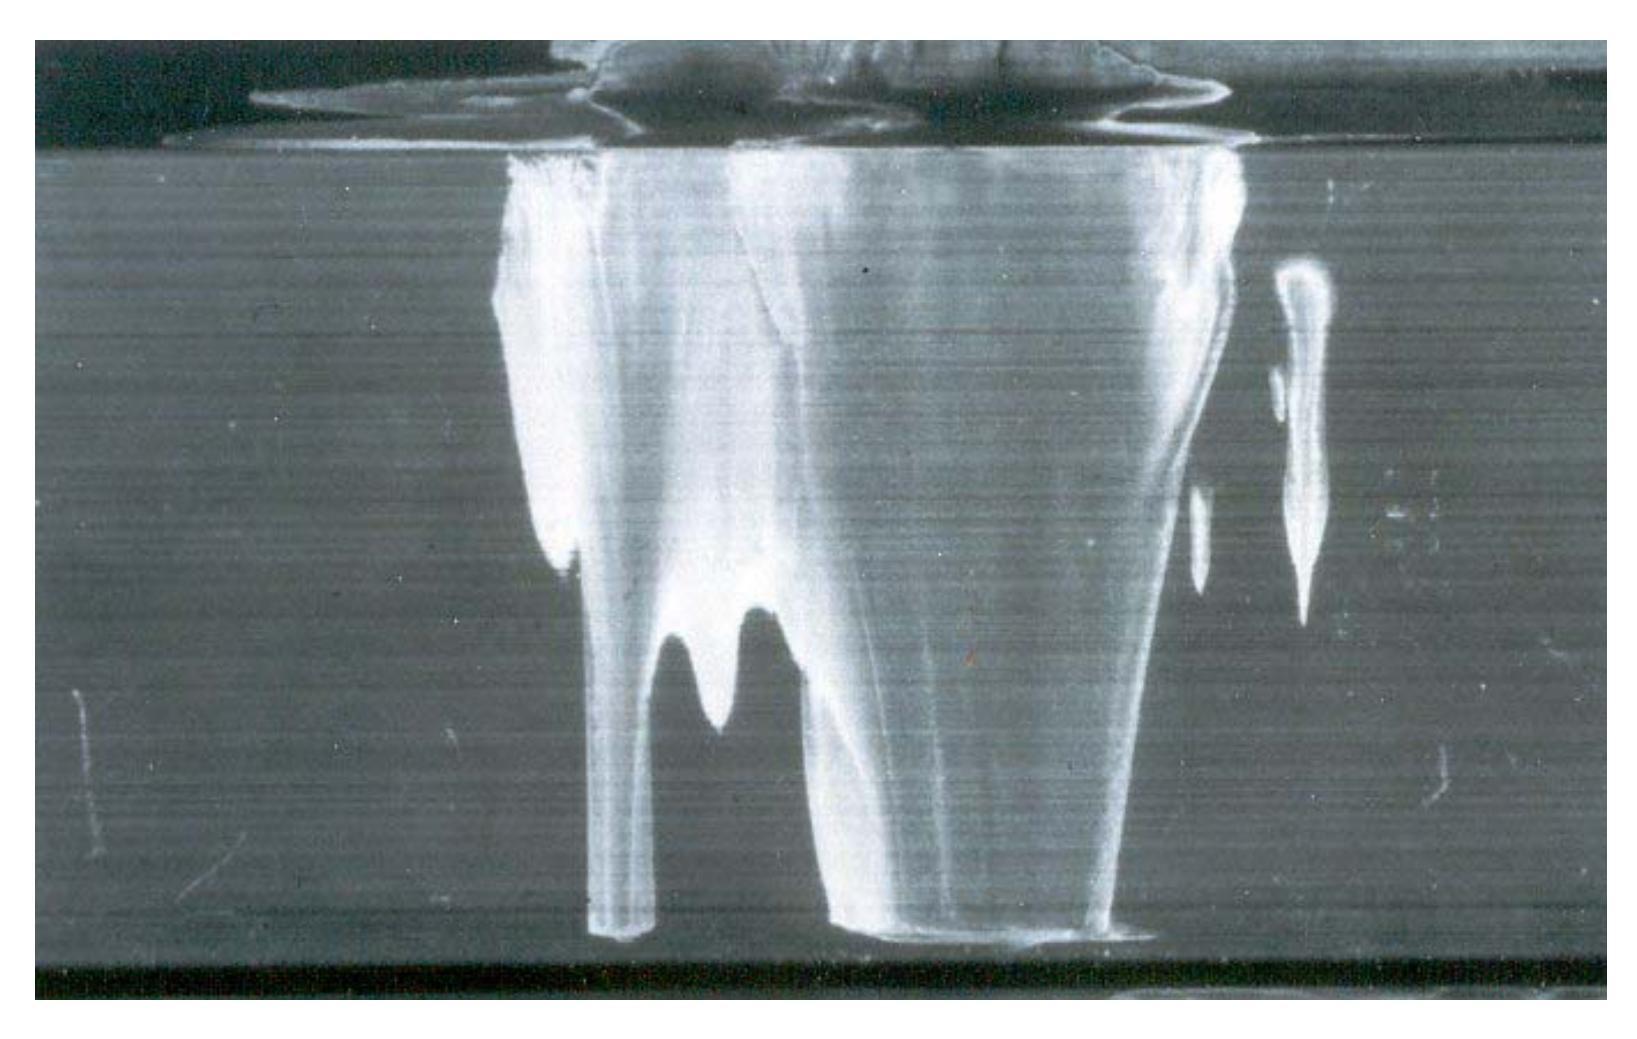
Figure 48. Example of severe transfer etch staining on 6063 alloy extrusion.

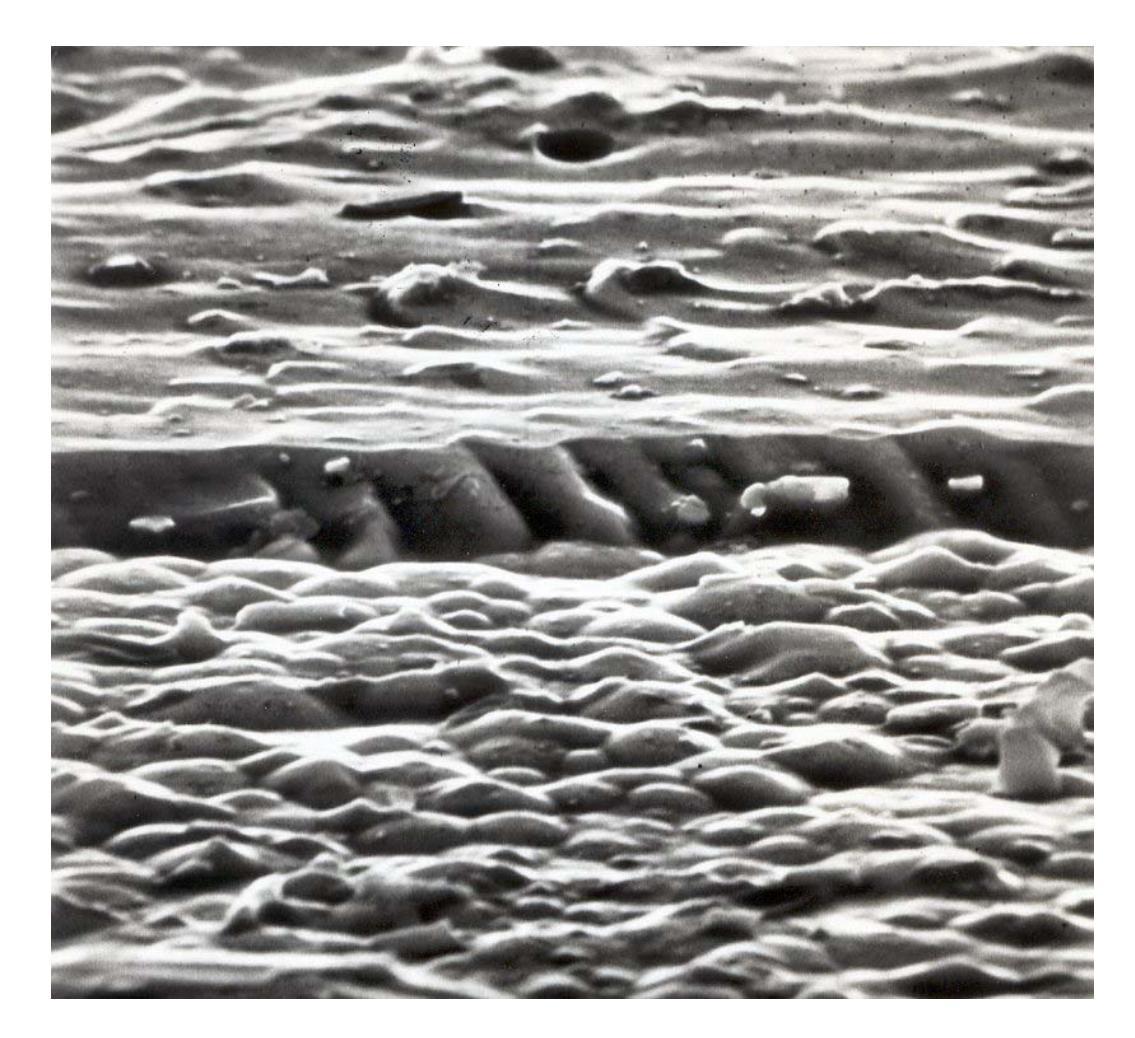
Figure 49. SEM picture of the surface of a 6063 extrusion showing spangle etching and illustrating the 5μ m step between grains caused by the preferential attack. (x 2000)

Figure 49. SEM picture of the surface of a 6063 extrusion showing spangle etching and illustrating the 5µm step between grains caused by the preferential attack. (x 2000)

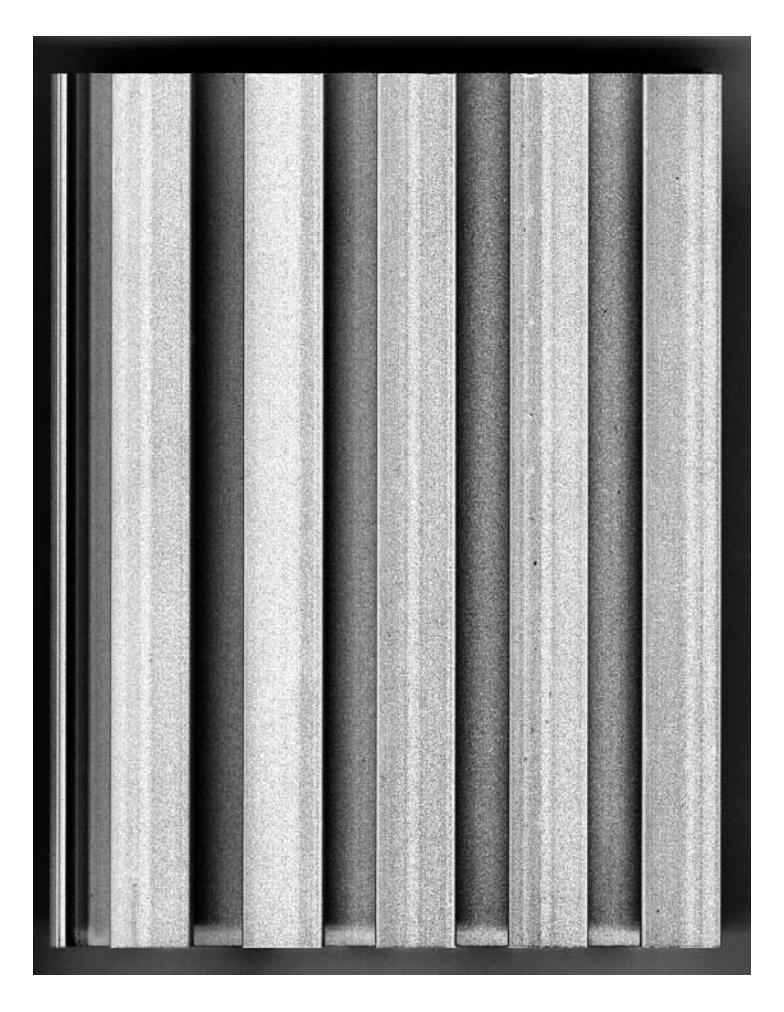
Figure 50. 6063 extrusion containing 0.04% Zn showing a light spangle etch.

The maximum Zn content for extrusions in 6063 alloy to be used for architectural anodizing should not exceed 0.03%. Modern etches contain additives formulated to complex the zinc and hence eliminate the problem regarding zinc contamination of the etching solution. The zinc is often precipitated as zinc sulphide using an additive based on sodium sulphide. This is the reason for many long-life etch systems turning very black during use.

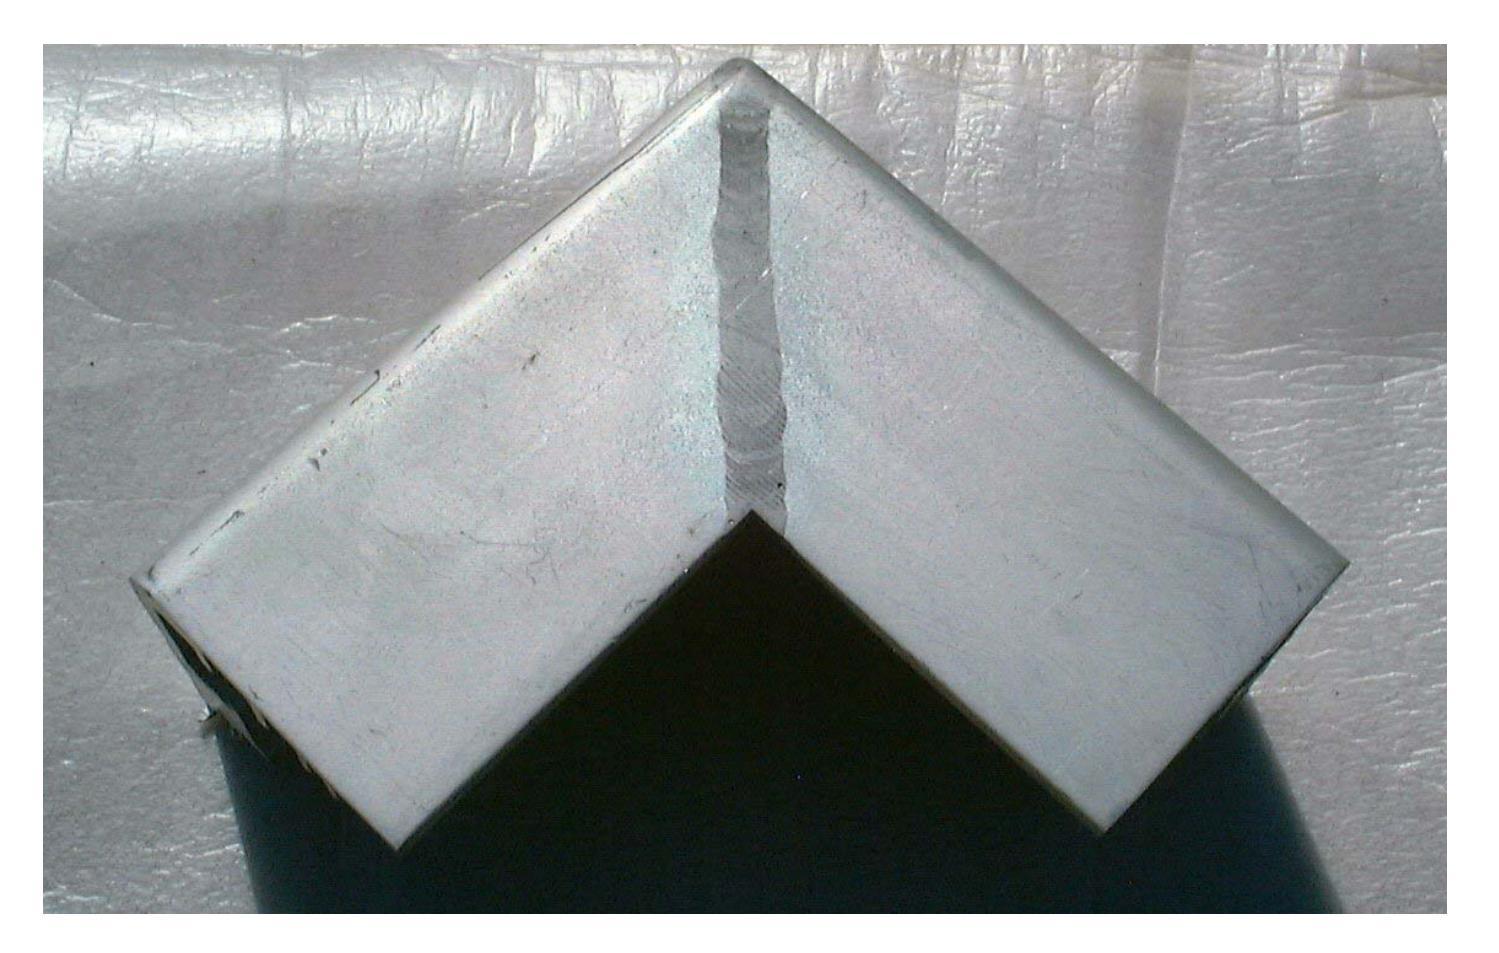
Figure 53. Staining on a 6063 alloy welded and linished mitred window frame joint after normal etching and anodizing. The dark nature of the weld suggests the filler rod used for welding contained a higher silicon content than that of the alloy. The heat-affected zone in the extrusion adjacent to the weld is just visible.

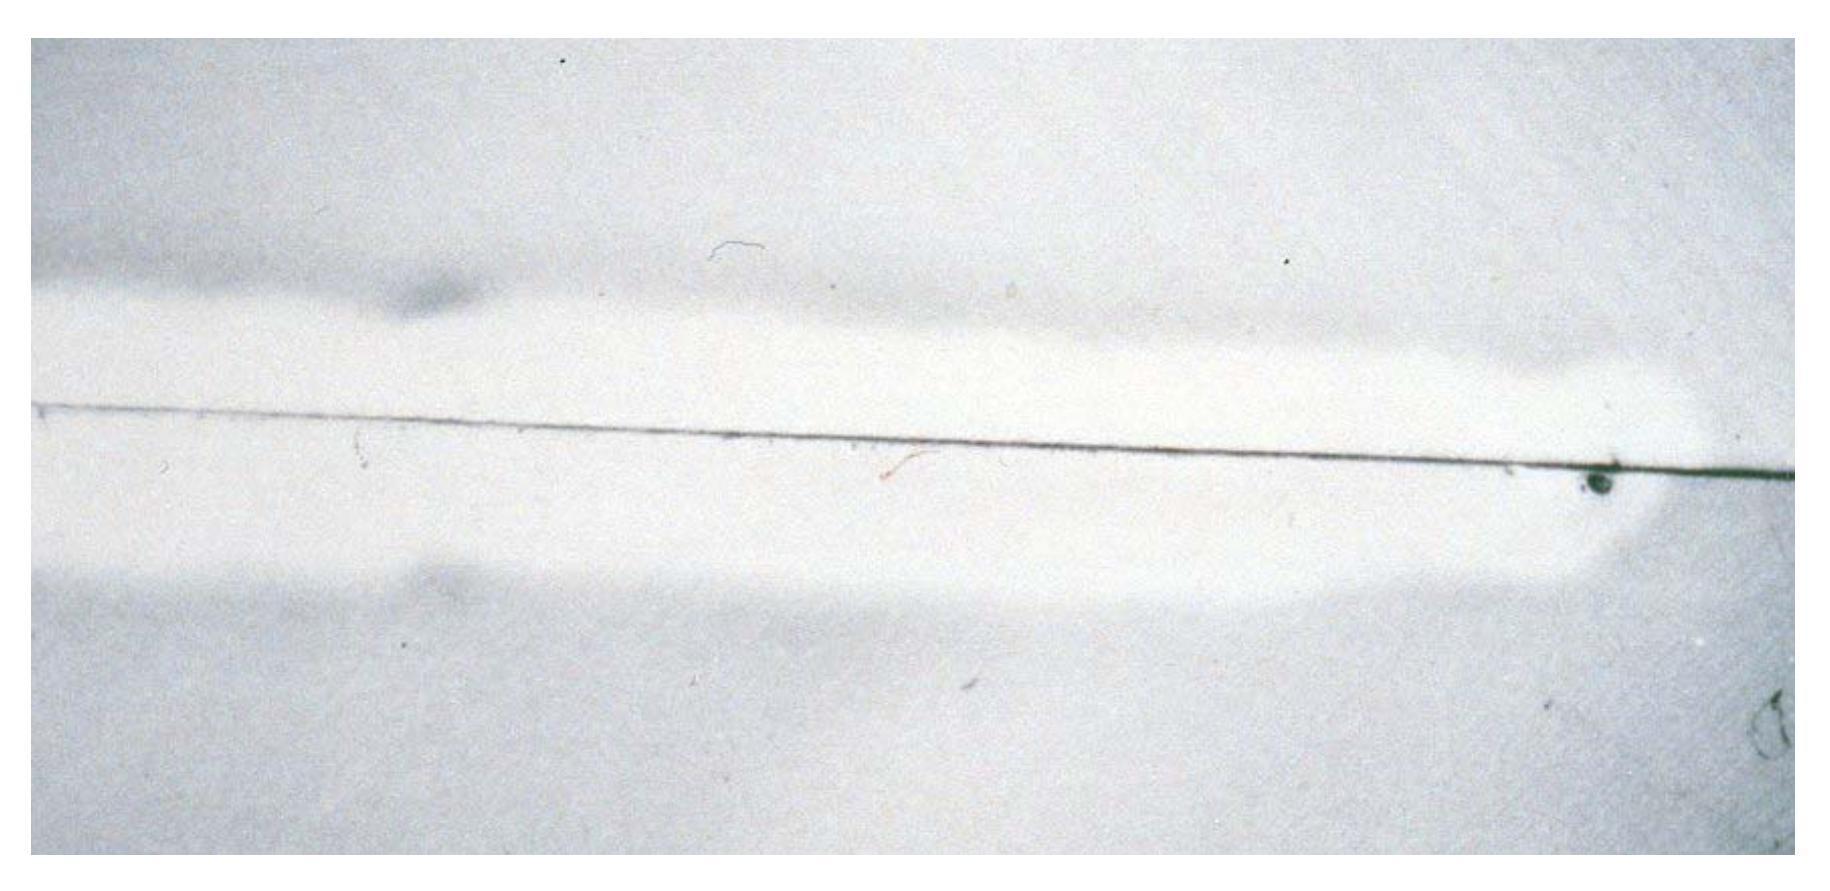
Figure 54. Heat-affected zone on a sample of thin gauge Al-Mg sheet when the part was welded on the back side only of the sheet.

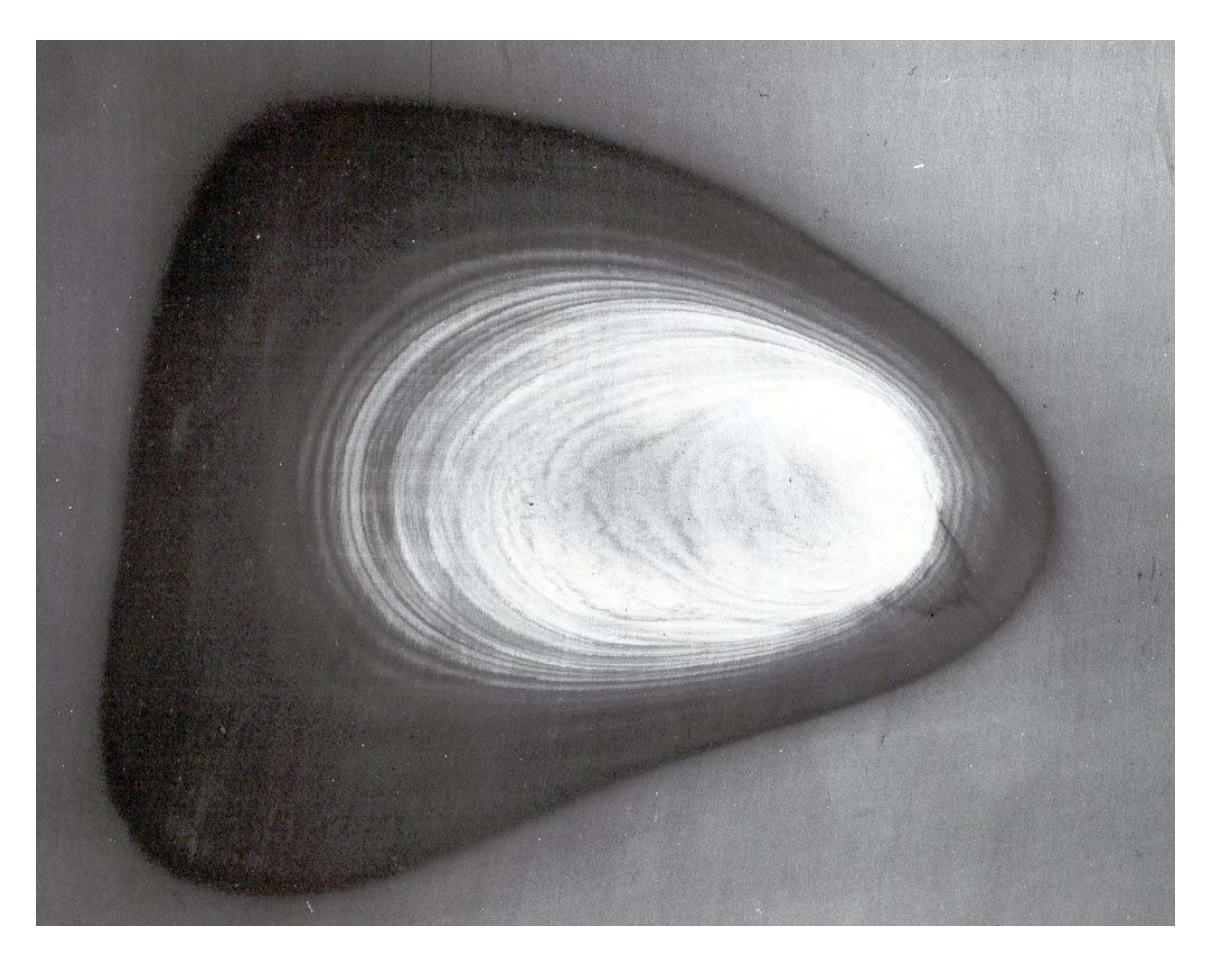
Figure 57. An example of anodizing burn in sulphuric acid electrolyte.

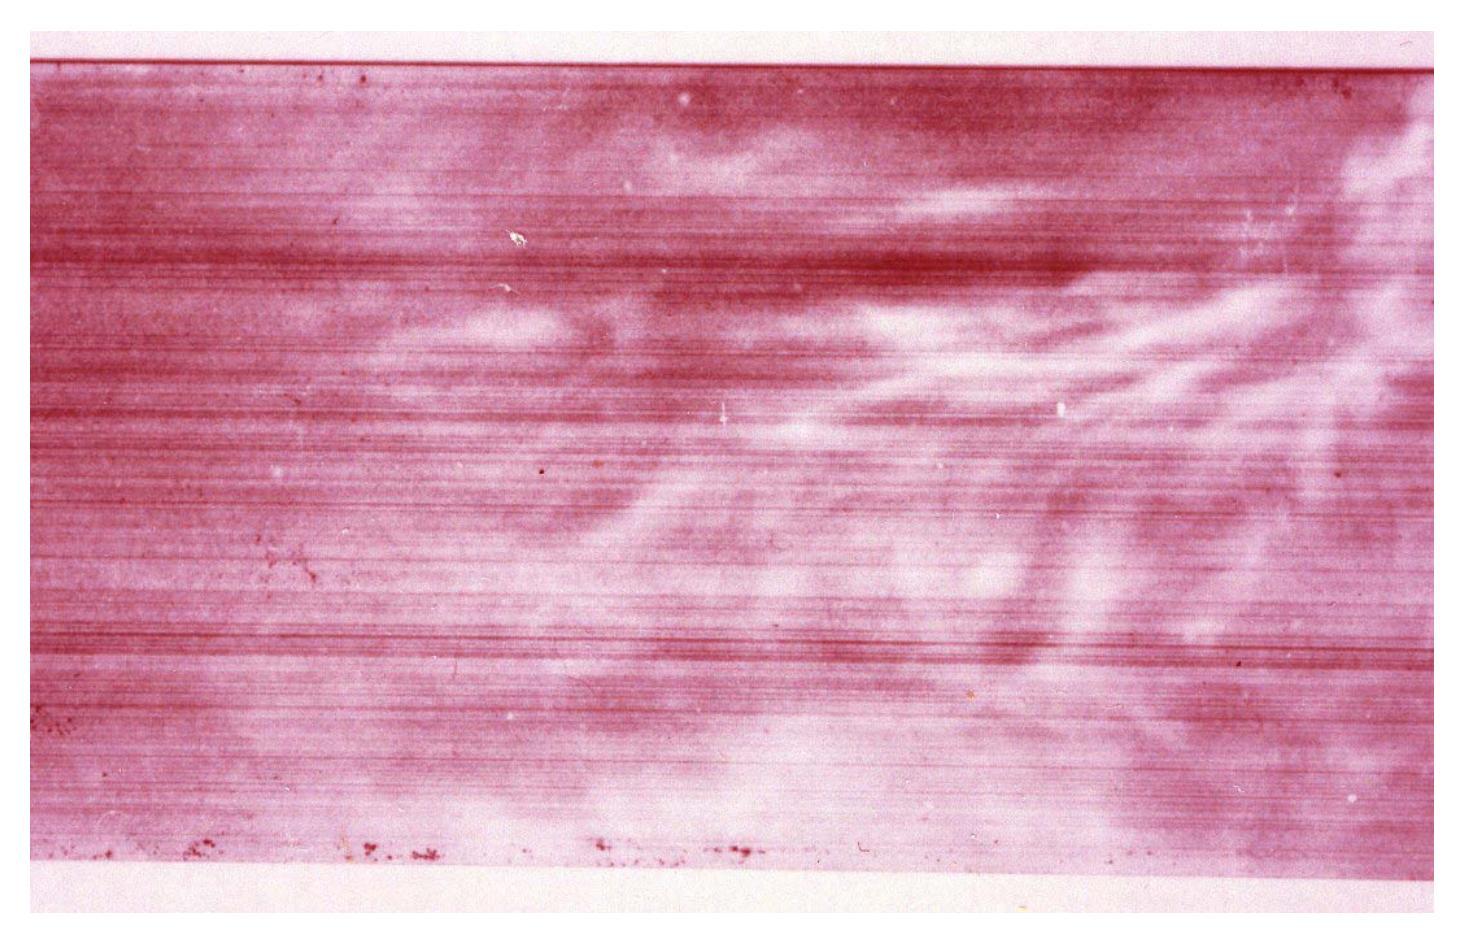
Figure 58. Patchy dyed finish due to poor rinsing of an anodic film before colouring.

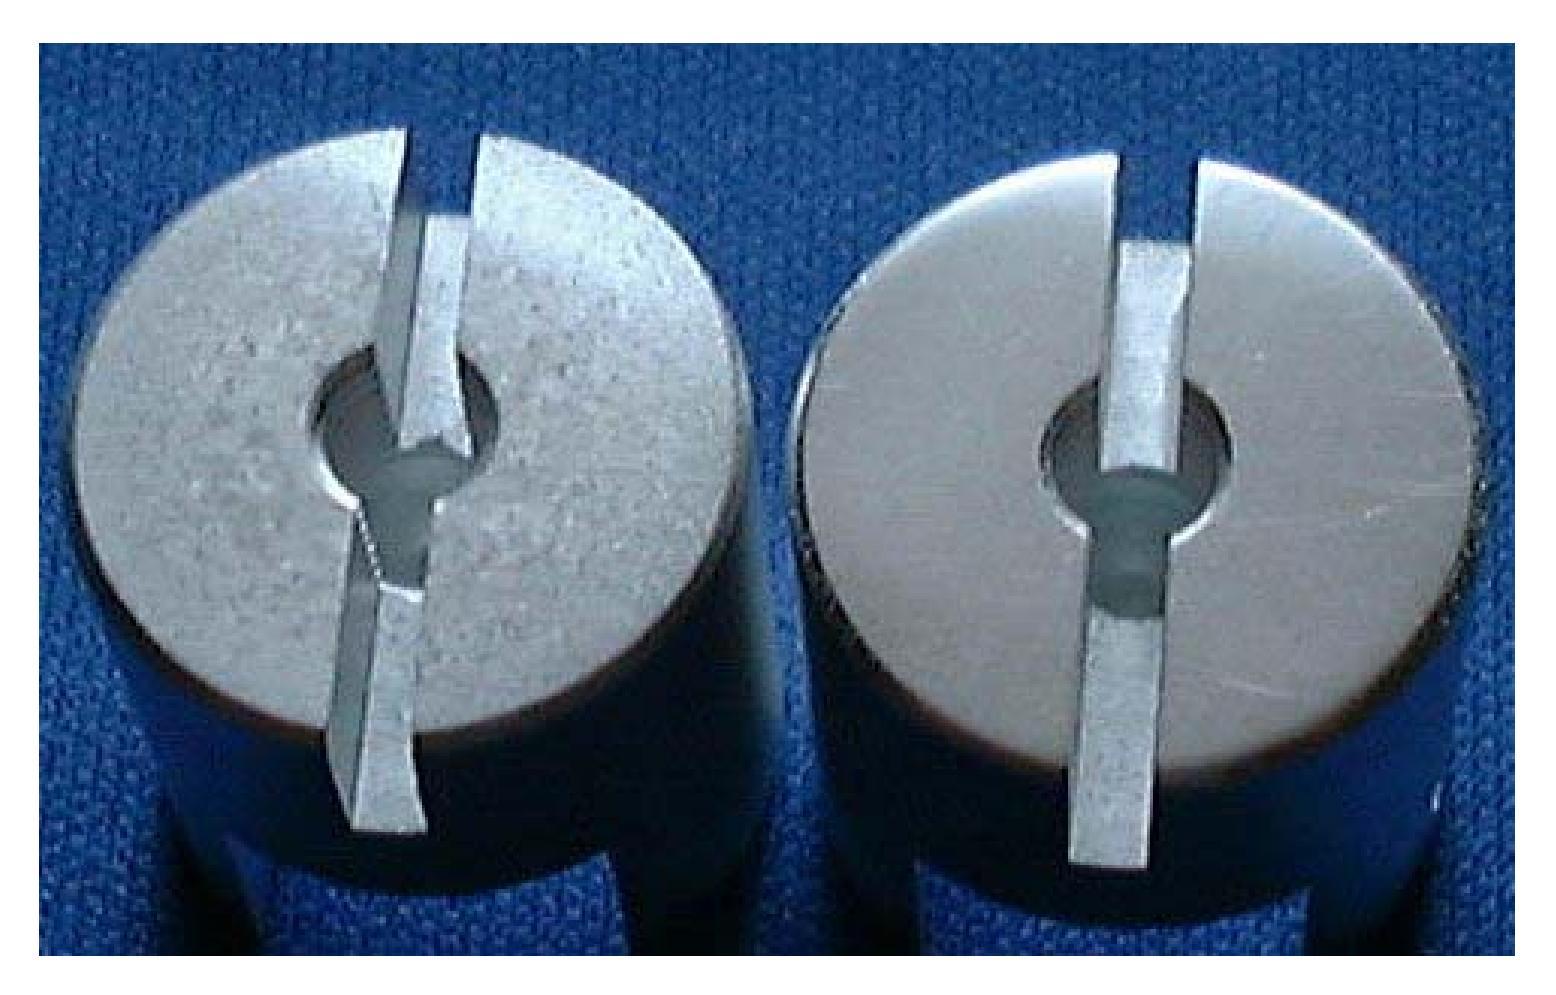
Figure 67. Variation in degree of coarse grain on components machined from the same bar stock. The sample on the left has coarse grain, that on the right, normal grain size.

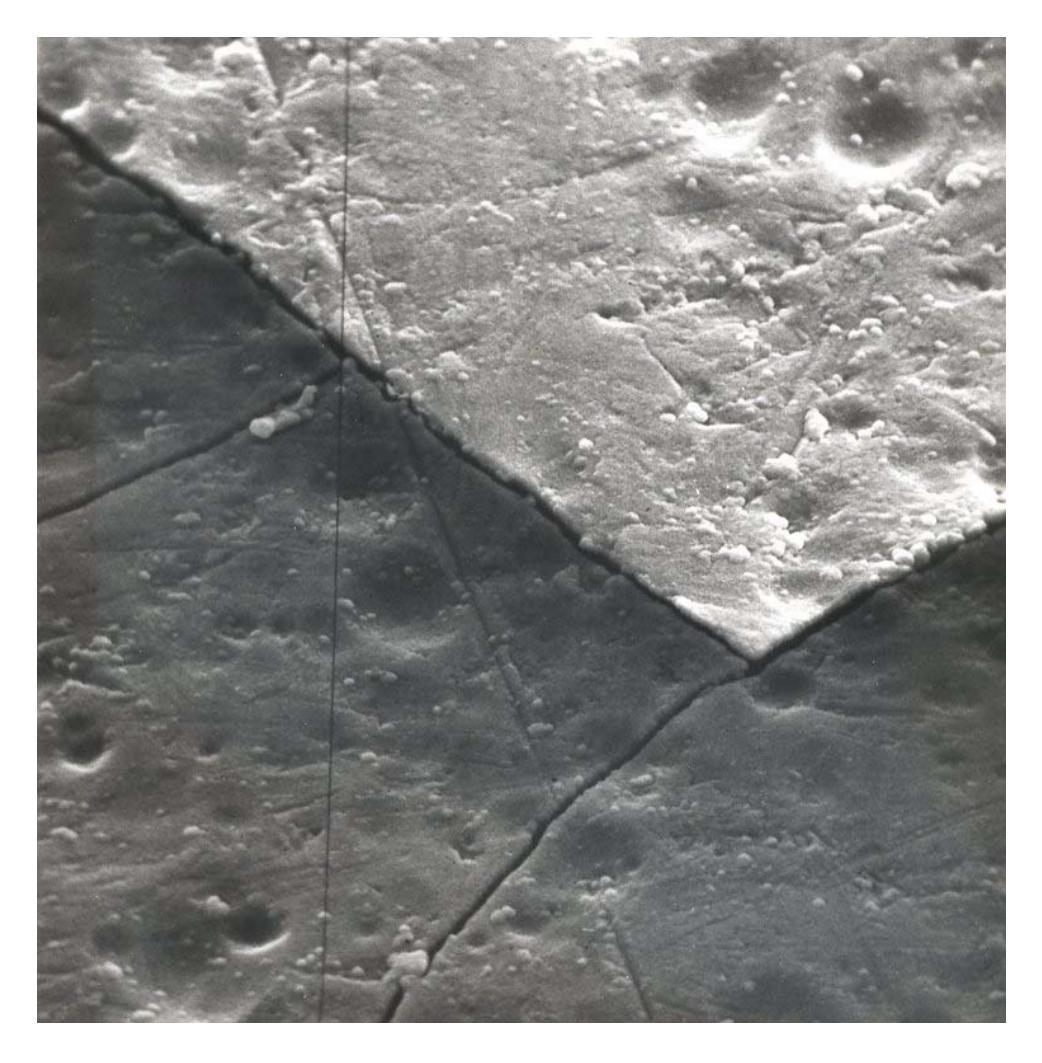
Figure 71. Example of thermal crazing showing crack in the anodic film. \sim (x 500)

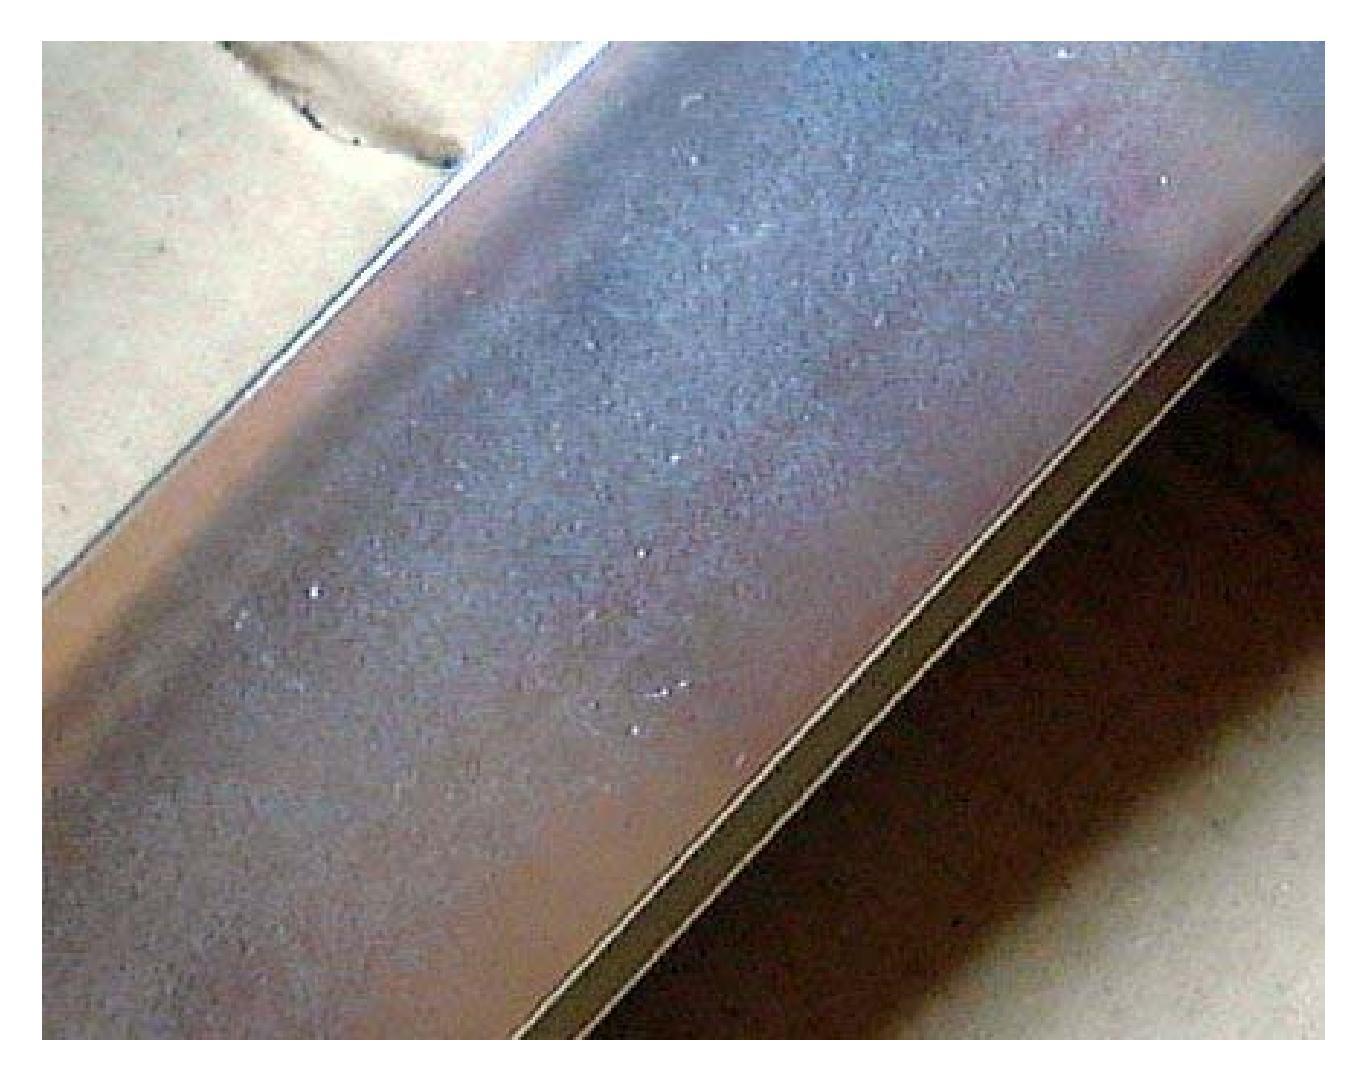
Figure 72. Transfer-etch stain on 6063 polished and bright anodized extrusion.

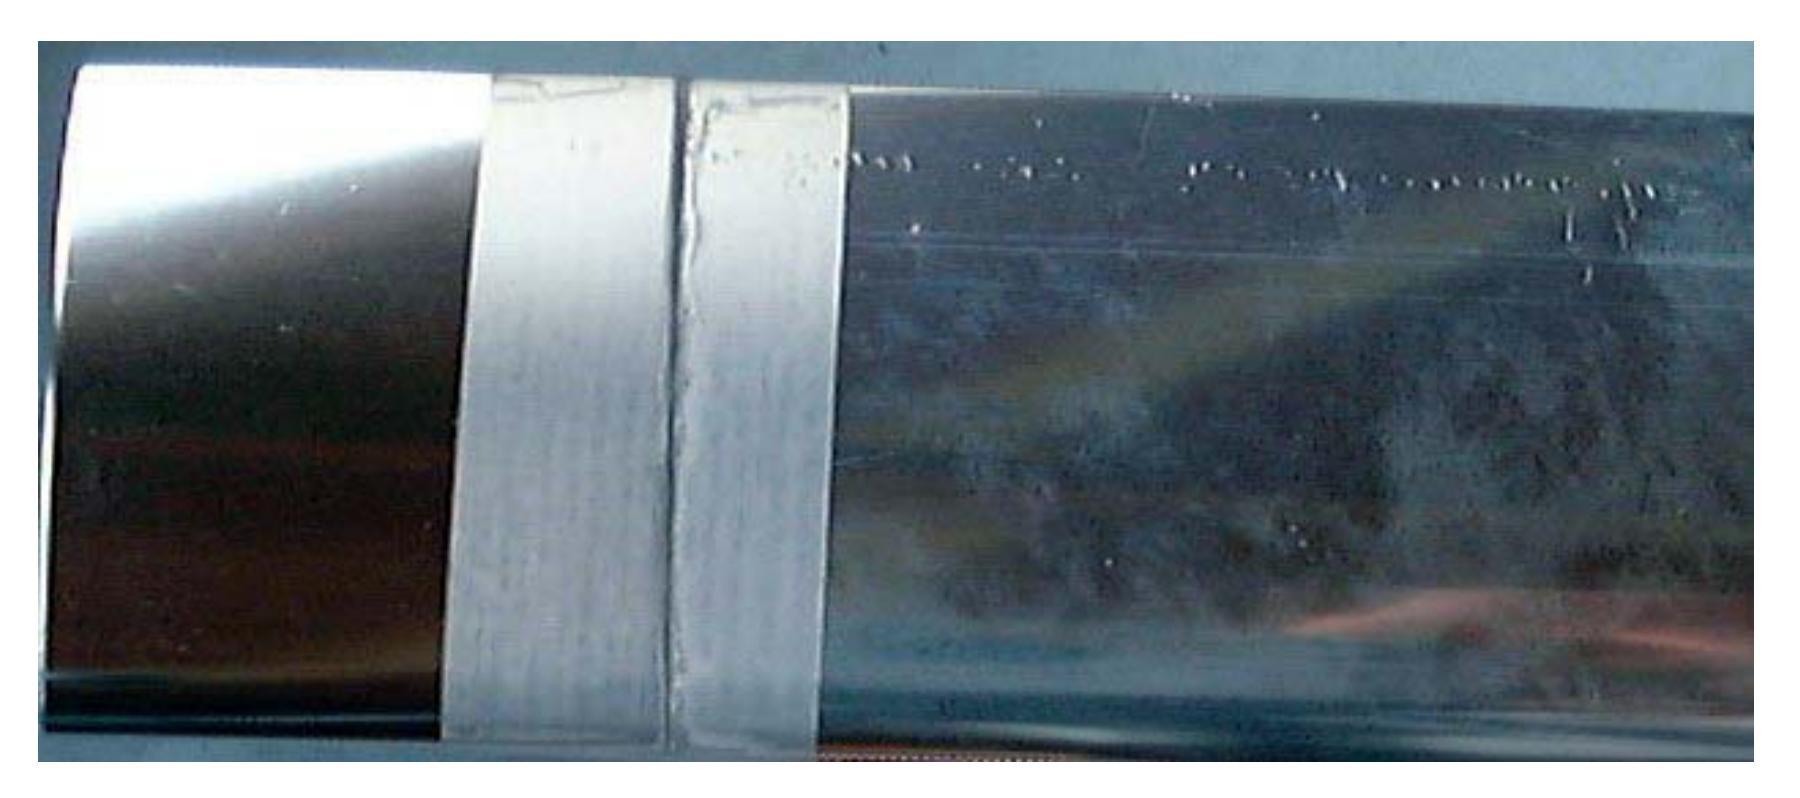
Figure 73. Sample on left of tape brightened in solution containing 5% HNO₃ and sample on right brightened under same conditions but with only 4% HNO₃ in the brightening solution.

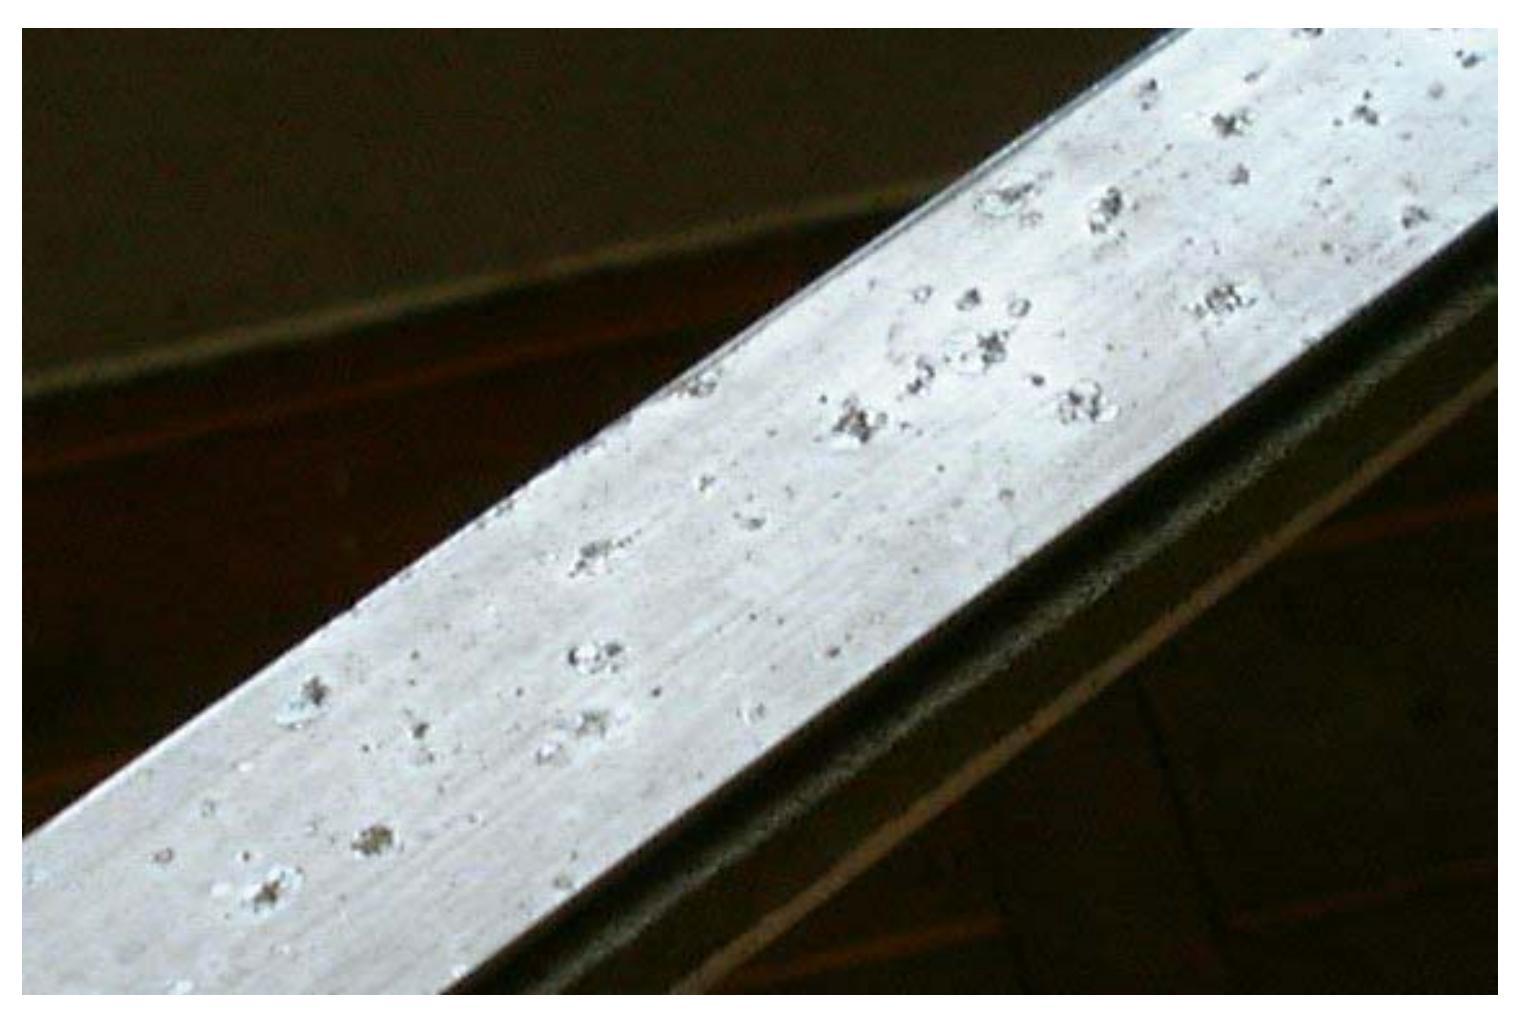
Figure 76. Pitting of an architectural finish in service due to lack of cleaning maintenance.

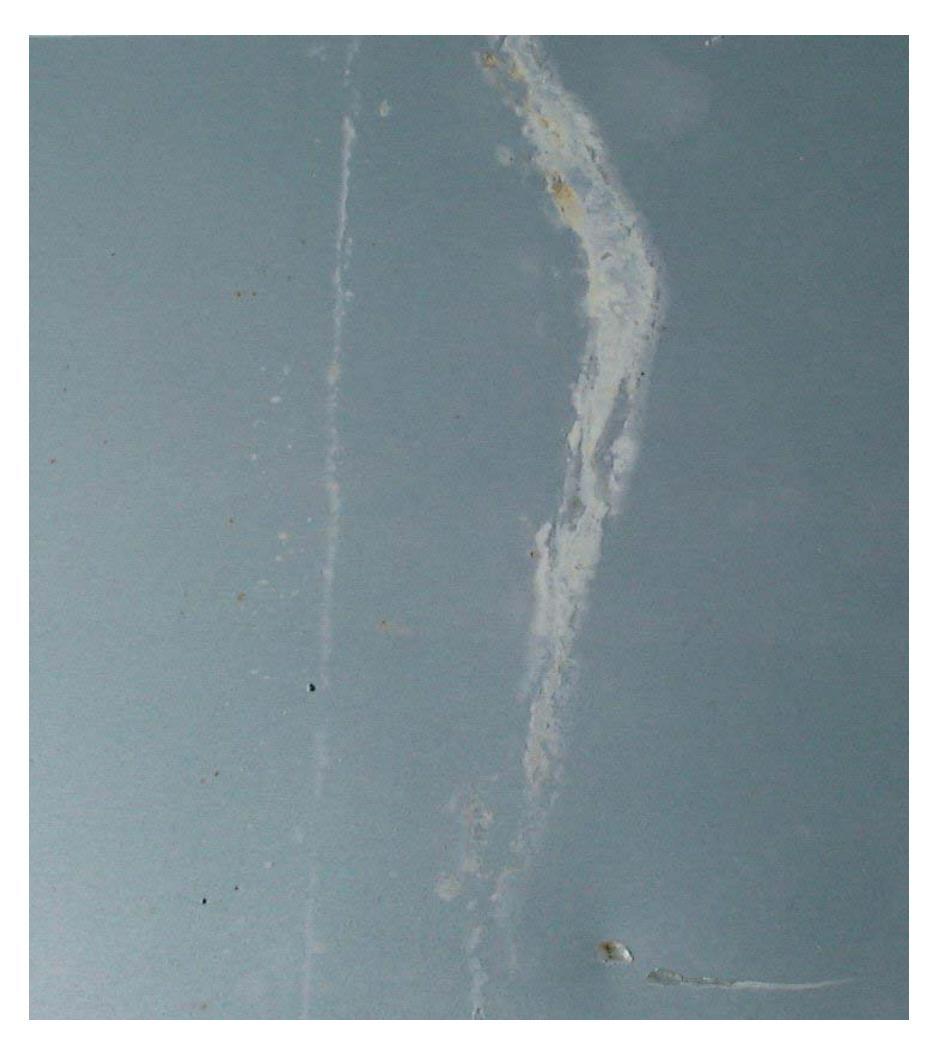
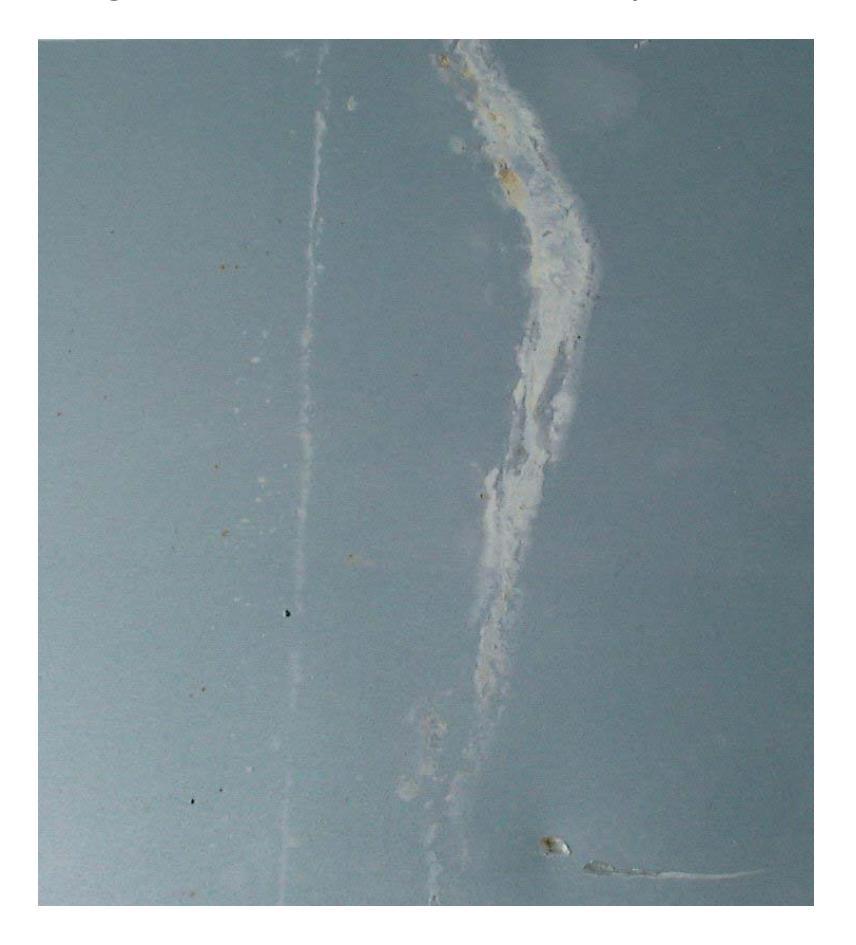
Staining can occur if an anodic film is in contact with wet mortar or cement. This is normally localised and should not happen if adequate precautions are taken during the construction or fitting stage. A typical example is shown in Figure 77. Once stained in this way, an anodic film cannot be refurbished.

Figure 77. Staining due to wet mortar or cement being splashed onto an anodic film.

It is normal practice to protect anodized coatings during fitting on site, with a suitable protective tape or strippable lacquer coating. This protective coating is allowed to remain in place until the construction work is complete. It is then normally removed and the finish cleaned with water containing about 1% of a suitable wetting agent, such as Teepol.

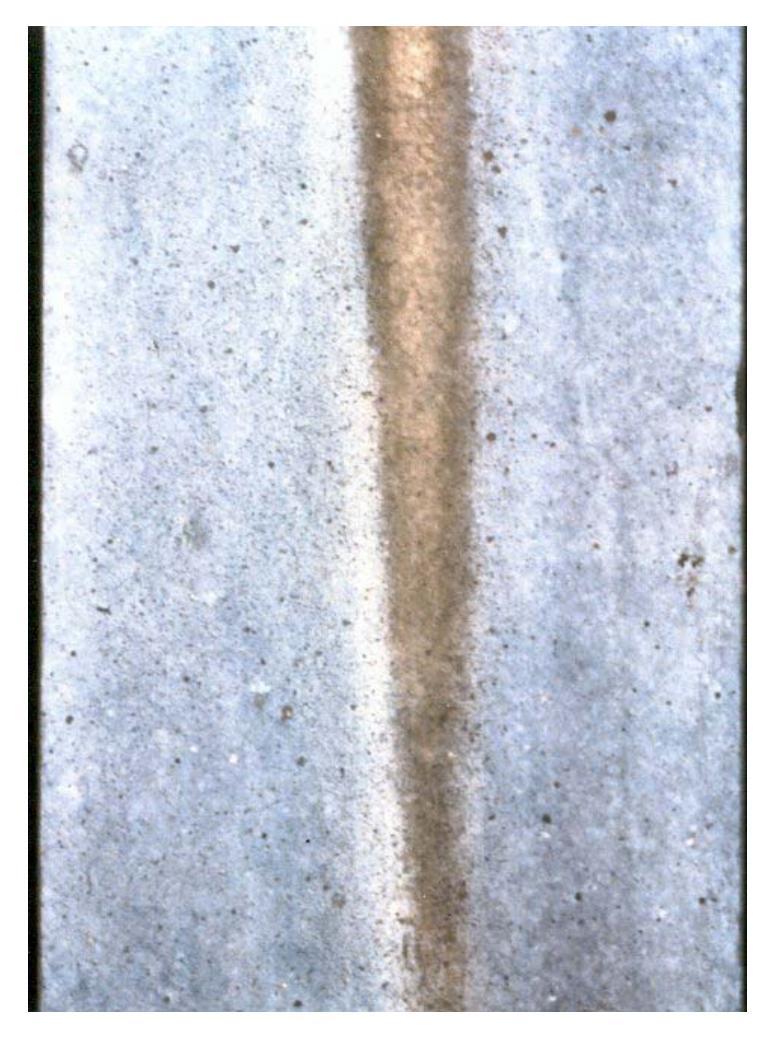
Figure 78. Sample of staining on a poorly sealed anodic film exposed to the atmosphere for about 6 months.

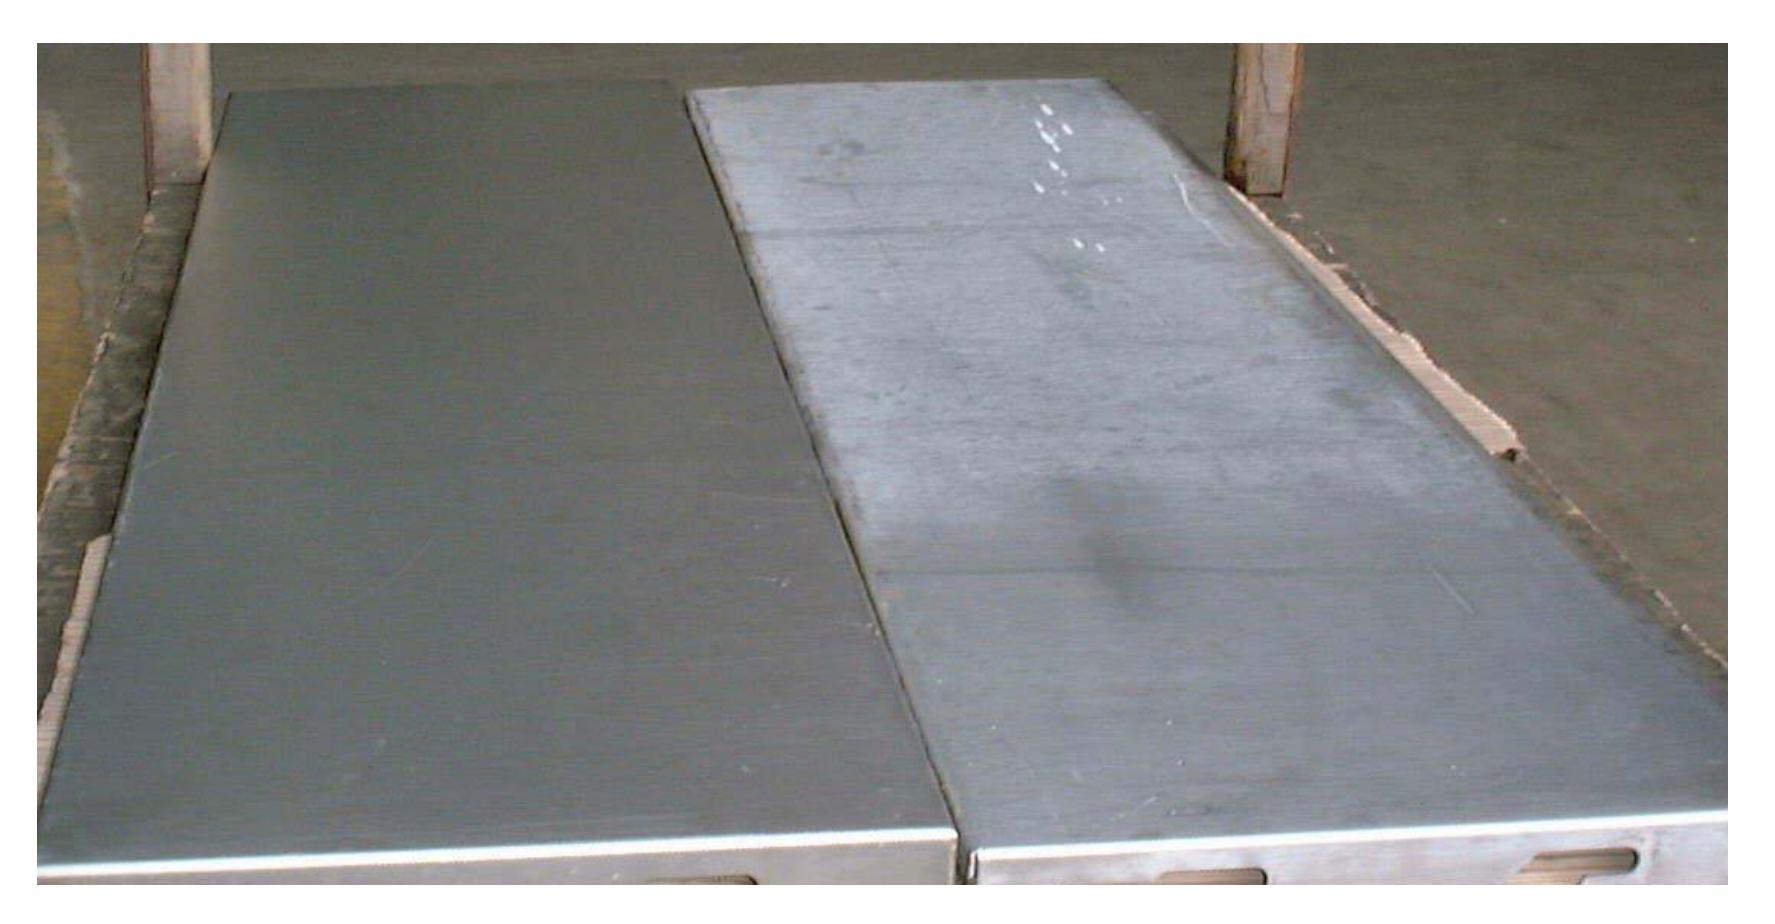
Figure 79. Curtain walling panels that had not been given regular cleaning maintenance showing on the right hand panel the white 'weathering bloom' before cleaning. The left hand panel is a similar panel after cleaning with a Scotchbrite pad and a solution of Teepol in water.
