The Identification and Prevention of Defects on Anodized Aluminium Parts

by Ted Short, Aluminium Finishing Consultant

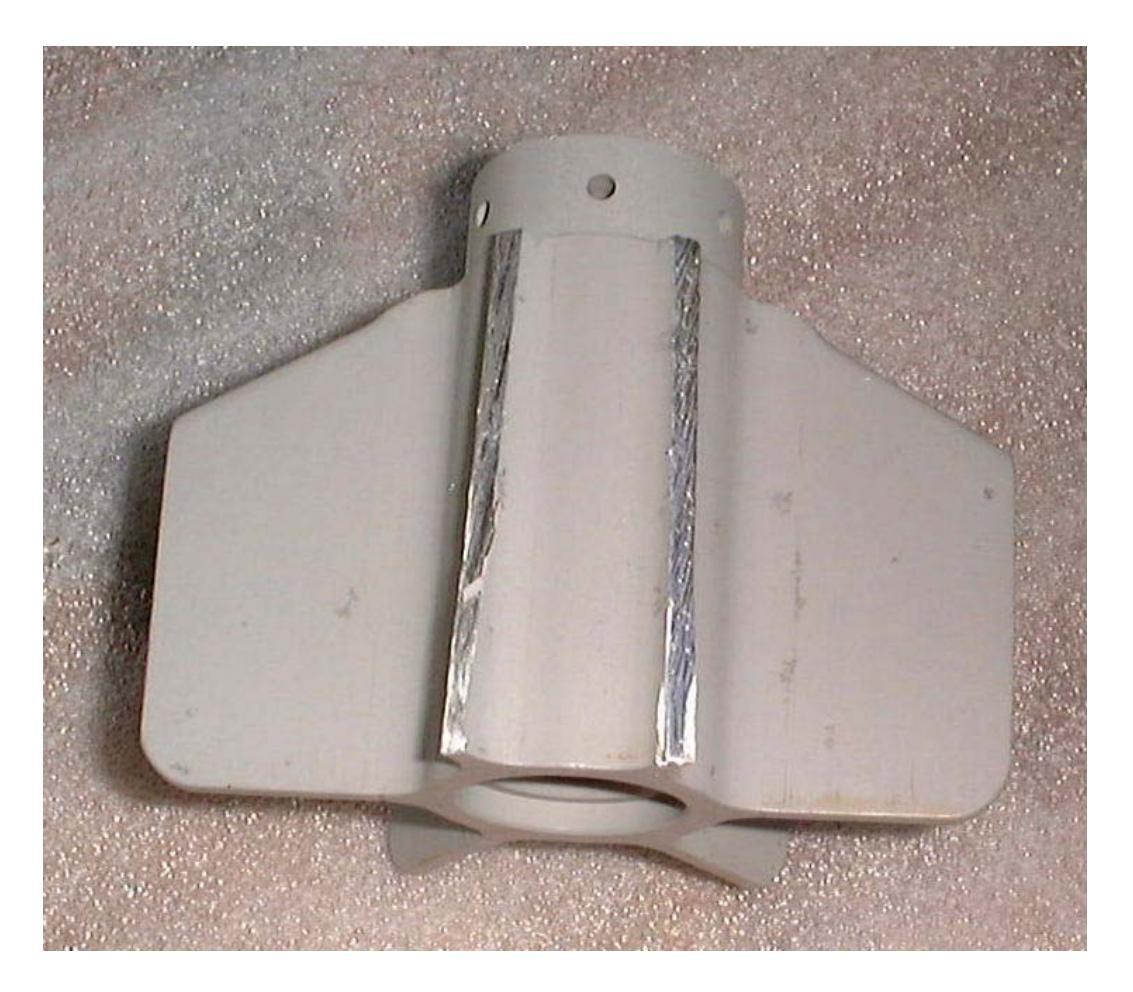
Example of chromic acid anodized finish showing some pitting on mortar bomb fins probably due to corrosion of the component before anodizing. Fig 83a. Fin showing dark stains

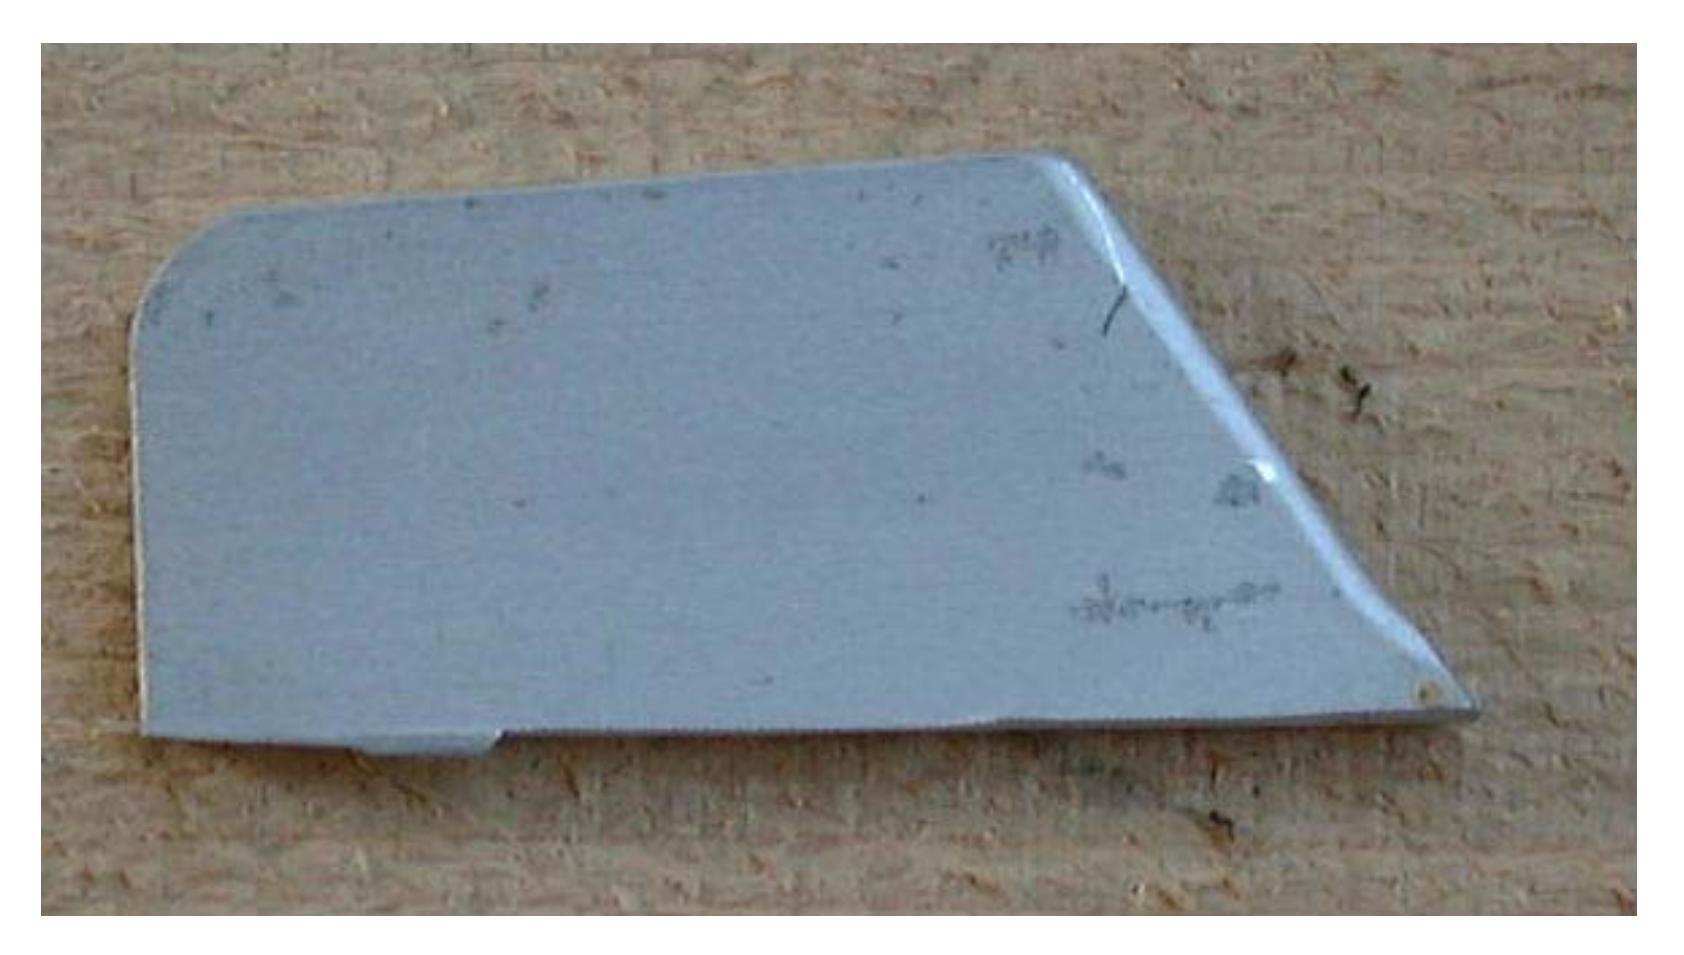
Example of chromic acid anodized finish showing some pitting on mortar bomb fins probably due to corrosion of the component before anodizing.

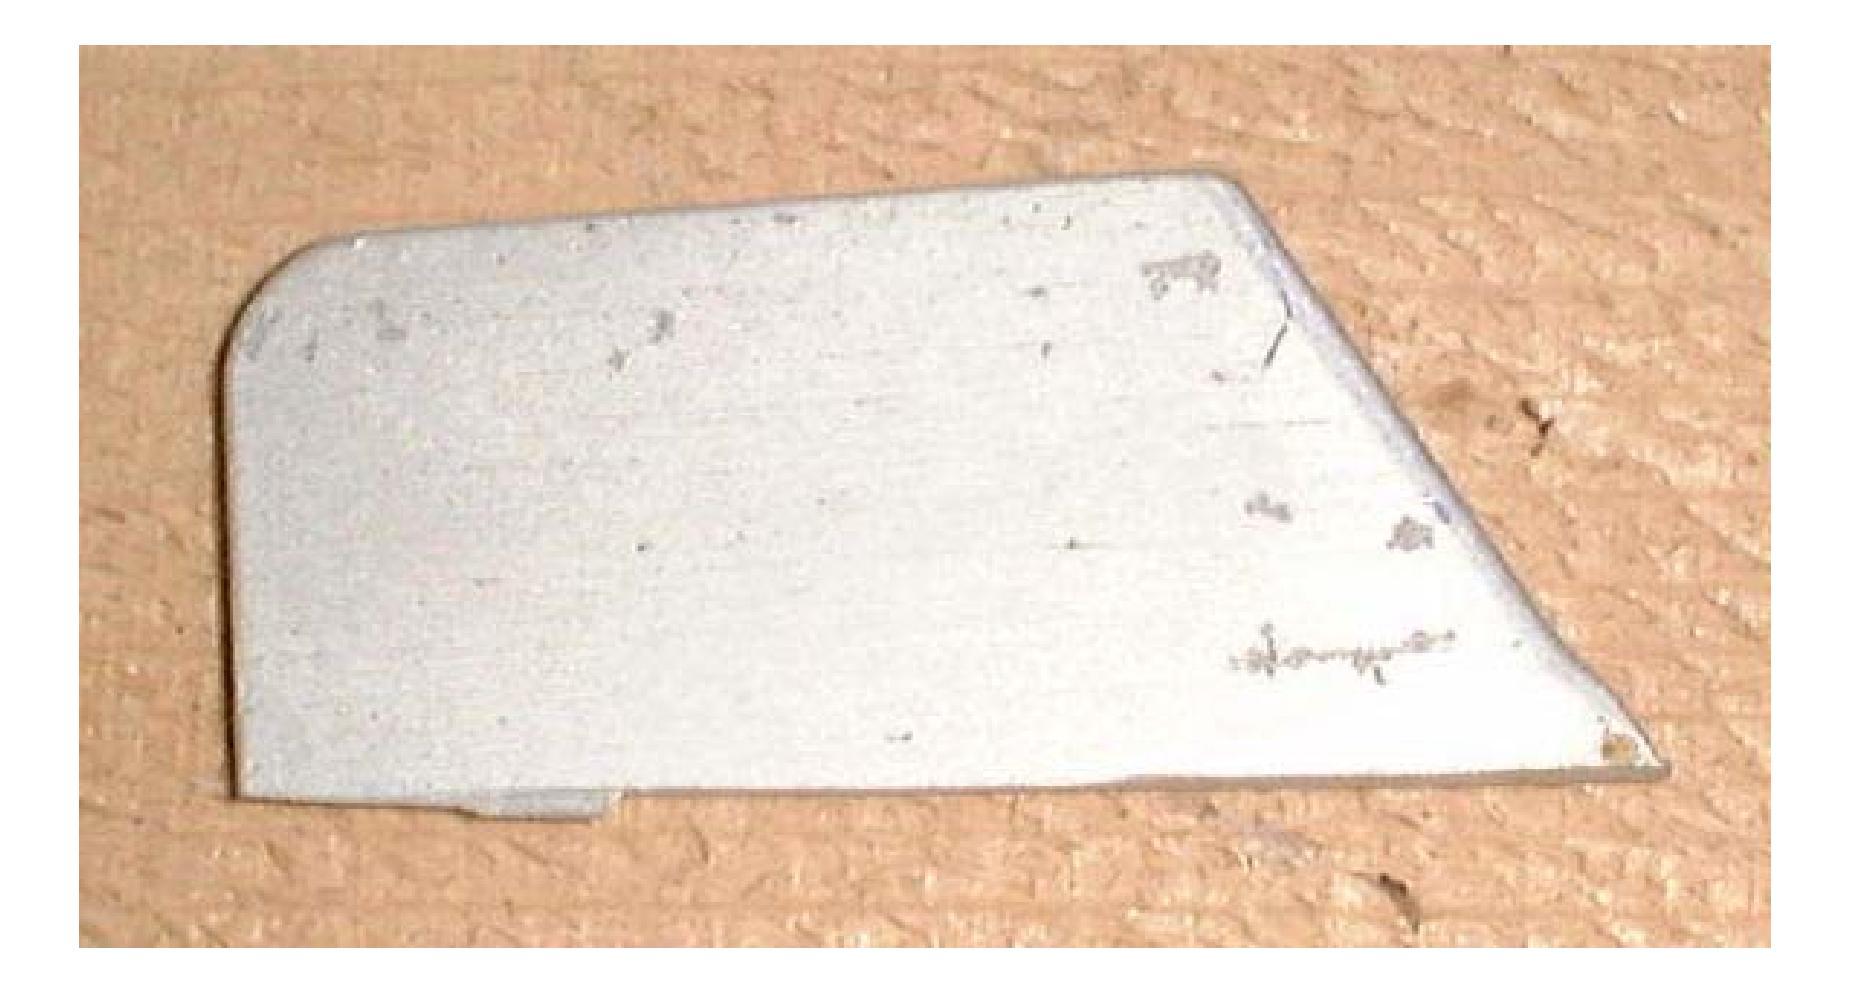
Example of chromic acid anodized finish showing some pitting on mortar bomb fins probably due to corrosion of the component before anodizing. Fig 83c. Same fin after removal of anodic film by etching in 10% NaOH at 60°C for 2 to 3 minutes
