The Identification and Prevention of Defects on Anodized Aluminium Parts

by Ted Short, Aluminium Finishing Consultant

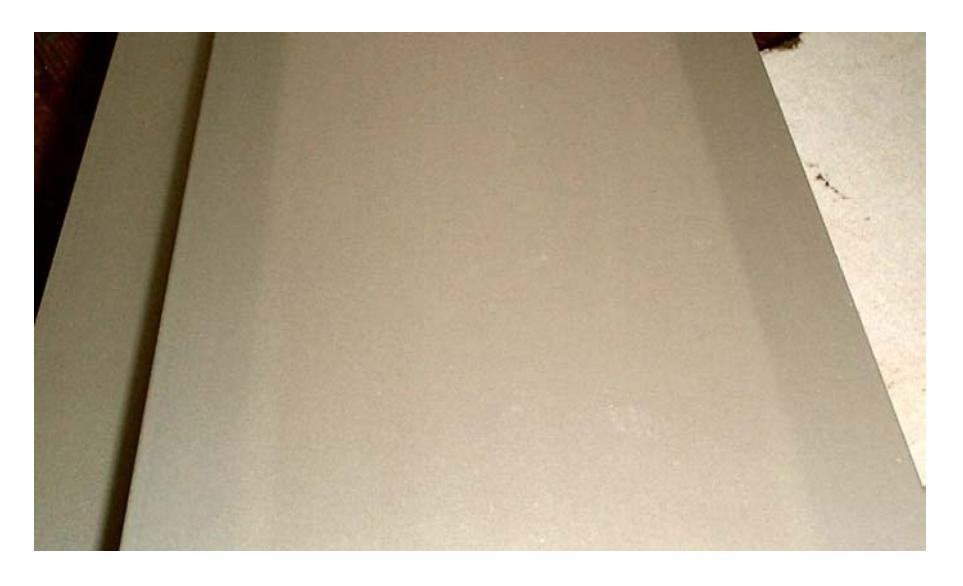
Transverse weld streaking occurs mainly on hollow extrusions and manifests itself as a variation in the degree of mattness or perhaps depth of colour across one or more surfaces of the extrusion. This streaking is revealed by etching and anodizing and is associated with metallurgical or structural differences in the material. A characteristic of this type of streaking is that the width of the streak changes along the length of the extrusion and usually tapers to a 'V' shape towards the front end. Figure 28 illustrates the effect of a transverse weld a few metres from the front end of the extrusion. These streaks may disappear completely over the next few metres of extrusion. Figure 29 is a typical example of a transverse weld at the front end of the extrusion. Mixing of metal in hollow section dies or solid dies using a feeder plate or welding chamber is the usual cause of this type of streaking. Metal from the front end of the ingot being extruded is mixed with metal from the back end of the previous ingot.

Figure 28. Transverse weld effect on a hollow extrusion after etching and anodizing.

Obviously the mixed alloy problem is a question of good housekeeping. In the case of a normal transverse weld, scrapping a sufficient length of section at the front end should eliminate the problem. It is also important to avoid using ingots from different sources, or with different thermal treatment histories or casting structures for a specific project. Finally, modifying the die design to reduce the feeder size may help reduce the defect by allowing smaller discards at the cut to length stage.

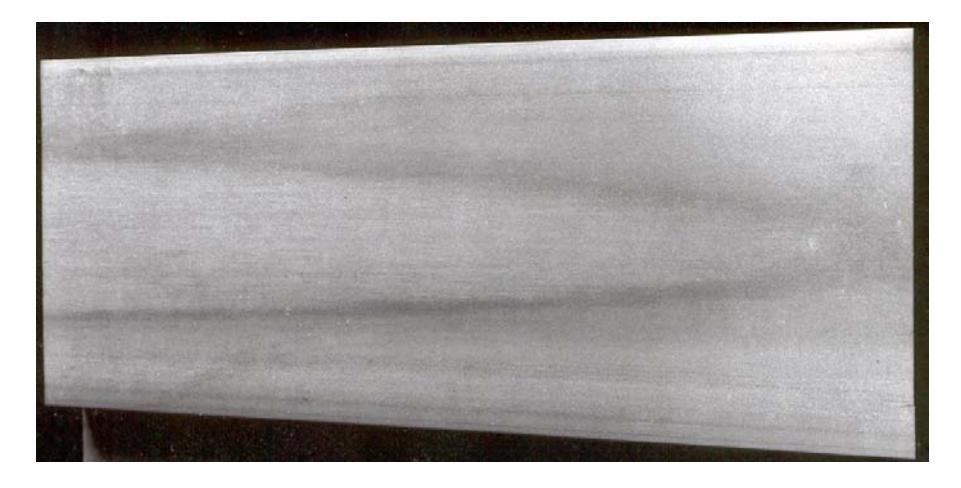
Figure 29. Example of a transverse weld defect at the front end of an extrusion after etching and anodizing.

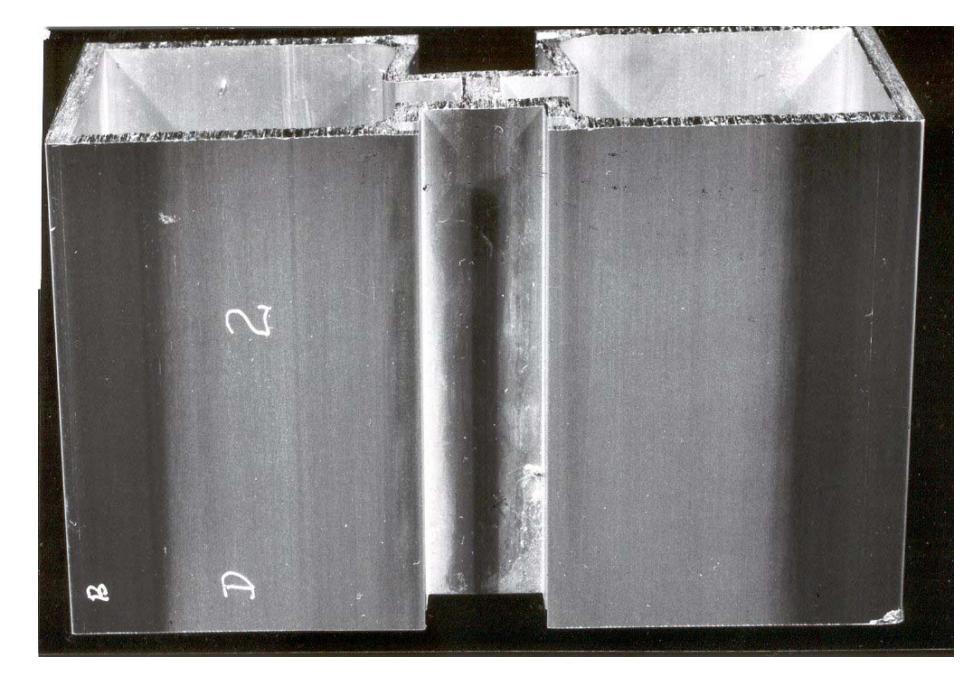
This type of streaking can be further enhanced when the extrusion ingot alloys are accidentally mixed. An extreme example would be when a 3000 series ingot was accidentally mixed with a batch of 6063 alloy. However, a more normal situation would be where, say, a 6463 alloy ingot was accidentally mixed with a batch of 6063 ingots. The former being a bright anodizing quality alloy with a higher purity base would produce a much brighter etching and anodizing response than the latter. The net result would be an extrusion having bright and matt streaks when etched and anodized as illustrated in figure 30.

Figure 30. Streaking due to mixing of alloys on a hollow extrusion.

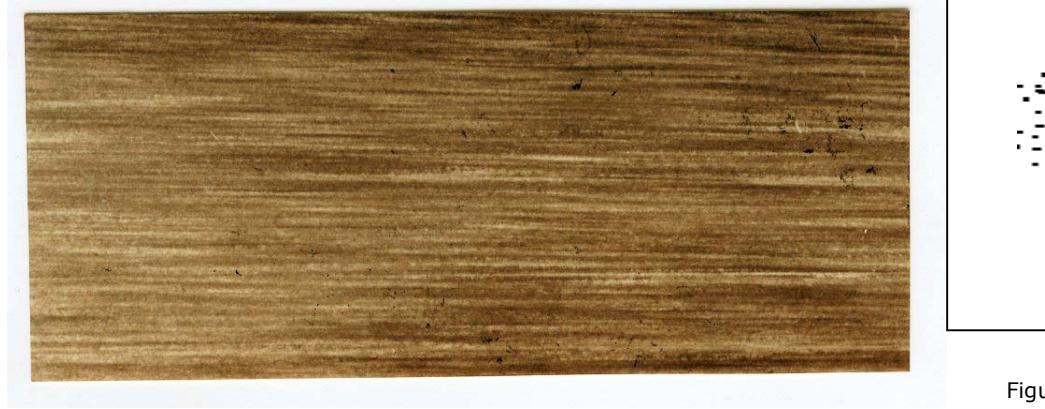
Non uniform light and dark flecks or short streaks in the extrusion direction on some anodized and electrolytically coloured components are usually attributable to a non- uniform distribution of the iron-bearing phases in the material. Figure 31 shows a typical example of the defect and figure 32 shows a schematic illustration of the variation in iron phase distribution between a normal and a flecked sample.

This non-homogeneity originates from the extrusion ingot and is usually considered to be related to the efficiency of the grain refinement during the casting stage.

Figure 31. Flecking occurring during electro-colouring due to iron phase segregation.

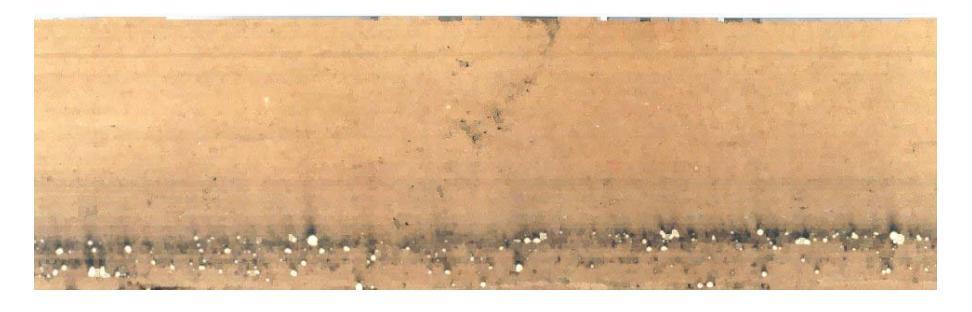
Clusters of intermetallic particles such as TiB_2 or MgO/Al₂O₃ spinels can produce streak defects. The streak usually takes the form of a row of pits or protrusions on the surface. These usually remain uncoloured when the finish is dyed or electrolytically coloured. An example of the streaking caused by coarse titanium diboride particle clusters in an ingot used to extrude a section for an architectural application is shown in Figure 33.

Figure 33. Streaking due to ${\sf TiB}_2$ clusters and oxide inclusions in the extrusion ingot used to extrude a section as revealed by anodizing and electro-colouring of the section.

The presence of coarse intermetallic or clusters of TiB_2 grain refiner particles in an extrusion ingot is usually an indication of poor casting practice. This may be due to the quality of the grain refiner rod or, poor control of the feeding of the rod into the molten metal. Similarly, inadequate filtering of the molten metal can result in coarse particles of grain refiner or aluminium oxide/magnesium oxide spinels being present in the ingot.

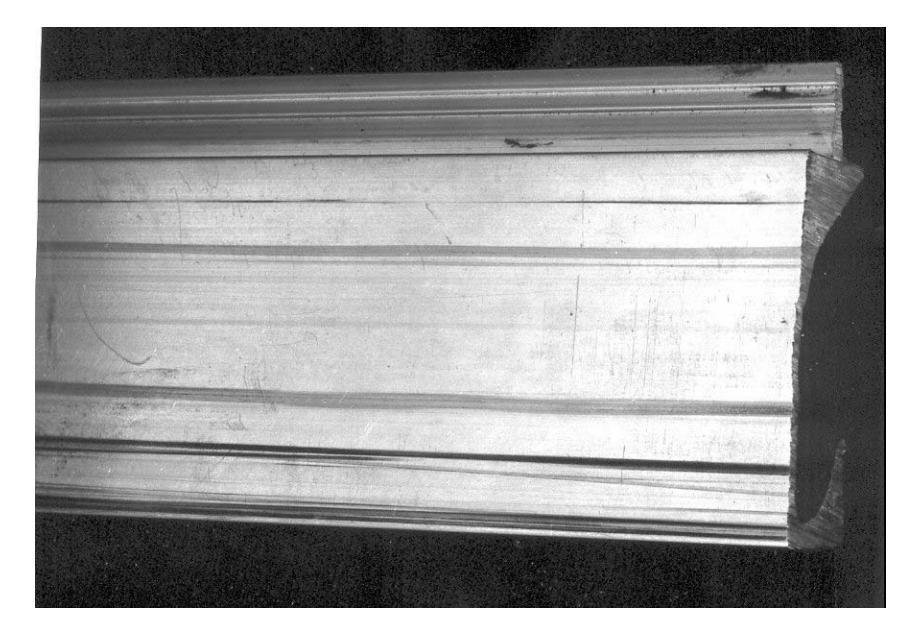
Longitudinal black marks in the extrusion direction are sometimes visible on one face of an extruded section. These are commonly called carbon marks and are usually due to the extruded section rubbing on the carbon blocks as it emerges onto the run-out table. An example of carbon marking on an 'as-extruded' section is shown in Figure 34. In the case of rubbing on the run-out table the localised thermo-mechanical can affect the size and distribution of the Mg_2Si precipitate in that area. The metal in this area reacts differently in etching and brightening solutions to produce a contrast and hence a streak. Figure 35 shows the same sample after etching for 10 minutes in 100g/l sodium hydroxide at 60°C.

Figure 34. Carbon streaks on an 'as extruded' section.

The problem is usually overcome by attention to the condition of the material used on the run-out table or walking beam and, if carbon blocks or rollers are used, replacing them with a material of lower thermal conductivity, such as Kevlar or Railco (see 3g).

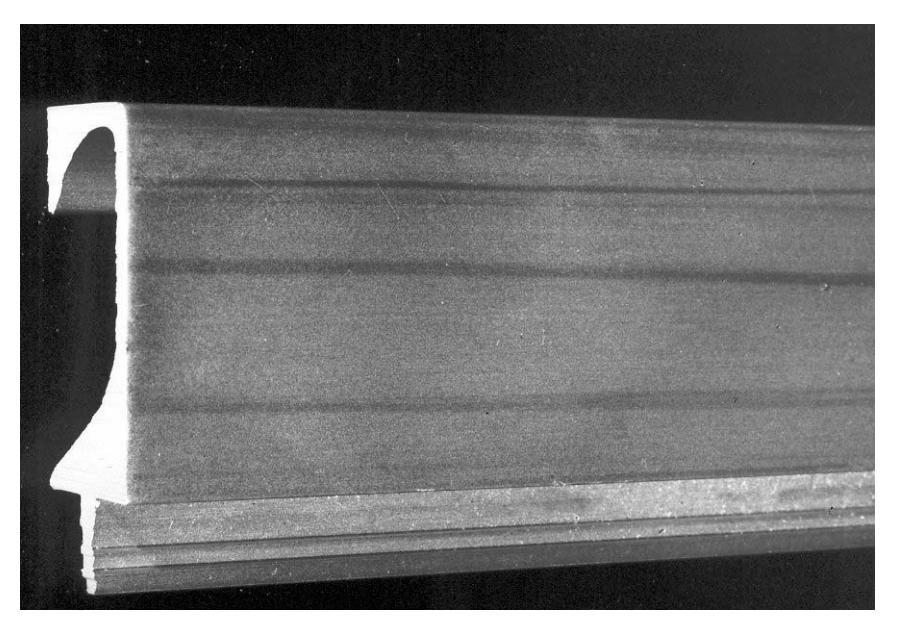
Figure 35. Carbon marks after etching for 10 minutes in 100g/l NaOH at 60°C.

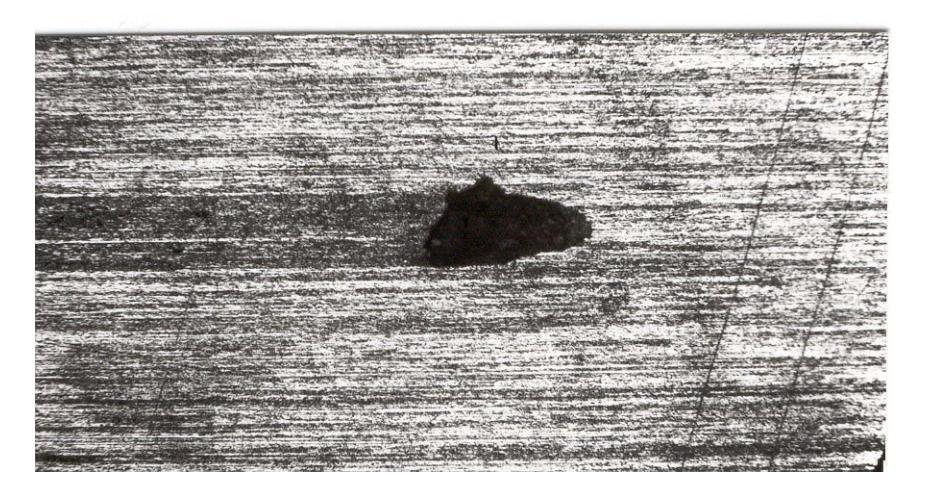
Figure 36. Graphite inclusion due to excess lubricant at front end of ingot. x 20

A similar but not identical effect may result from excessive usage of graphite lubricant on the front end of the extrusion ingot, an example of this is illustrated in Figure 36. Reducing the amount of lubricant applied should resolve the problem.

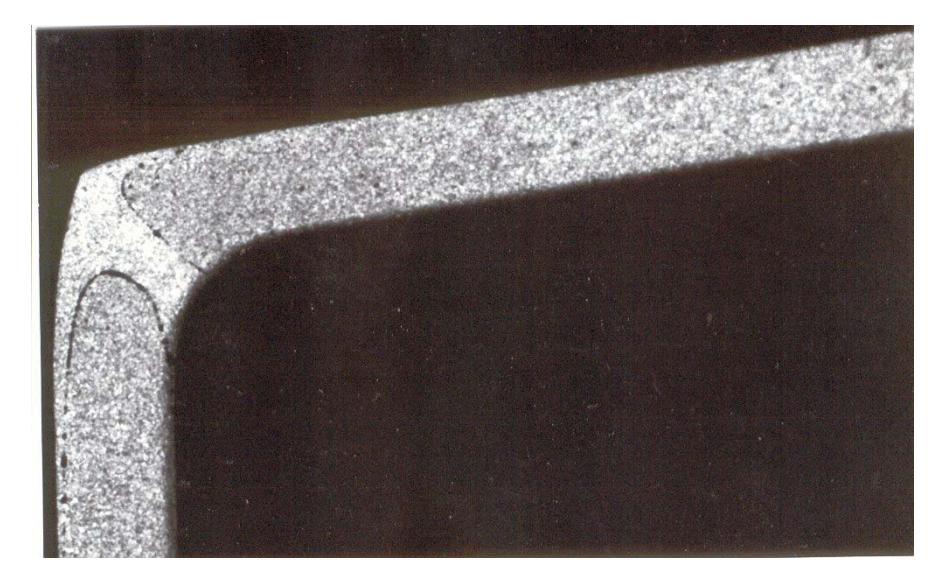
Back end or extrusion defect streaks are caused by ingot skin or container skin being extruded on or near to the section surface. These defects differ from transverse welds in that they normally occur at the back end of an extruded length and are not confined to feeder plate or hollow extrusions. They should be eliminated by inspection at the sawing-to-length stage. Etching a cross section of the defect in 10% NaOH is a simple way of demonstrating the problem.

Figure 37. Etched cross sections of extrusions demonstrating back end defects and associated streaking.

Adjusting the length of the ingot discard to prevent inflow of discard metal into the die should eliminate the problem. Extrusion conditions such as high ingot temperatures and small temperature difference between the ingot and container are likely to make the problem worse.

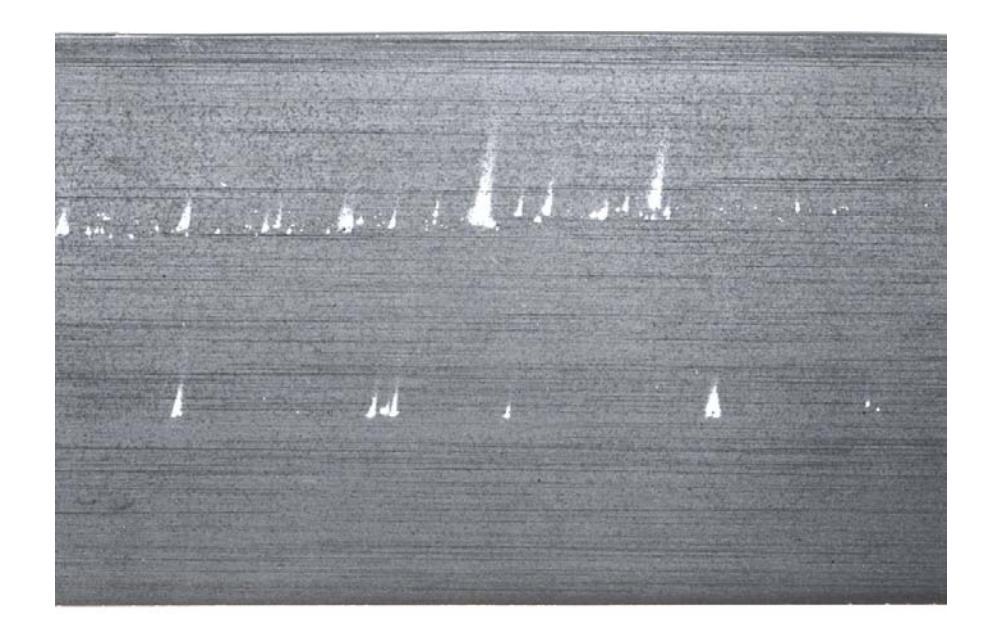
Figure 38. Surface streaking or flecks due to back end defect or transverse weld on an anodized and electrolytically pigmented extrusion.

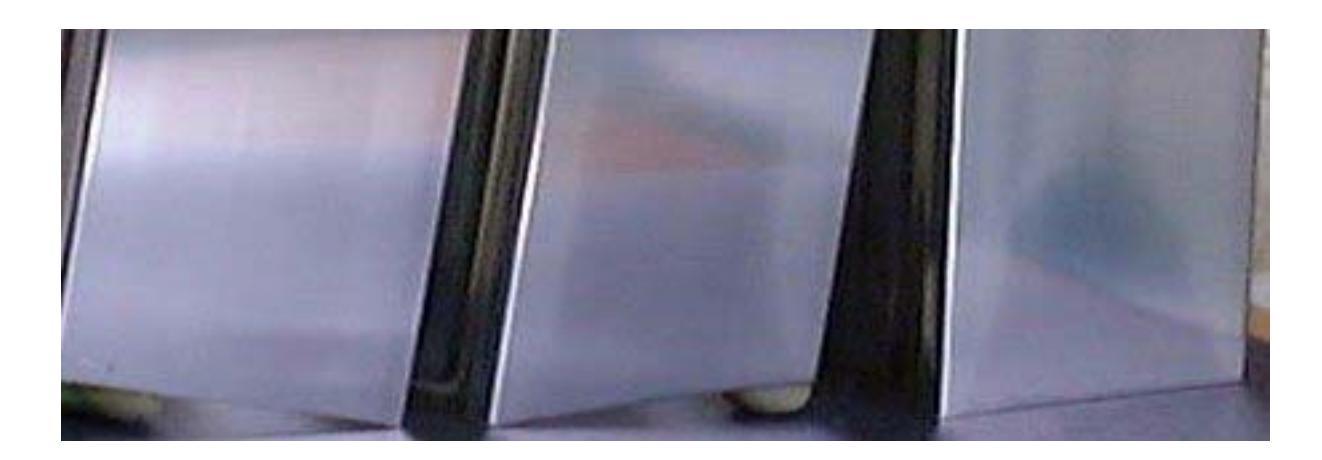
- If the streak varies in width or disappears as in Figure 39 or moves to the left or right and varies in width as in Figure 40, it is most probably caused by segregational effects.

Figure 39 (above). Effect of relatively uniform and taper polishing on the bright band on a polished and anodized extrusion showing a dulling due to a thin segregate layer on the surface near the edges. The heavier the polish the wider is the area of the brighter subsurface material revealed.

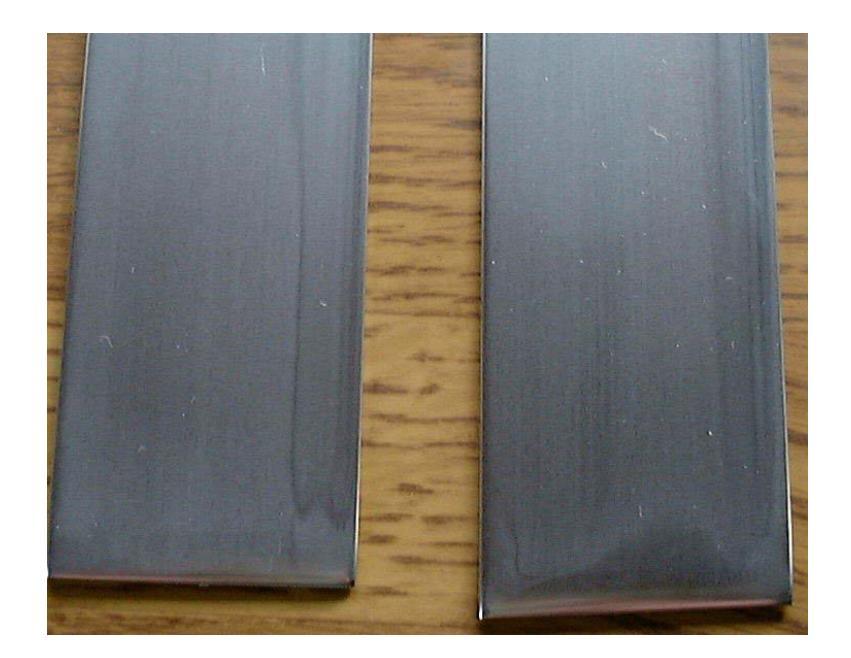
Figure 40 (right). Effect of taper polishing and anodizing a section having segregational streaking or back end defect streaking, upon the position of the streak. The heaviest polishing has been applied towards the bottom of the samples in this picture.

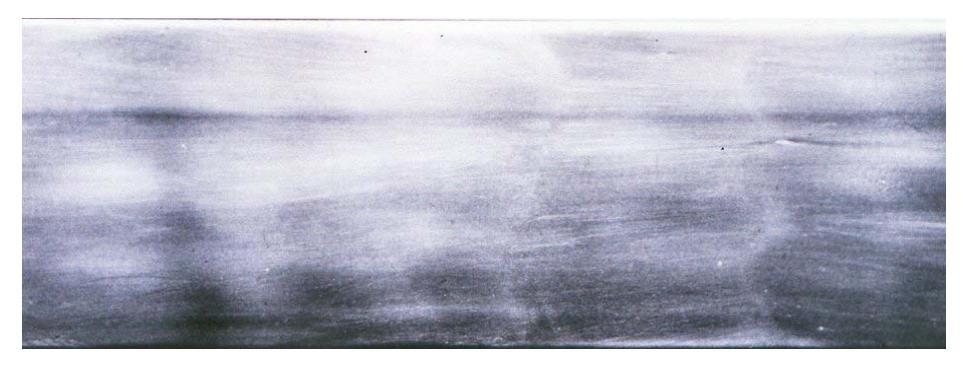
When too much pressure and/or insufficient polishing compound or liquid is applied to a polishing mop, localised overheating of the aluminium surface may take place. This can result in some modification of the precipitate structure near the surface of the aluminium alloy that will subsequently affect the etching and anodizing response of the alloy. The normal effect is to produce a non-uniform abrasion or bloom pattern on the surface that is not removed by the etching treatment before anodizing as illustrated in Figure 41.

Figure 41. Non-uniform appearance on an etched and anodized extrusion caused by poor mechanical polishing.

Once this overheating has changed the precipitate condition, it is difficult to rectify the problem. Attention to the polishing mop pressure and/or improving the application of polishing compound should prevent future recurrence of the problem.

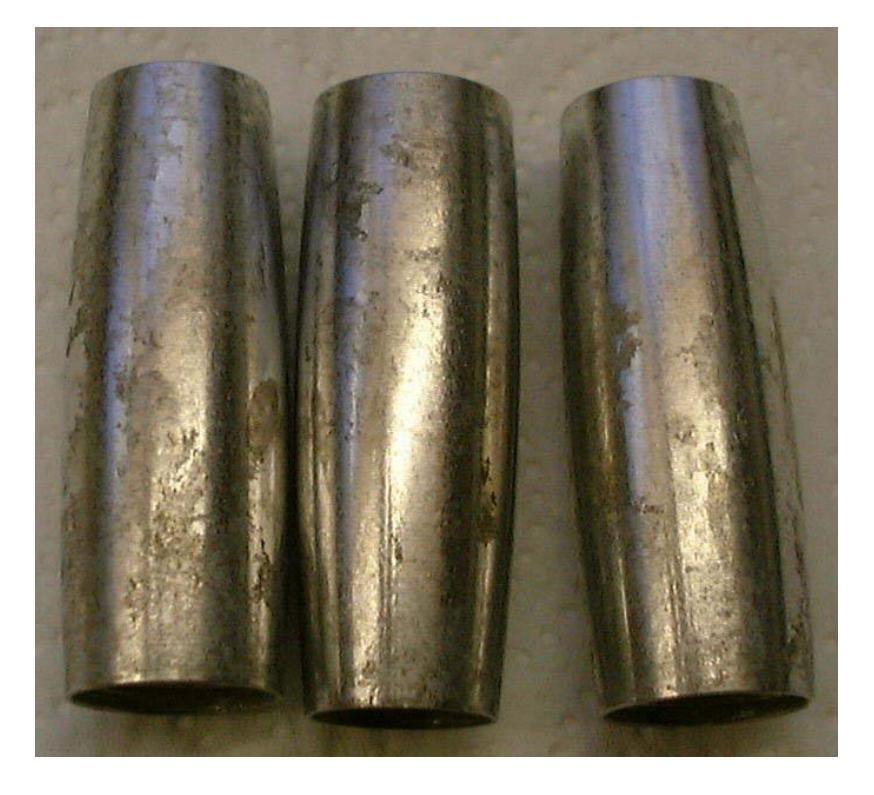
When aluminium is in contact with moisture from condensation or water entrapment a thickening of the natural oxide film occurs. This is commonly known as water staining and examples are shown in Figures 42 and 43.

Figure 42. Water staining on samples of machined tube in storage prior to etching and anodizing.

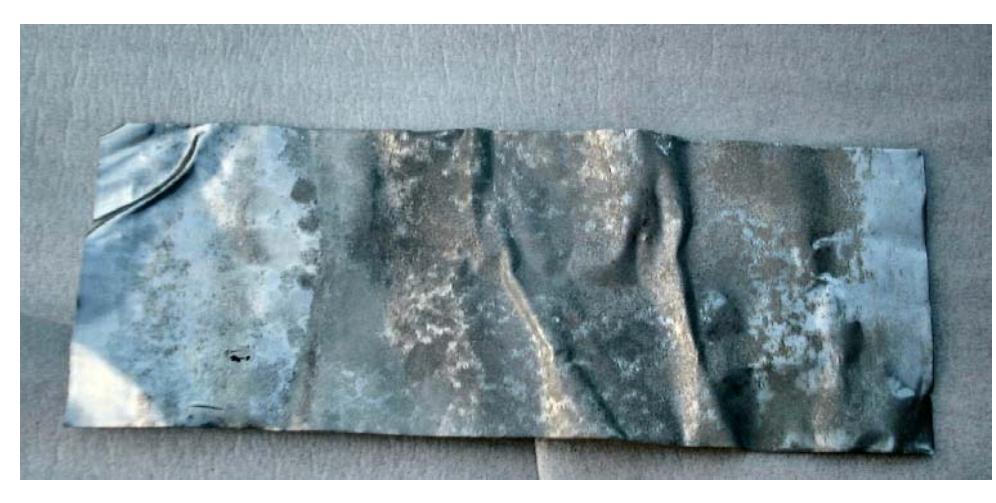
In some circumstances, for example, if the water contains aggressive ions, quite severe corrosion of the substrate can take place. It is not until the parts are pre-treated by etching or brightening and then anodized, that the pitting problem is evident. Figure 44 shows the effect of brightening, anodizing and dyeing the water stained samples illustrated in Figure 42.

Figure 43 (left). Water staining on aluminium 1050 alloy foil caused by the coiled alloy becoming wet in storage.

Figure 44 (below). Samples of water stained material from same batch as samples in Figure 29 after brightening anodizing and colouring showing that quite severe corrosion was associated with the water staining

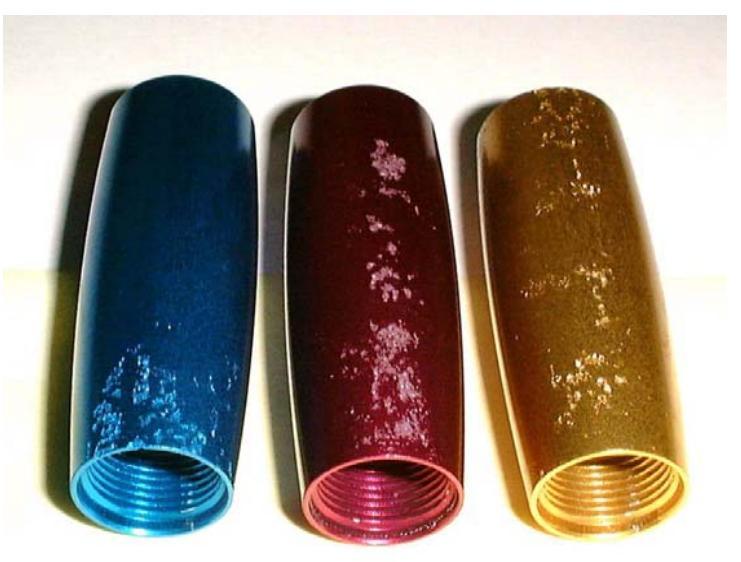
Where a section has not been adequately degreased or cleaned to remove dried-on cutting oil or any other protective film such as adhesive tape or lanolised dewatering fluid, a similar non-uniform etching to that resulting from water staining may also occur. It is important, when such a protective is used, that the anodizer is informed so they can take the necessary steps to ensure it is all removed before the etch stage. Once preferential etching has occurred due to inhibition in contaminated areas by the oily deposit, nothing can be done to rectify the problem. Such defects look similar to the effects caused by water staining and Figure 45 is indicative of the type of preferential etch that can result from inadequate degreasing.

Figure 45. Effect of water staining or inadequate degreasing prior to etching.

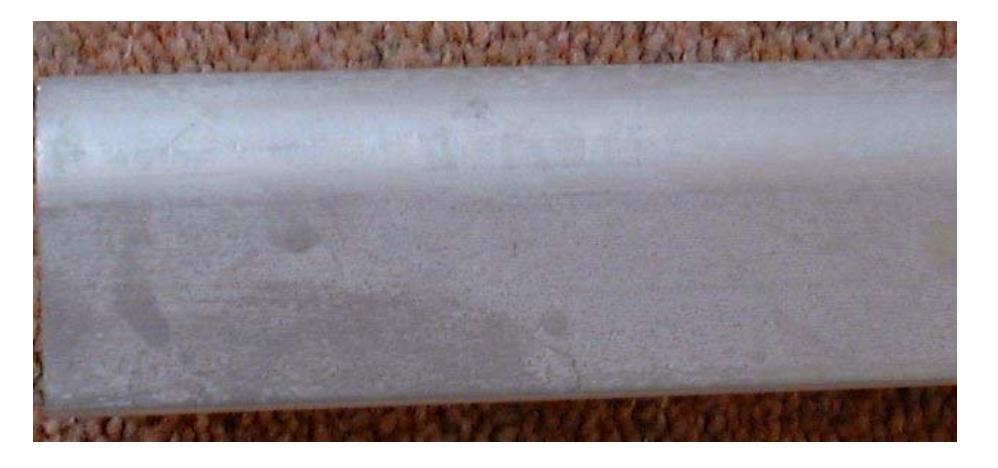
White etch bloom is the description given to a common defect that normally occurs in the caustic etching stage of the pre-treatment process before anodizing. It appears as a patchy non-uniform white etch that may show fingerprint patterns which are more specular or silver in appearance. It is due to the incomplete removal, in the degreasing stage before etching, of the mixed magnesium oxide/aluminium oxide film present on air quenched 6063 extrusions. The magnesium oxide is insoluble in alkali etches resulting in a roughening of the section surface due to preferential attack. This manifests itself as a patchy white finish perhaps wrongly named 'white etch bloom'. Figure 46 shows an example of normal 'white etch bloom' and Figure 47 is typical of 'white etch bloom' where some of the magnesia on the mill finish surface has been removed by handling of the extrusion prior to degreasing.

Figure 46. Typical example of 'white etch bloom' on 6063 extrusion.

The problem can be avoided by using an inhibited, non-etching, alkali degrease or an acid degrease. Alternatively, dipping in an acid desmut solution before degreasing will remove the magnesia. The latter may not be desirable as, in time, it will contaminate the desmut solution. The fingerprints are visible due to acid in the sweat on fingers locally removing the magnesia in the mixed oxide film. Aluminium extrusions or sheet in the mill-finish conditions should always be handled by operators wearing clean cotton gloves.

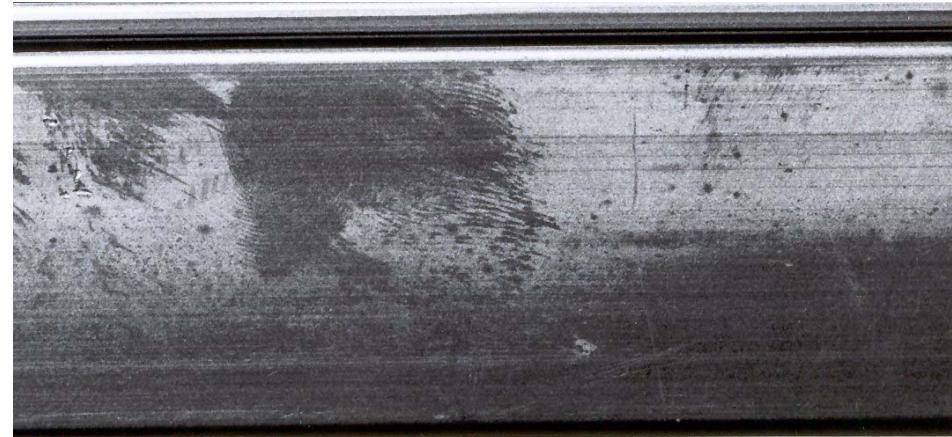
Figure 47. Sample of 'white etch bloom' on 6063 extrusion showing brighter, or darker, areas where fingerprints have removed the magnesia film before etching.

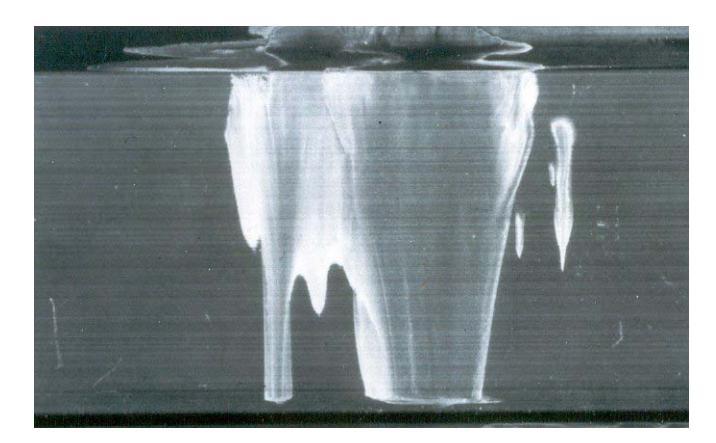
When a load of sections is withdrawn from an etching solution, depending upon the solution temperature and the ambient temperature, the transfer time to the post-etch rinse can be quite critical. If this is too long, then the etching solution may dry onto the surface before it can be rinsed off. A non-uniform film of aluminium hydroxide then forms on the surface that does not rinse off and is not easily removed in the subsequent desmut stage. A very severe example of etch staining is illustrated in Figure 48.

Figure 48. Example of severe transfer etch staining on 6063 alloy extrusion.

The defect is rare but where it is encountered the etch temperature and transfer times from the etching solution to the post etch rinse should be investigated.

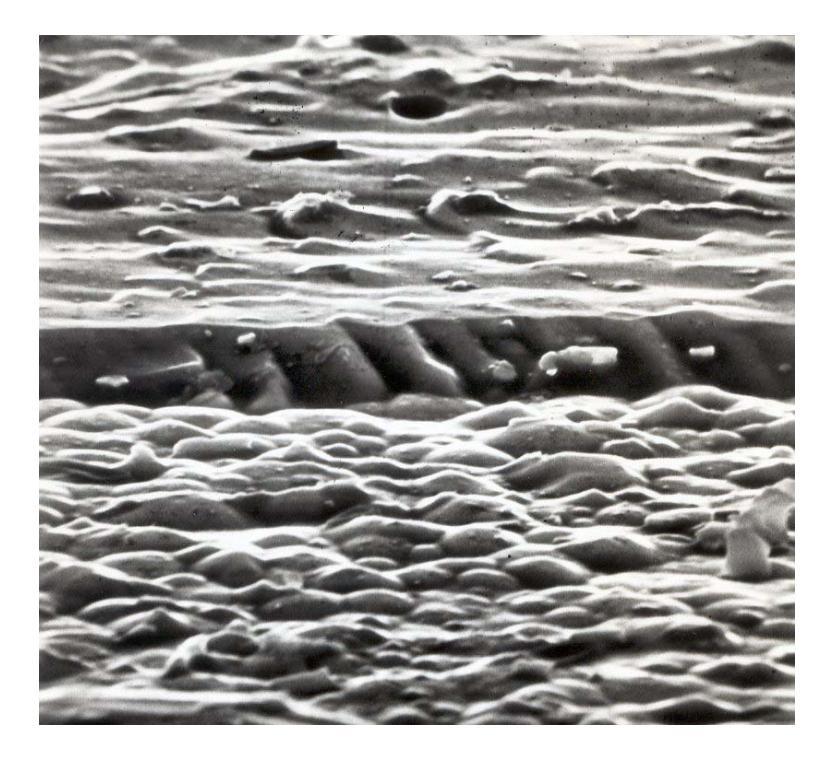
This defect has a characteristic galvanised appearance due to the very pronounced preferential attack of the grain structure in the caustic soda etching stage as seen in Figure 49. The problem is usually associated with the level of zinc in the etching solution or in the alloy. When the concentration of zinc in a 6063 alloy is greater than 0.03%, some simple caustic soda based etches will produce this spangle finish (see figure 50). Simple caustic soda based etches will also produce the spangle finish on any 6063 alloy, irrespective of its zinc content, when the level of zinc in the etch reaches about 50ppm.

Figure 49. SEM picture of the surface of a 6063 extrusion showing spangle etching and illustrating the 5μ m step between grains caused by the preferential attack. (x 2000)

The maximum Zn content for extrusions in 6063 alloy to be used for architectural anodizing should not exceed 0.03%. Modern etches contain additives formulated to complex the zinc and hence eliminate the problem regarding zinc contamination of the etching solution. The zinc is often precipitated as zinc sulphide using an additive based on sodium sulphide. This is the reason for many long-life etch systems turning very black during use.

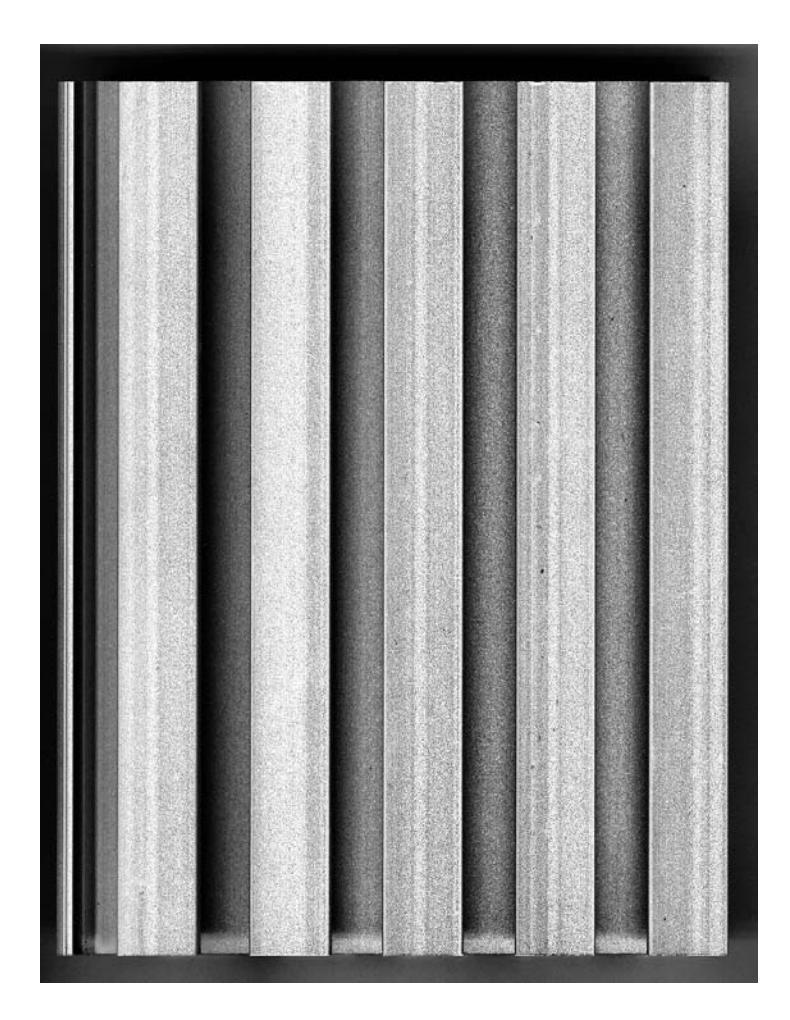
Figure 50. 6063 extrusion containing 0.04% Zn showing a light spangle etch.

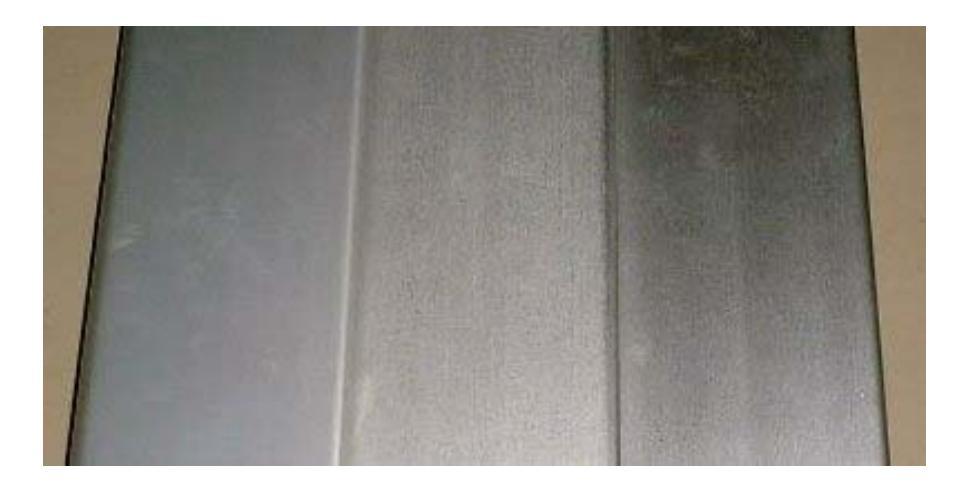
When a batch of etched and anodized aluminium in the same allov exhibits a difference in degree of mattness it could be due to one of several causes. A typical example of the degree of variation that can occur is shown in Figure 51. Causes could be a variation in anodic film thickness from one part to another, variation in the etching conditions used in the pre-treatment or the anodizing conditions used from one load to another, or some metallurgical variation from one part to another. The anodic film thickness should be measured to establish that the cause is not due to large differences in film thickness. The anodic film should then be stripped from samples illustrating the variation, using the standard chromic acid phosphoric acid stripping solution and their appearance examined again. If the samples now appear the same, variations in anodizing conditions used, could be responsible or the samples may be of a different alloy or temper. Check the chemical composition and temper of the samples. If there are no significant differences, re-anodize the samples and, if they are now the same, the original anodizing conditions should be suspected. If the difference is still present, mechanically polish one face of each

Figure 51. Variable etching response of 6063 extruded sections as etched and anodized.

sample and then re-etch them in 10% NaOH at 60°C. If the polished and etched surfaces now all look alike, it suggests lack of control in the original etch process used by the anodizer. If they still show a difference in mattness then check the size and distribution of Mg₂Si precipitate in the samples. Metallurgical factors that may affect the etch response of 6063 extrusions are well documented in technical literature. In cases where the above tests have indicated that the problem is associated with the metallurgy of the aluminium there is nothing the anodizer can do to overcome this. In such cases the metal usually has to be replaced. Where reprocessing eliminates the difference, the anodizer needs to look closely at the etching and anodizing conditions being used.

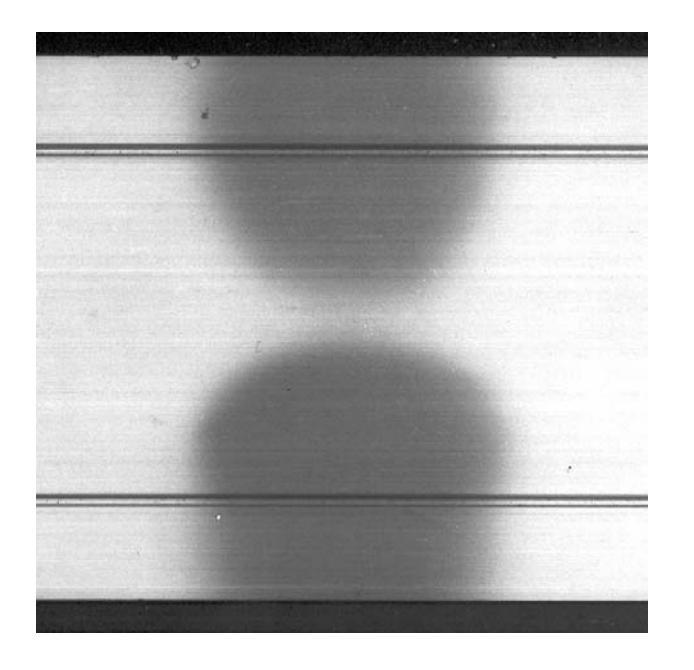
A hot spot is a discoloured area sometimes seen on 6000 series alloys and is usually black on clear anodized finishes, as shown in Figure 52, but it can be white or grey on clear and coloured finishes. The defective areas are only on one face of the section and are usually at regular intervals along its length. If the defective sample is etched in a 10% NaOH etching solution at 60°C a heavy black smut will be observed in the area of the hot spot. This is a metallurgical problem, not an anodizing fault. Hardness readings taken in these areas will usually produce significantly lower readings than in the normal areas on the section. The defect is caused by excessive Mg₂Si precipitation in these areas, due to differential cooling on the extrusion run-out table or walking beam.

Figure 52. Example of a hot spot on an etched and anodized 6063 extrusion.

Controlling the time the hot sections are allowed to stand on the run-out table or the walking beam slats, when the extrusion is at a temperature higher than 230°C, should help to eliminate the problem. Forced air-cooling and purpose-designed materials, such as Kevlar or Railco, formulated to reduce the rate of heat conductivity from the extrusion have practically eliminated this problem. A cooling rate on the extrusion run-out table of 1°C per second, down to 200°C, is considered to be typical for a good air quench on 6063 alloy extrusions. The hot spot type defect is generally most likely to occur on thick wall hollow extrusions.

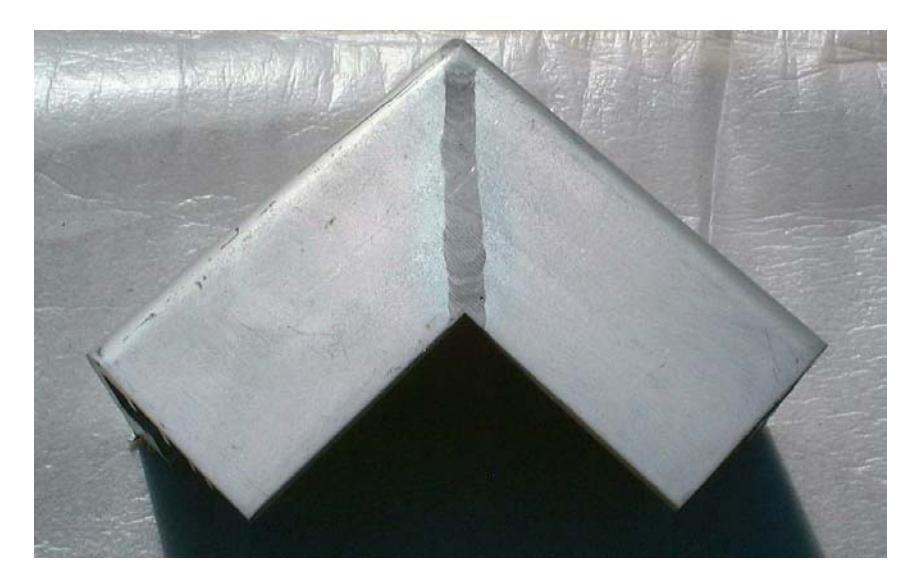
The affect of localised overheating of 6063 alloy during TIG or MIG welding of aluminium alloys can result in some modification to the precipitate metallurgy in the heat-affected zone. This may manifest itself as an area of different colour or degree of mattness when the welded part is etched and anodized, as illustrated by the examples in Figure 53 and 54. The defect is usually visible at the etching stage and will still be present after anodizing.

Figure 53. Staining on a 6063 alloy welded and linished mitred window frame joint after normal etching and anodizing. The dark nature of the weld suggests the filler rod used for welding contained a higher silicon content than that of the alloy. The heat-affected zone in the extrusion adjacent to the weld is just visible.

There is no simple method of overcoming the problem of these heat-affected zones. The effects may be minimised by using weld filler rod of a chemical composition as near as is practical to the alloy being welded. In addition, the use of heat sinks on the back of the part being welded and, where practical, just welding the back of the component will reduce the problem. The welding technique known as flash butt-welding is the best method of reducing heat-affected zones in the weld area. This method of welding may not be practical on all components, depending upon their size and shape. The most popular method of eliminating this problem is by the use of mechanical joining techniques.

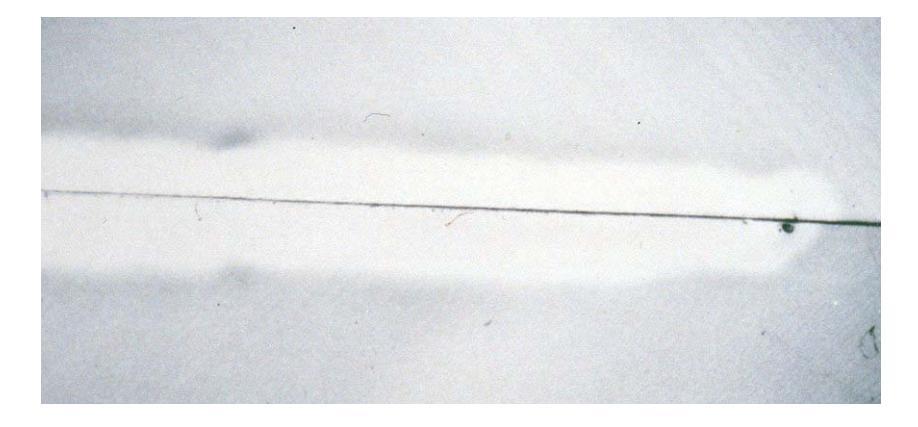
Figure 54. Heat-affected zone on a sample of thin gauge Al-Mg sheet when the part was welded on the back side only of the sheet.

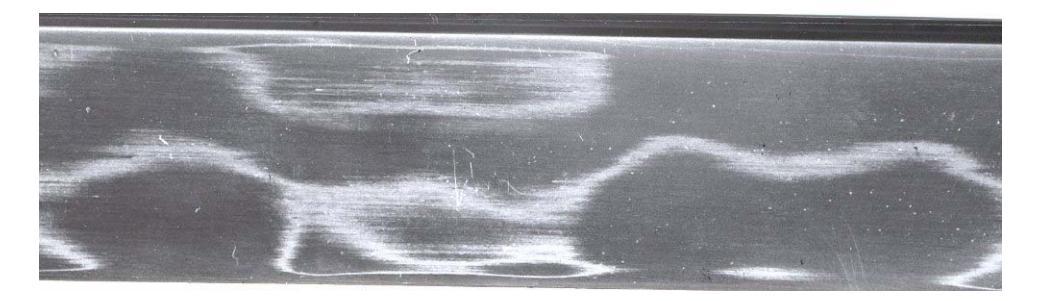
Sometimes the skin on the container of the extrusion press can become extruded into the section surface or subsurface. When etched and anodized this will show as a different texture to the bulk of the material and may present as illustrated in Figure 55.

Figure 55. Effect of container skin contamination after etching and anodizing a 6063 alloy extrusion.

The cause of this type of problem is usually associated with some ovality of the container on the extrusion press. Ensuring the correct temperature differential between the container and the ingot may also help to reduce the problem. The container should always be at a lower temperature than the ingot.

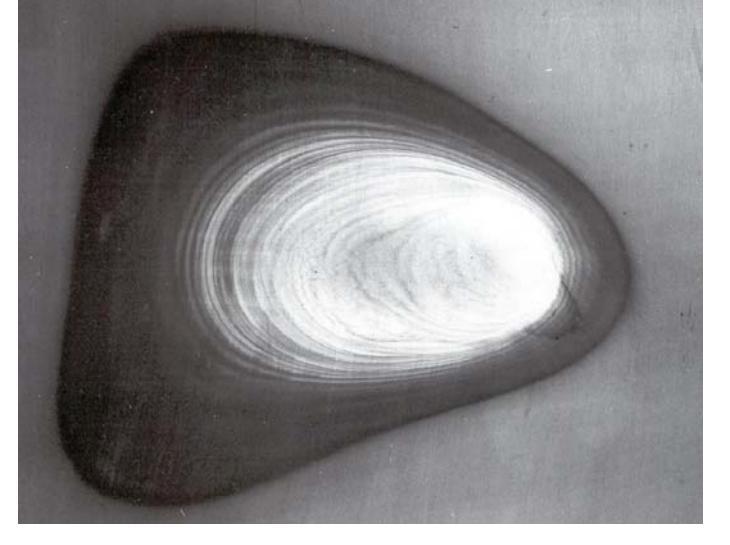
When the anodizing current density on a component is above a certain critical level, the anodic film may rapidly dissolve. This is known as 'burning' and it usually takes place at a weak point in the anodic film, due perhaps to a heavy die line or scratch in the substrate surface, a drilled hole or sharp edge or even a large intermetallic constituent. The lower resistance of the barrier layer at the weak point results in a localised higher current density and hence an increase in the temperature at that point. The metal/oxide interface overheats as a result of the high current density and the anodizing process breaks down and becomes a form of electrolytic etching. The problem sometimes occurs at a poor electrical contact between the aluminium being anodized and the rack material. Alternatively, where the agitation of the anodizing electrolyte is poor or there is a weakness at the metal/oxide interface, the local current density will increase resulting in overheating at this point. Once these situations occur, the problem is self-perpetuating and the net result is a large white shiny area (see Figure 57) and, in extreme cases, complete dissolution of the substrate. The aluminium high-copper alloys are very prone to burning particularly during hard anodizing.

Figure 57 (right). An example of anodizing burn in sulphuric acid electrolyte.

The solution to the problem is to improve electrolyte agitation over the part and not to use too high an anodizing current density. In the case of hard anodizing of aluminium-copper alloys, attention to the anodizing electrolyte composition is often necessary.

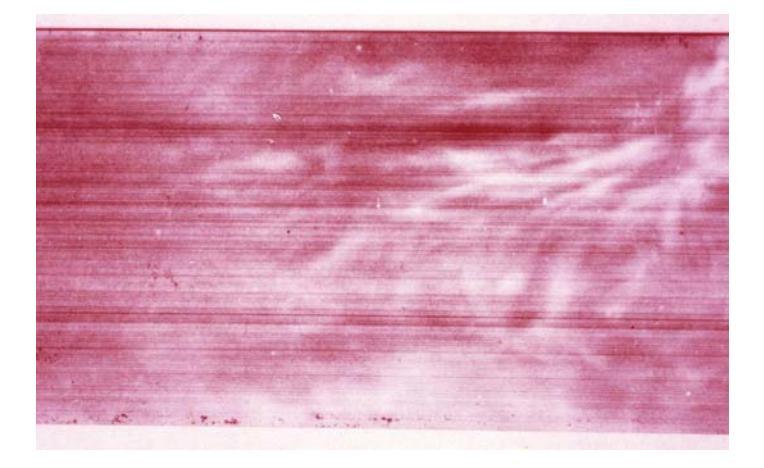
After anodizing it is important to remove substantially all the aluminium ions dissolved in the acid electrolyte trapped in the pores of the anodic oxide film on the surface. Rinsing the anodized parts in a very clean and pH-neutral rinse directly after anodizing, results in the precipitation of aluminium hydroxide in the pores. This gelatinous precipitate of aluminium hydroxide blocks the pore of the anodic film resulting in a non-uniform deposition of colouring species in any subsequent colouring process. An example of an anodized finish rinsed in a neutral rinse only, after anodizing and then coloured in a red dye solution is shown in Figure 58.

Figure 58. Patchy dyed finish due to poor rinsing of an anodic film before colouring.

The first rinse after anodizing should always be in an acidic solution, preferably pH 2 or less, to ensure that the aluminium ions are rinsed from the pores of the anodic film. The anodized parts should then be rinsed in a second, less-acid rinse before dyeing or electro-colouring. In an anodizing plant operating at normal production rates, the post anodizing rinse is normally acid due to drag-over of the anodizing electrolyte. It is when this rinse is emptied for whatever reason and renewed with clean water, that the problem is most likely to occur. Under such circumstances the addition of an amount of the anodizing electrolyte sufficient to adjust the pH of the rinse to 2.5 should prevent the problem.

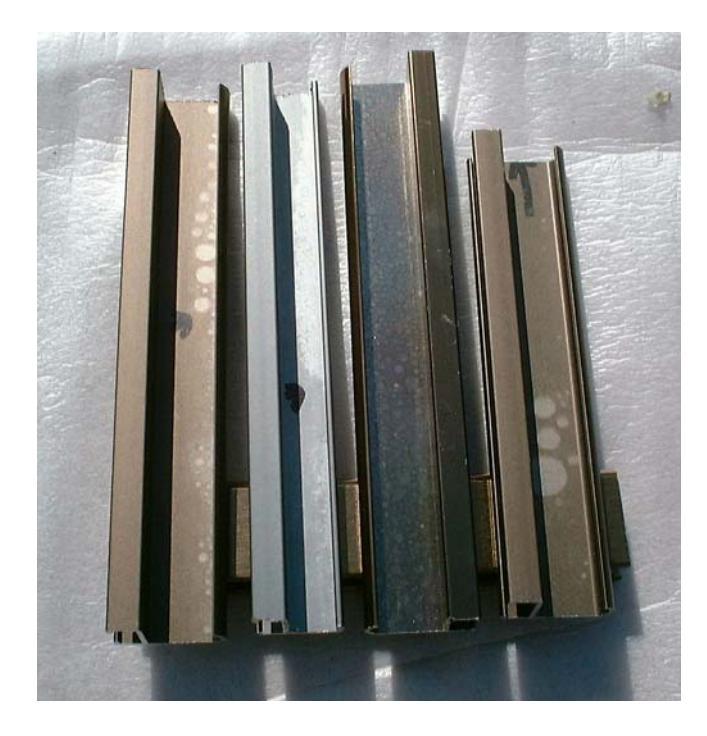
The trapping of air from the air agitation system or gas evolved by electrochemical reactions in the anodizing or colouring process stages, can result in pockets of gas on the underside of sections. These gas pockets act as insulators or masking agents. Depending upon the process-stage where such gas trapping occurs, it may inhibit the actual anodizing process or a subsequent colouring stage. The defect appears as random spots or areas of different hue or colour, on one face of a section. Often the anodic film is thinner in these areas. With dyed or electro-coloured finishes the colour may be lighter or darker in these areas depending upon the method of colouring, as seen in Figure 59.

Figure 59 (left). Typical examples of non-coloured areas due to gas trapping

Jigging the sections in a manner such that gas cannot be trapped under a horizontal surface or that any gas trapping is on a non-significant surface should eliminate the defect. Samples showing the defect can be stripped and reprocessed. For some types of thin film finishes it may be desirable to replace the air agitation with some form of mechanical agitation or use an eductor, hence eliminating one source of the problem.

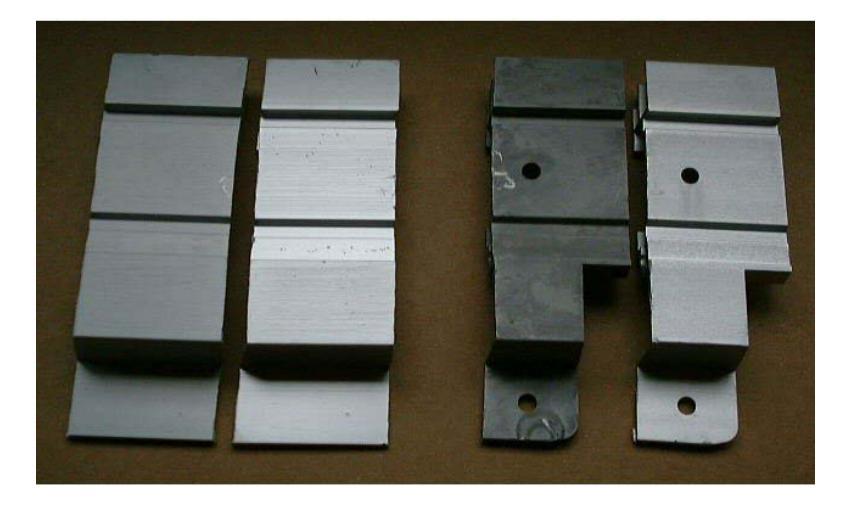
Colour differences are visually detectable and may be due to poor control of the colouring process. However, they can also be caused by a variable etch response of the extrusions and should be examined using the techniques described for this problem. (See 3f) An example of the latter is where the alloy ageing process is varied such that the size and distribution of the Mg₂Si precipitate is significantly different. This condition is indicated by a variation in colour of the smut after caustic etching as seen in Figure 60 and sometimes in the anodic film after anodizing and colouring as is illustrated in Figure 61. This variation in ageing conditions is not always detectable by measuring the hardness of the alloy and metallurgical examination is required to identify the variation.

Figure 60. Variation of smut levels on two 6063 extrusions having different size Mg2Si precipitates due to under-ageing and over-ageing, after etching in 10% NaOH at 60°C for 10 minutes.

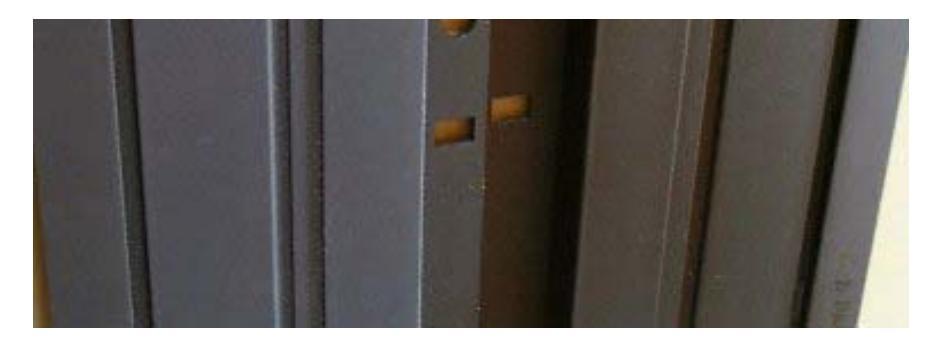
Figure 61. The same samples as in Figure 60 after anodizing and dyeing black.

Any prolonged immersion of the 'as-etched' material in an acid rinse prior to anodizing can enhance these effects and under optimum pre-treatment and anodizing conditions, it is often possible to process 6063 extrusions even with different precipitate conditions, to a satisfactory finish. However, this should not serve as an excuse for the aluminium extruder to tolerate such variations in their extrusions, and every attempt should be made to produce a consistent product in terms of Mg₂Si precipitation.
