The Identification and Prevention of Defects on Anodized Aluminium Parts

by Ted Short, Aluminium Finishing Consultant

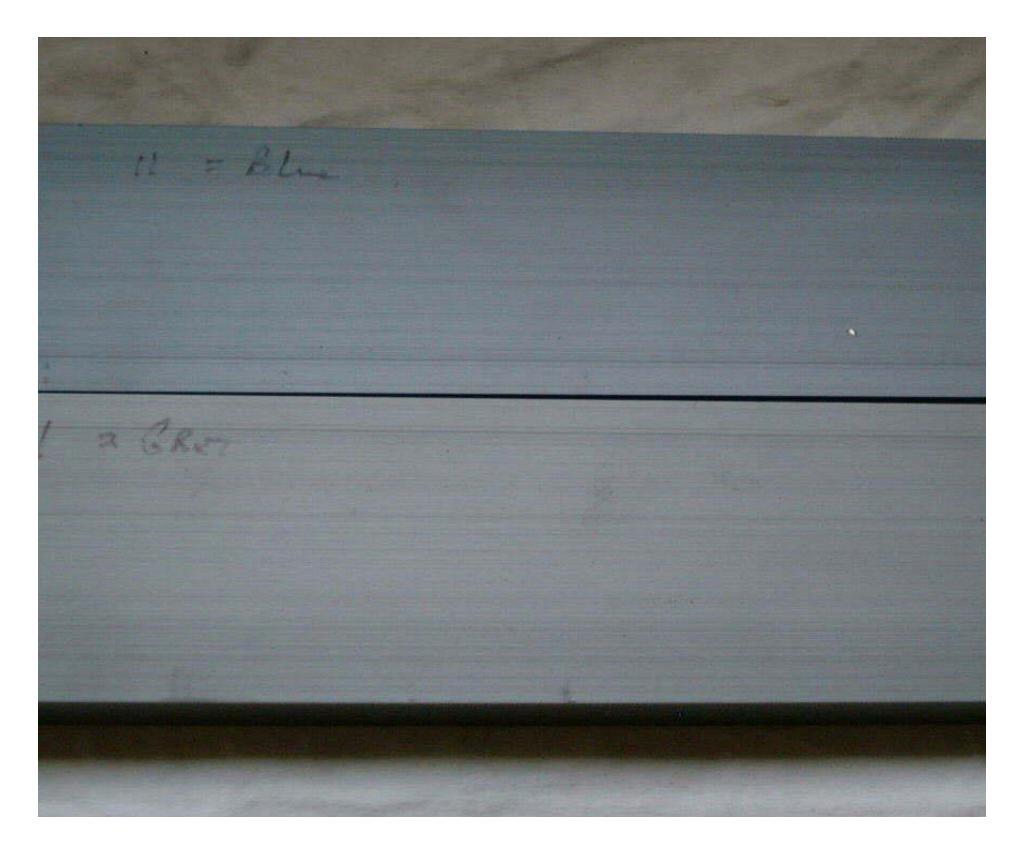
A similar colour variation due to differences in Mg₂Si precipitate size or distribution can occur during electrocolouring, particularly with the interference techniques used to produce grey colours. In this instance the effect is often just to change the tone of the grey colour from a neutral to a bluer overtone as illustrated in Figure 62.

Figure 62. Variation in colour within a single load of interferencecoloured grey finishes due to poor control of the ageing practice on the extrusions resulting in differences in Mg₂Si precipitate size. Colour match problems can arise from lack of control of the anodizing and colouring processes and every precaution should be taken to ensure consistency in these practices.

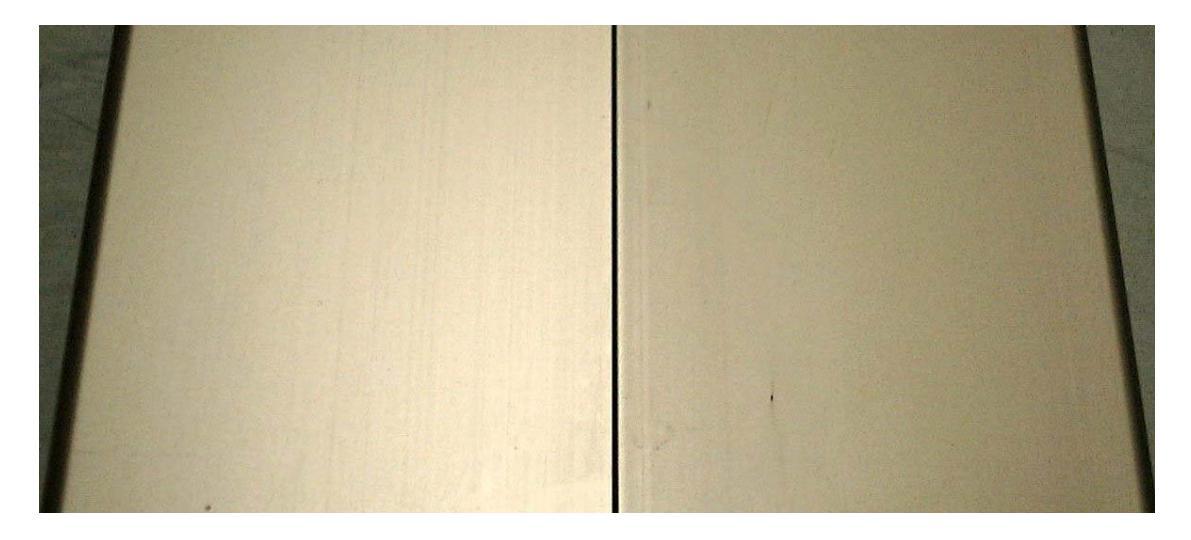
The degree of colour variation illustrated in Figure 64 however, would be considered to be too wide in the eyes of most architects, although it is a very subjective assessment.

Figure 64. Poor colour match on an architectural bronze anodized finish.

In the event of a dispute over the consistency of the colour match on a particular project the agreed dark and light colour limits should be used in any arbitration. However, it should be noted that the angle of viewing, the design of the extrusions or panels and how adjacent flat panels are located, all have an effect on perceived colour. The architect of a well-designed building should have taken such potential problems into account at the design stage.

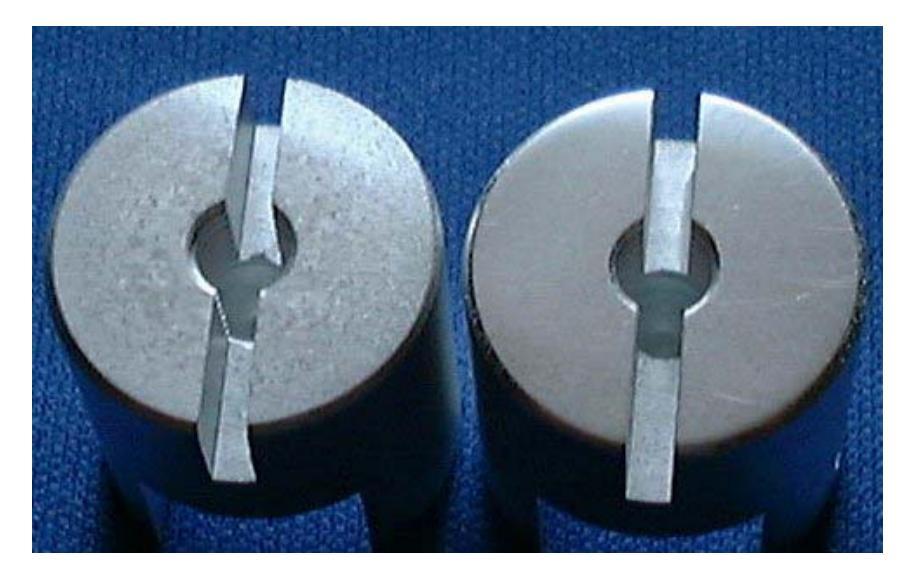
It is unusual to find a coarse grain structure in the normal architectural alloys used in anodizing. However, it is often necessary to use 6082 or 6351 alloys for applications where strength and machinability are required. These alloys, particularly in extruded bar form, can develop relatively coarse grains during the extrusion process. This coarse grain structure may not run along the complete bar and may be more severe towards the back end of the extrusion. It is often variable across the width of the extrusion but is sometimes confined to an area near to the surface when it is described as a coarse outer band effect. When etched and anodized these coarse grains affect the appearance of the product and are often reasons for rejection. Figure 67 shows the variation of this coarse grain effect on components machined from one end of an extruded bar to the other.

Figure 67. Variation in degree of coarse grain on components machined from the same bar stock. The sample on the left has coarse grain, that on the right, normal grain size.

There is no easy way of reducing this problem other than to use another alloy. Depending upon the application, alloys such as 6063 or, perhaps a free machining alloy such as 6062, 6061A or 2011, might provide a suitable alternative.

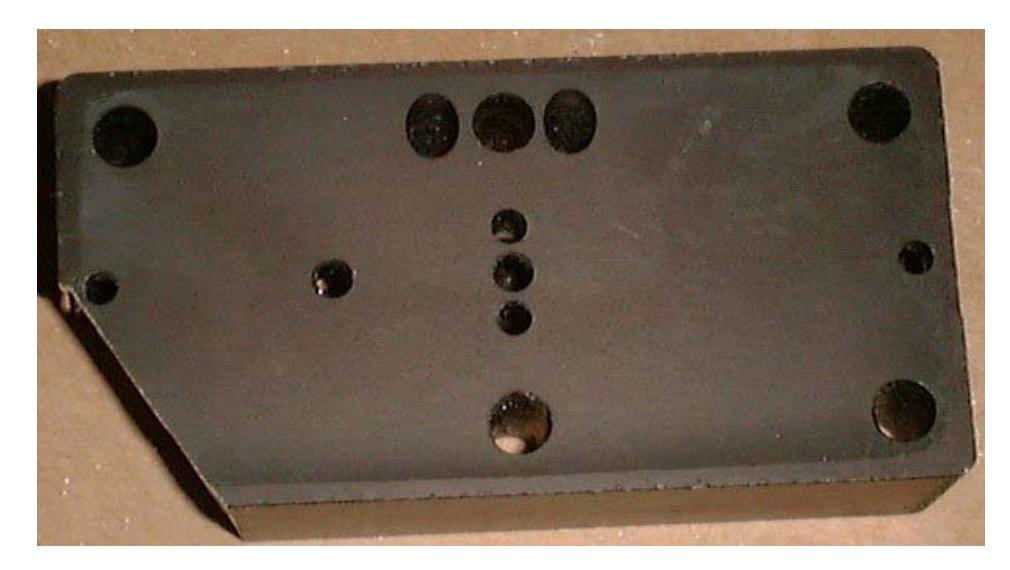
The effect of an outer band of coarse grain on a sample of etched, anodized and black dyed extrusion is illustrated in Figure 68.

Figure 68. Coarse grain outer band effect causing an apparent difference in colour on an etched, anodized and dyed 6082 extruded bar.

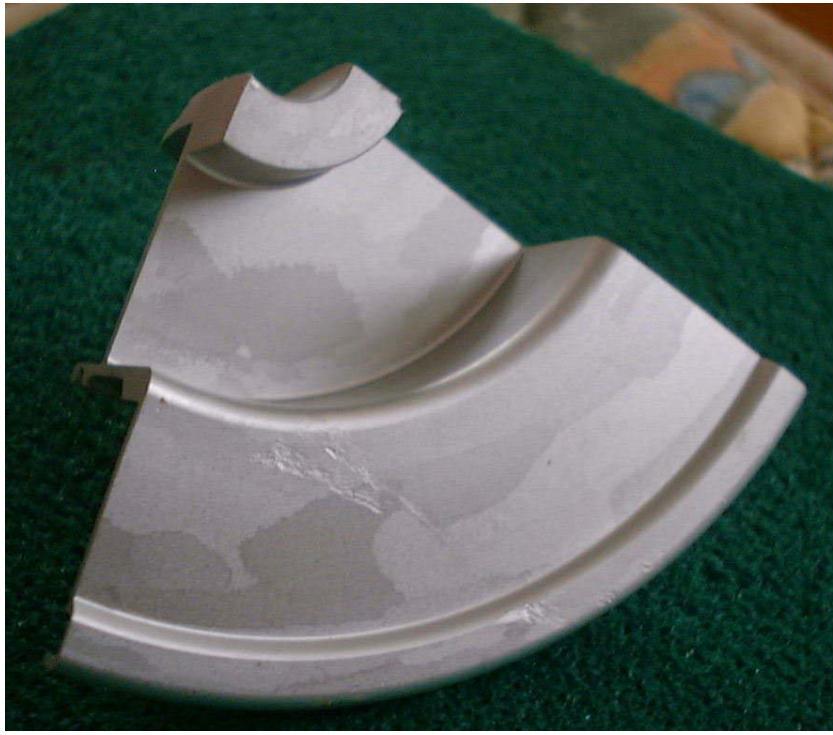
A similar problem can occur when attempts are made to anodize forged 6082 alloy an example of which is shown in Figure 69. Such components can exhibit very large grain size, depending upon the thermomechanical history.

Figure 69. Giant coarse recrystallised grains on a forged, etched and anodized anglers fishing reel.

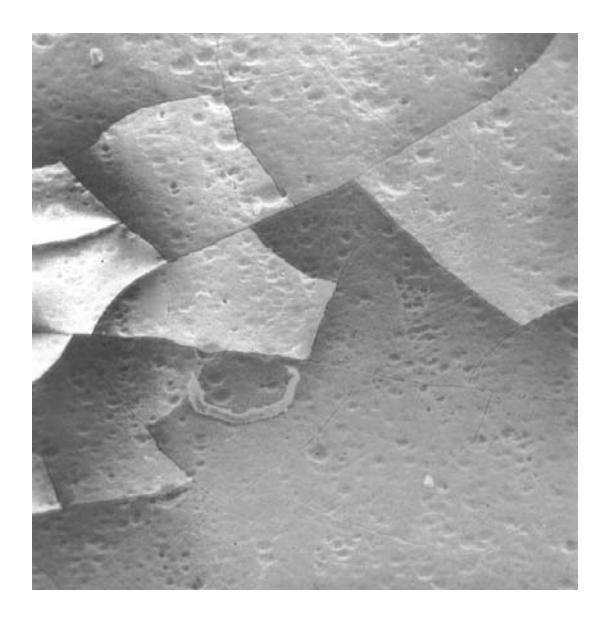
Some anodic films, especially if they are quite hard, can show a tendency to crazing during the final hydrothermal sealing stage of anodizing. Crazing has the appearance of a network of fine lines in a cobweb like pattern across the surface of the anodic film. As well as this thermal crazing, it is possible to form crazing in an anodic film by mechanically bending an anodized component. The fine lines produced by mechanical crazing are very similar to those of thermal crazing but they do tend to run parallel to each rather than in the random fashion typical of thermal crazing examples of which are shown in Figures 70 and 71. The tendency to crazing increases as the hardness of the anodic film increases. Samples having a smooth polished substrate before anodizing are also more likely to craze.

Figure 70. Example of thermal crazing. \sim (x 250)

Reducing the thermal shock of the sealing solution, by using a 70°C rinse pre-dip will help reduce crazing. Using a more matt finish and keeping the anodic film thickness and hardness as low as is technically acceptable will also help minimise the problem.

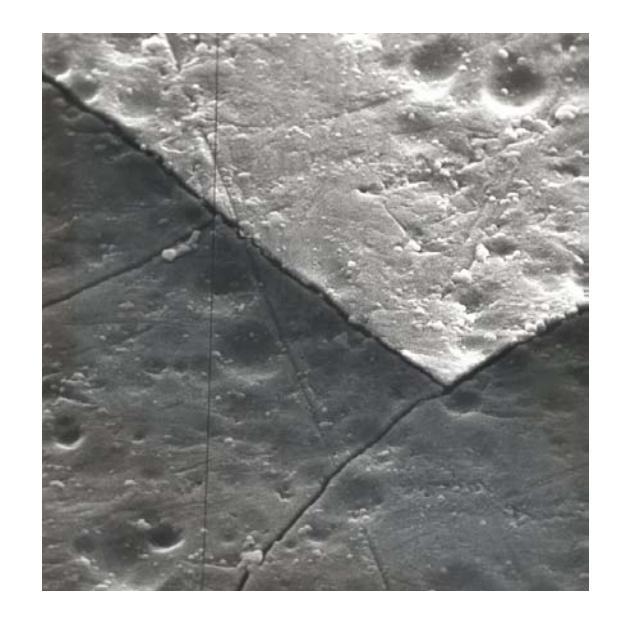
Figure 71. Example of thermal crazing showing crack in the anodic film. $\sim (x~500)$

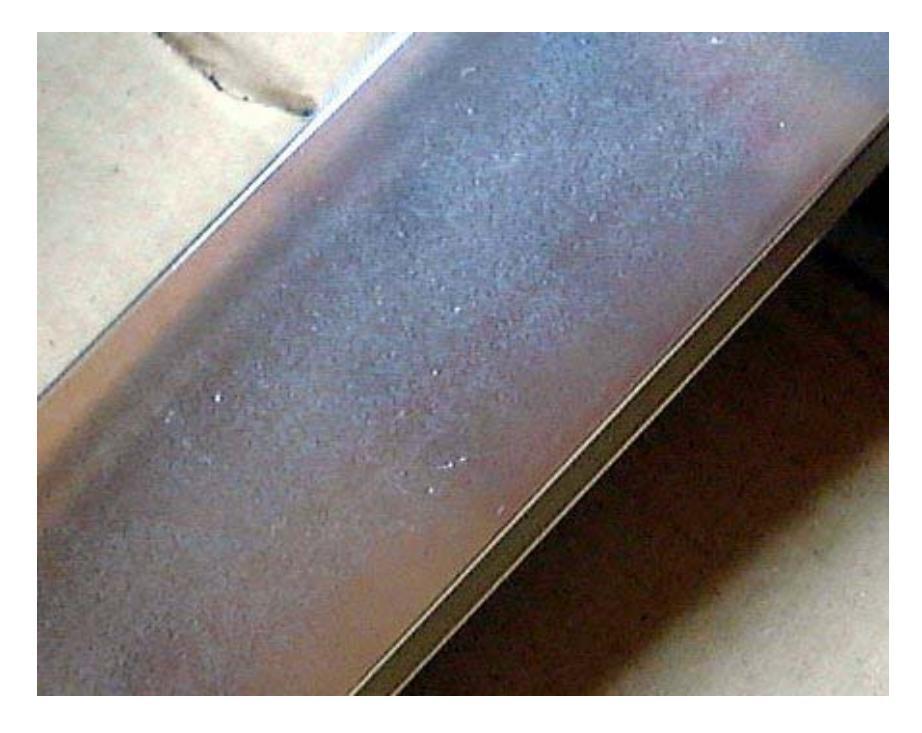
Aluminium that has been chemically brightened is usually given a warm water rinse after the brightening stage and prior to desmutting. Sometimes after the warm water rinsing stage, a tenacious smut remains on the surface that is not removed in the nitric acid desmut solution. This staining is often called transfer etch staining because if the part is anodized without removing the smut a white stain, as seen in Figure 72, results.

Figure 72. Transfer-etch stain on 6063 polished and bright anodized extrusion.

This problem is usually associated with too long a transfer time between the brightener and the warm water rinse. If it is not possible to reduce this transfer time, then increasing the nitric acid content of the brightener or increasing the amount of additive used to aid these longer transfer times on automatic lines may solve the problem. Figure 73 illustrates the effect that increasing the nitric acid content of the brightener from 4 to 5% had on this problem.

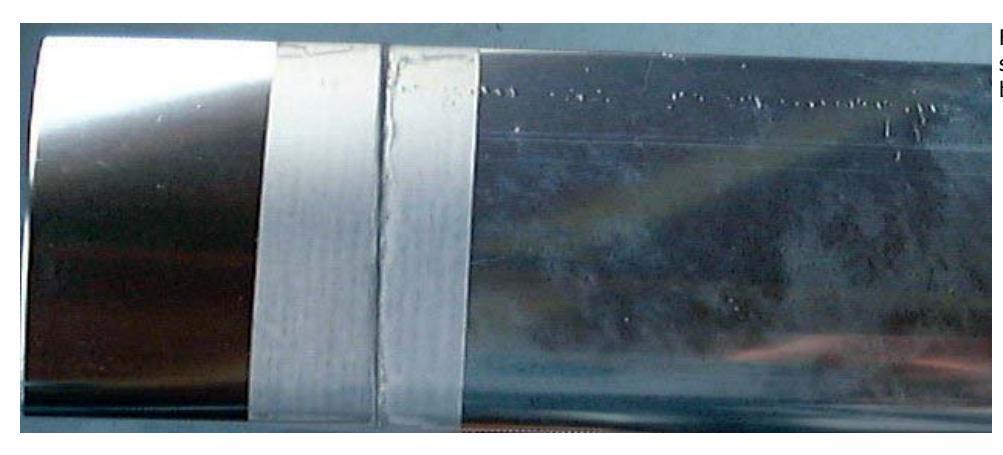
Figure 73. Sample on left of tape brightened in solution containing 5% HNO_3 and sample on right brightened under same conditions but with only 4% HNO_3 in the brightening solution.

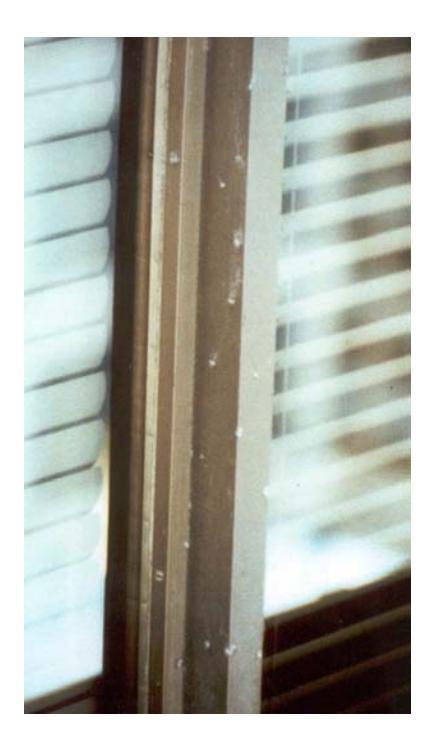
Pitting of finishes is usually associated with an inappropriate anodic film thickness being used for a particular application. Alternatively, lack of correct regular maintenance can be to blame. Typical examples are given in Figures 75 and 76.

Figure 75. Example of pitting on a bronze anodized architectural anodic finish in service due to inadequate anodic film thickness.

It is most important to ensure that the specification of an anodized finish for architectural applications is correctly defined. Normally the BS 3987 is used for this purpose in the UK, but there is often confusion when parts to be used on buildings in the UK are processed on the Continent, the Middle East or even North America. The local architectural specifications in these countries may not be as demanding as the British Specification, particularly regarding anodic film thickness requirements and the hardness or abrasion resistance of the anodized finish. It should be noted that BS specification 3987 was developed as a result of architectural anodized finishes displaying two main problems. These were isolated cases of premature pitting or very rapid formation of a white powdery bloom upon exposure to the elements. This specification calls for a minimum average anodized

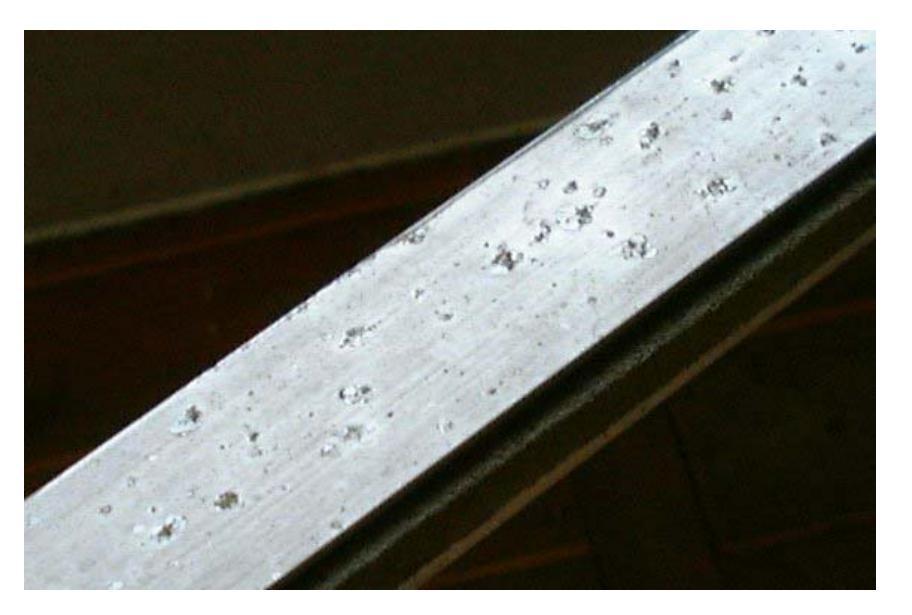
Figure 76. Pitting of an architectural finish in service due to lack of cleaning maintenance.

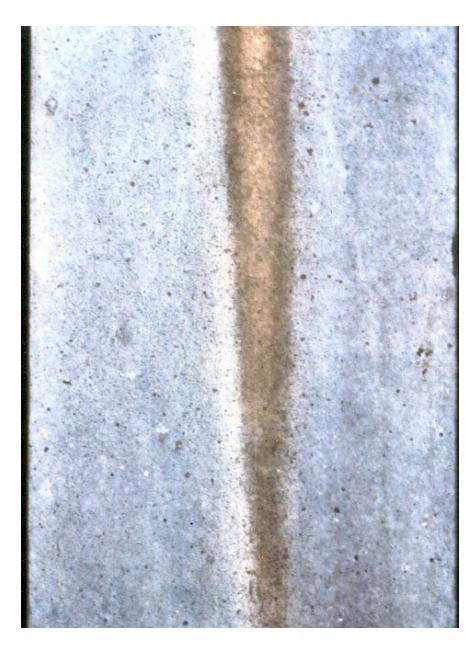
One form of staining is a weathering effect that occurs quite quickly (usually during the first 6 months) on anodized work that has been poorly sealed. As can be seen in Figure 78 it is a whitish bloom and may incorporate other stains where water has run down the surface in an exposed location. Similar forms of staining or bloom can occur on a good quality anodized finish, over a prolonged period of time (3 to 8 years) if the finish is not subjected to a regular cleaning or maintenance program, or where the anodic film was insufficiently hard. This is discussed under weathering bloom in section 4d and chalking in 4f respectively. Staining on a poorly sealed anodic film, whether it has a good abrasion resistance or not, is due to chemical attack and cannot be removed by abrasive cleaning treatments. It will only occur on component parts that were originally sealed with less than acceptable seal quality. The anodic film may have self-sealed in service, making it difficult to establish that the original cause of the problem was a poor sealing quality.

Because this type of weathering stain is due to chemical attack of the anodic film not just on the surface but also within the pores, it is difficult, if not impossible, to remove the staining by any cleaning process. In this, it differs from natural weathering bloom or chalking due to a soft anodic film.

Figure 78. Sample of staining on a poorly sealed anodic film exposed to the atmosphere for about 6 months.

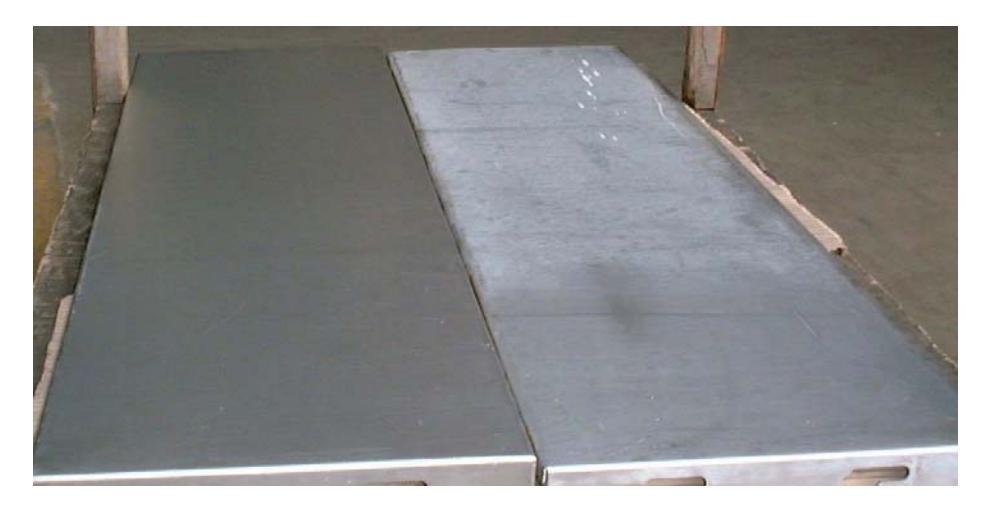
When a good quality anodic film is exposed to the atmosphere for, say 5 years or more, depending upon the degree of atmospheric pollution, without any regular maintenance, and particularly if it is not washed by rain, a surface bloom may form. This bloom is often referred to as 'weathering bloom' or 'white bloom' and slowly builds up on the surface of the anodic film over a prolonged time. The bloom is a relatively thin micro-rough layer of reaction product that can be removed by a vigorous cleaning treatment. A typical example is given in the right hand panel in Figure 79.

Figure 79. Curtain walling panels that had not been given regular cleaning maintenance showing on the right hand panel the white 'weathering bloom' before cleaning. The left hand panel is a similar panel after cleaning with a Scotchbrite pad and a solution of Teepol in water.

Pumice powder on a damp cloth or pad or a Scotchbrite' abrasive pad and water containing a detergent such as 'Teepol' are often used to remove this type of bloom. This removes the 'white bloom' and a satisfactory surface is restored as shown in Figure 79, which, if then regularly maintained, usually performs perfectly satisfactorily for many years. No significant film thickness loss should occur on a good quality anodic film during this cleaning process. This bloom should not be confused with the white staining due to poor sealing (4c) or chalking caused by a soft anodic film (4f).

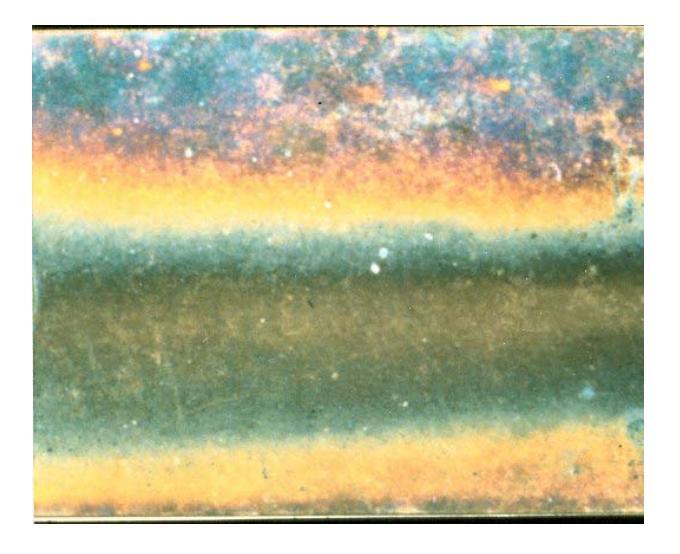
Iridescence is another form of staining caused by weathering or a further self-sealing of the film. It is usually most evident on electrolytically coloured finishes; in many cases occurring on finishes that have not been cleaned during the first 6 to 12 months of service. An example is shown in Figure 80. It can be removed by cleaning the anodized surface using a mild abrasive, such as pumice, on a damp cloth. No significant film thickness loss should result from the cleaning.

Figure 80. Iridescence formed during outdoor exposure on a sample of anodized and electrolytically coloured aluminium.

Once removed by the mild abrasive treatment the problem does not normally recur and in the case of finishes that have been regularly cleaned since installation it is unlikely to occur at all.

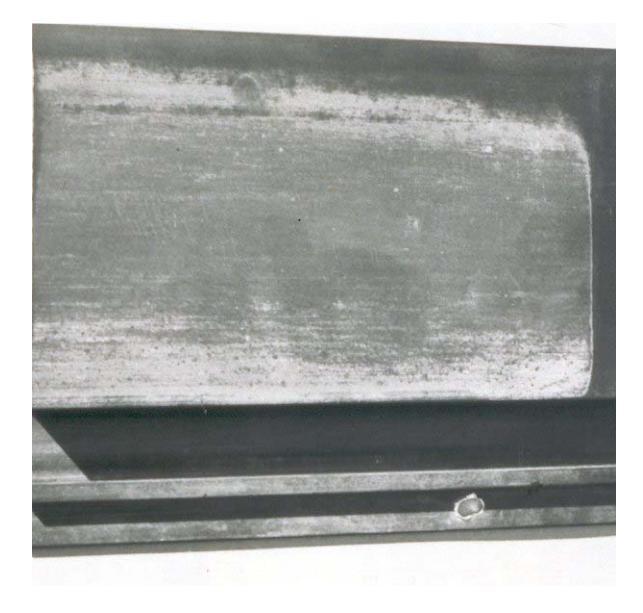
Chalking, or the formation of a heavy white deposit as illustrated in Figure 81, on an anodic film during the first year after installation on site, can be serious. It is usually associated with an anodic film of insufficient hardness, and the surface is often powdery (see Figure 82). The chalking can be removed by abrasive cleaning using a purpose designed anodized aluminium polish or pumice powder on a damp cloth. There is usually a significant (5 - 8µm) film thickness loss during such a cleaning treatment. An alternative cleaning media is Scotchbrite abrasive pads wetted with a solution of Teepol in water. Even after such cleaning treatments the bloom may return and a second cleaning will be required, removing even more anodic film, to eliminate the problem.

Figure 81. Chalking of an anodic finish in service due to a soft anodic film.

Such chalking is indicative of a soft anodic film and there is little that can be done to rectify this problem, other than removing the soft outer layer and this is no guarantee that the problem will not return. Attention to the quality of the anodic film in terms of abrasion resistance will prevent such defects. In general, soft anodic films are produced when the anodizing temperature or electrolyte concentration is too high or the anodizing current density is too low. The problem is more common on the thicker films specified for architectural use.

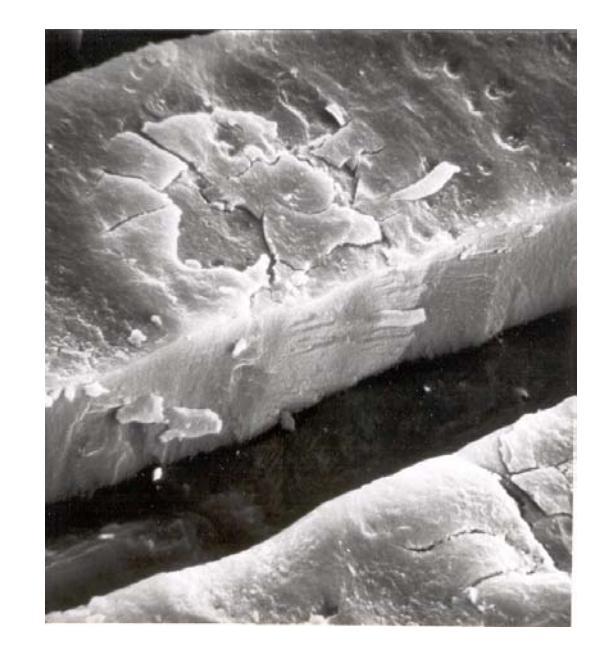
Figure 82. Detail of surface deposit on chalked anodic finish showing the powdery nature of the flaked surface.

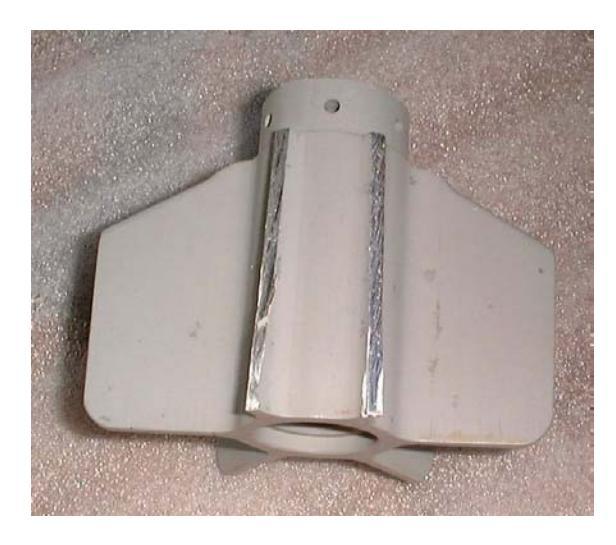
Example of chromic acid anodized finish showing some pitting on mortar bomb fins probably due to corrosion of the component before anodizing.

Fig 83a (above) Fin showing dark stains

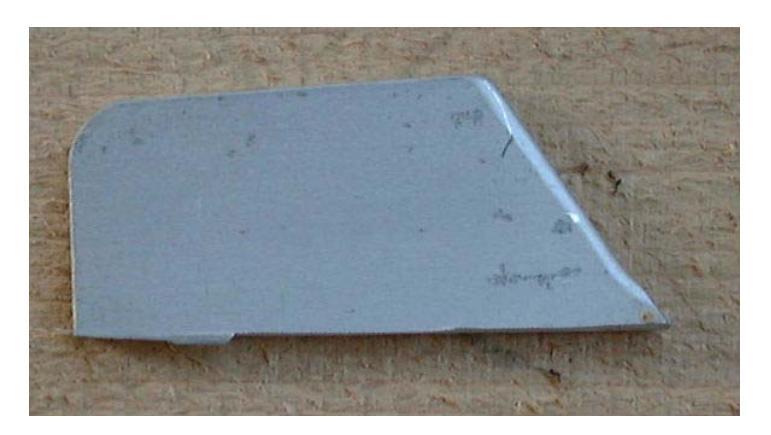
Fig 83b (top right) Fin as chromic acid anodised

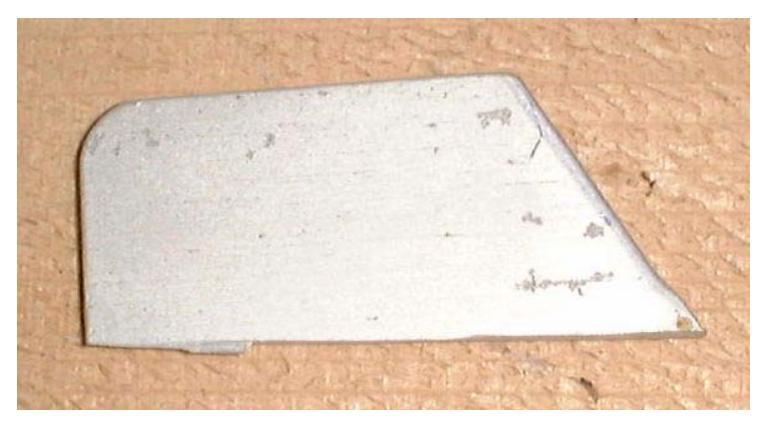
Fig 83c (top left) Same fin after removal of anodic film by etching in 10% NaOH at 60°C for 2 to 3 minutes

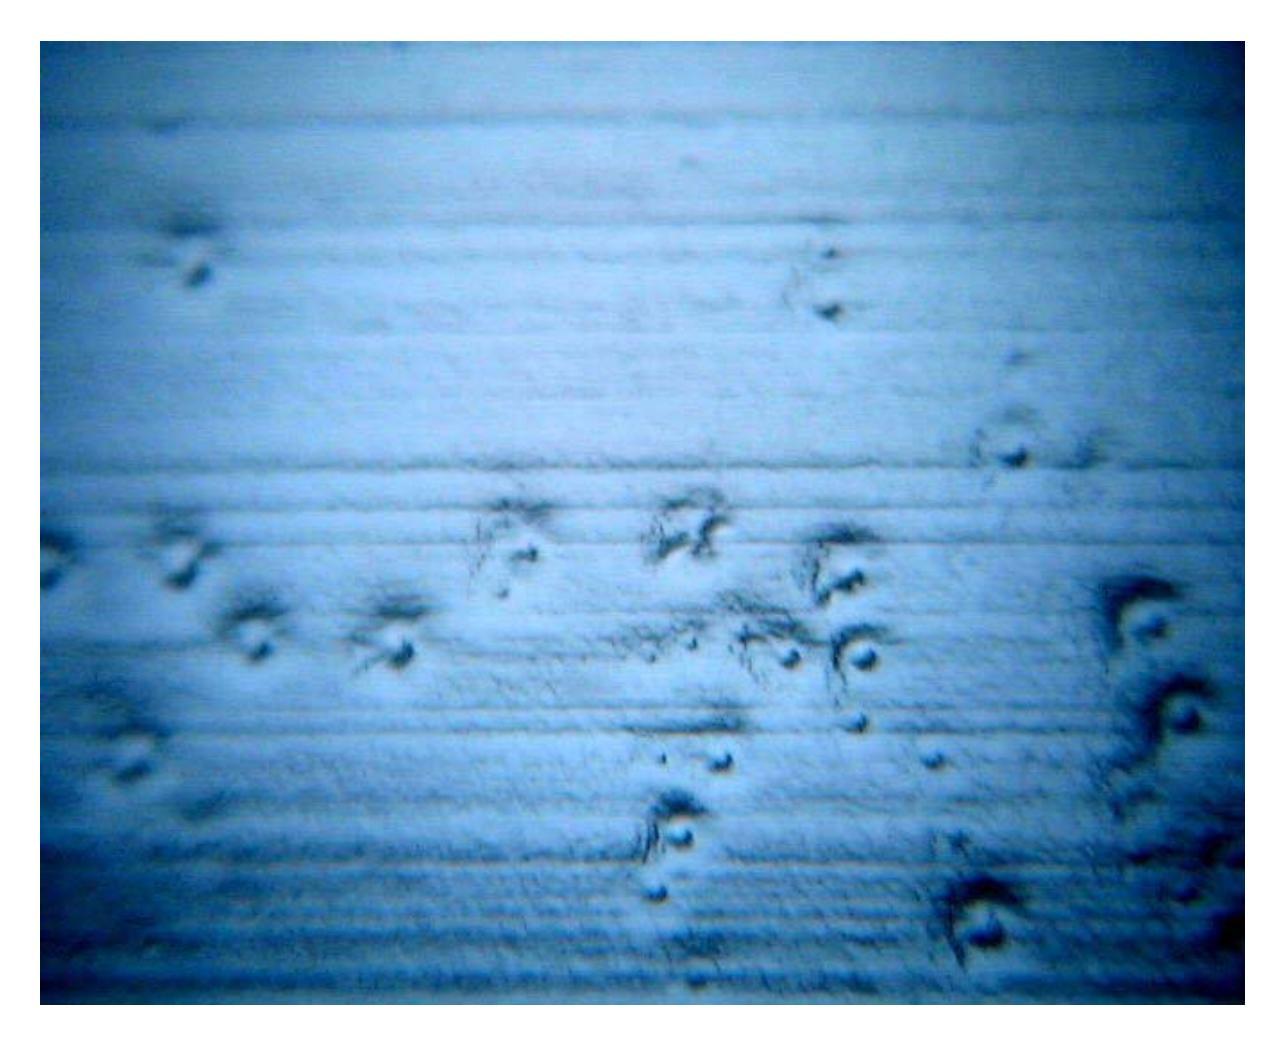
Figure 12. Pitting of the 'castle and moat' type. x 20

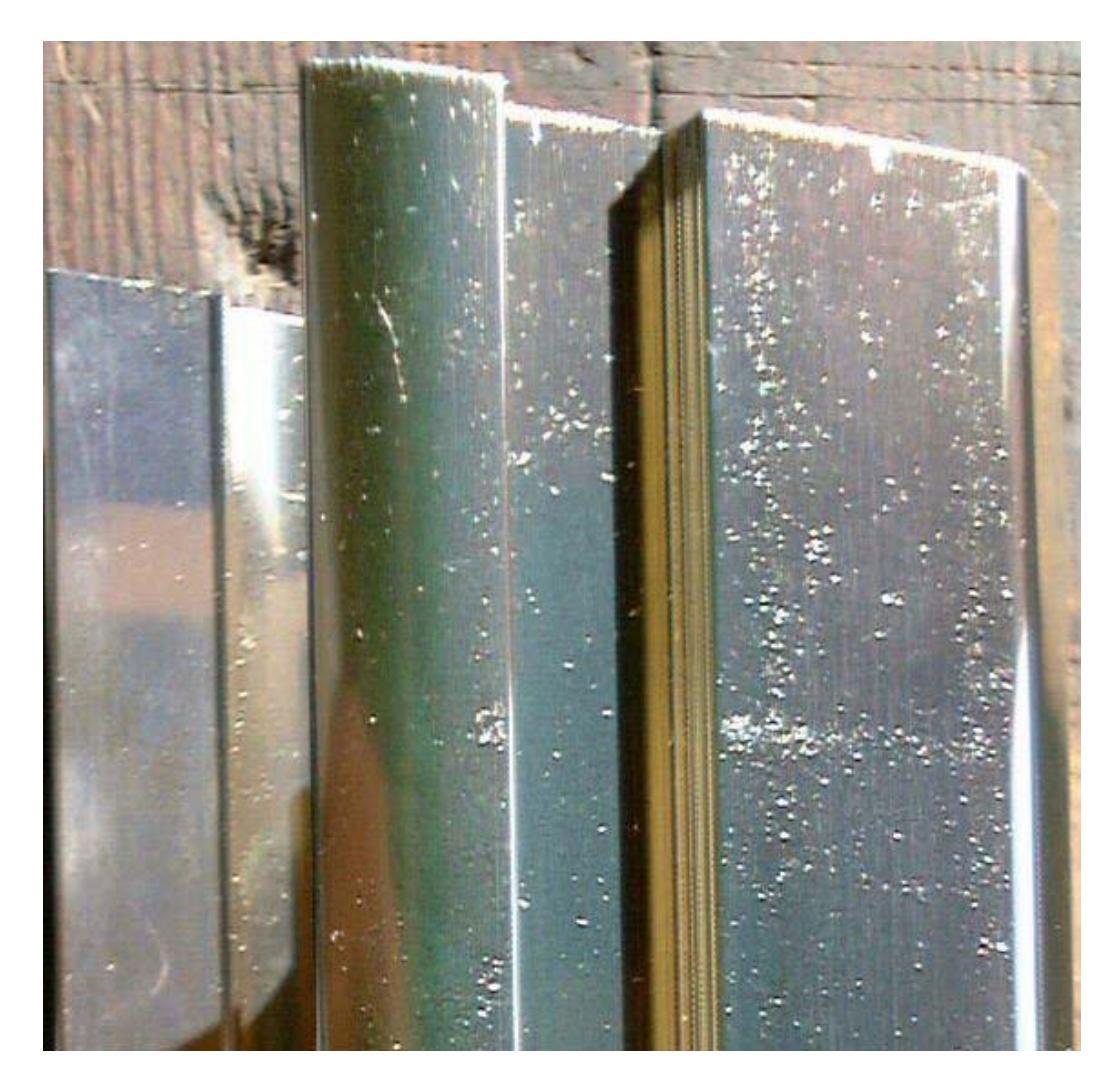
Figure 13. Example of 'castle and moat' pitting. x 1

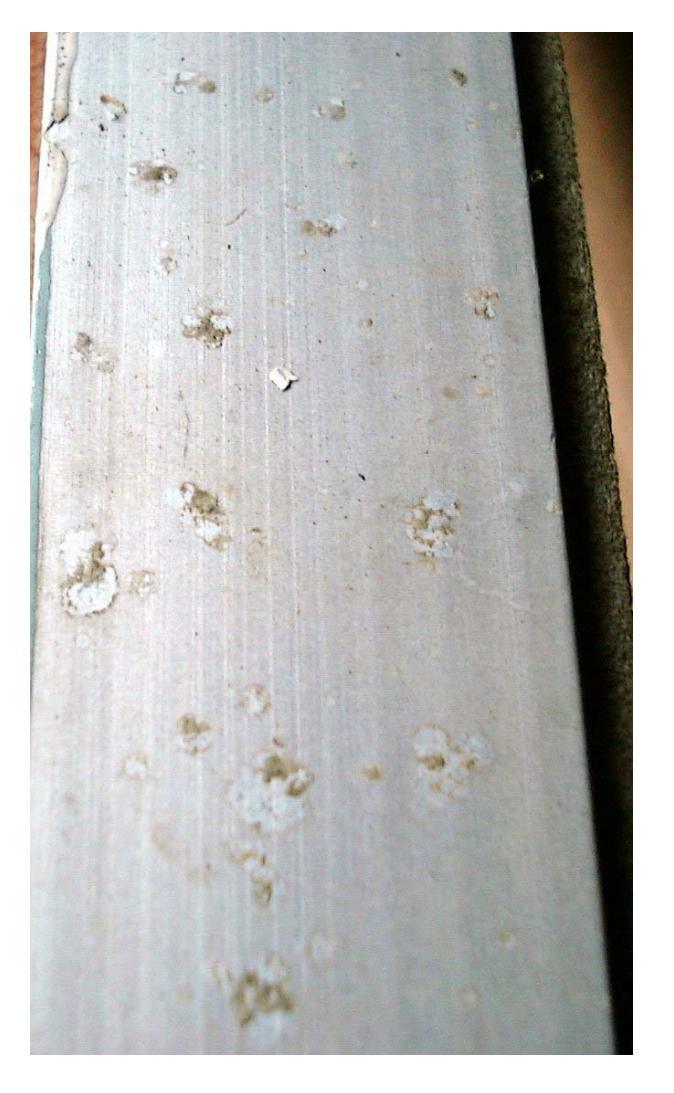
Figure 16. Examples of pitting of anodic films in service due to the film thickness being below specification.

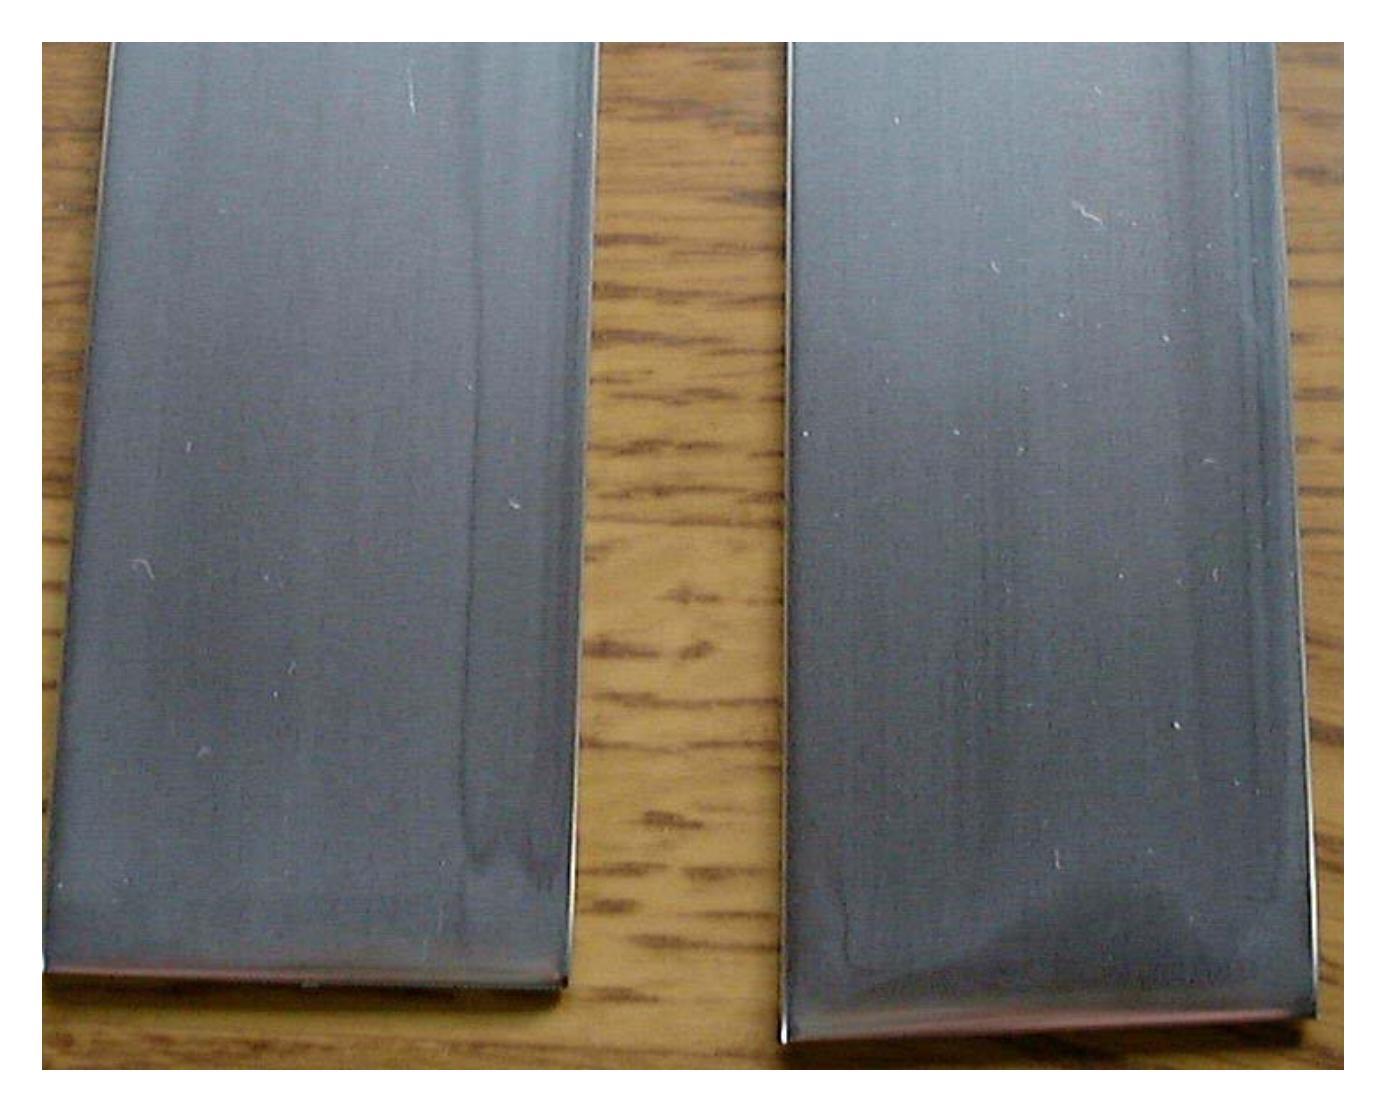
Figure 19. Example of shell zone segregational streaking after stripping the original anodic film, taper polishing the affected surface and re-etching and anodizing.

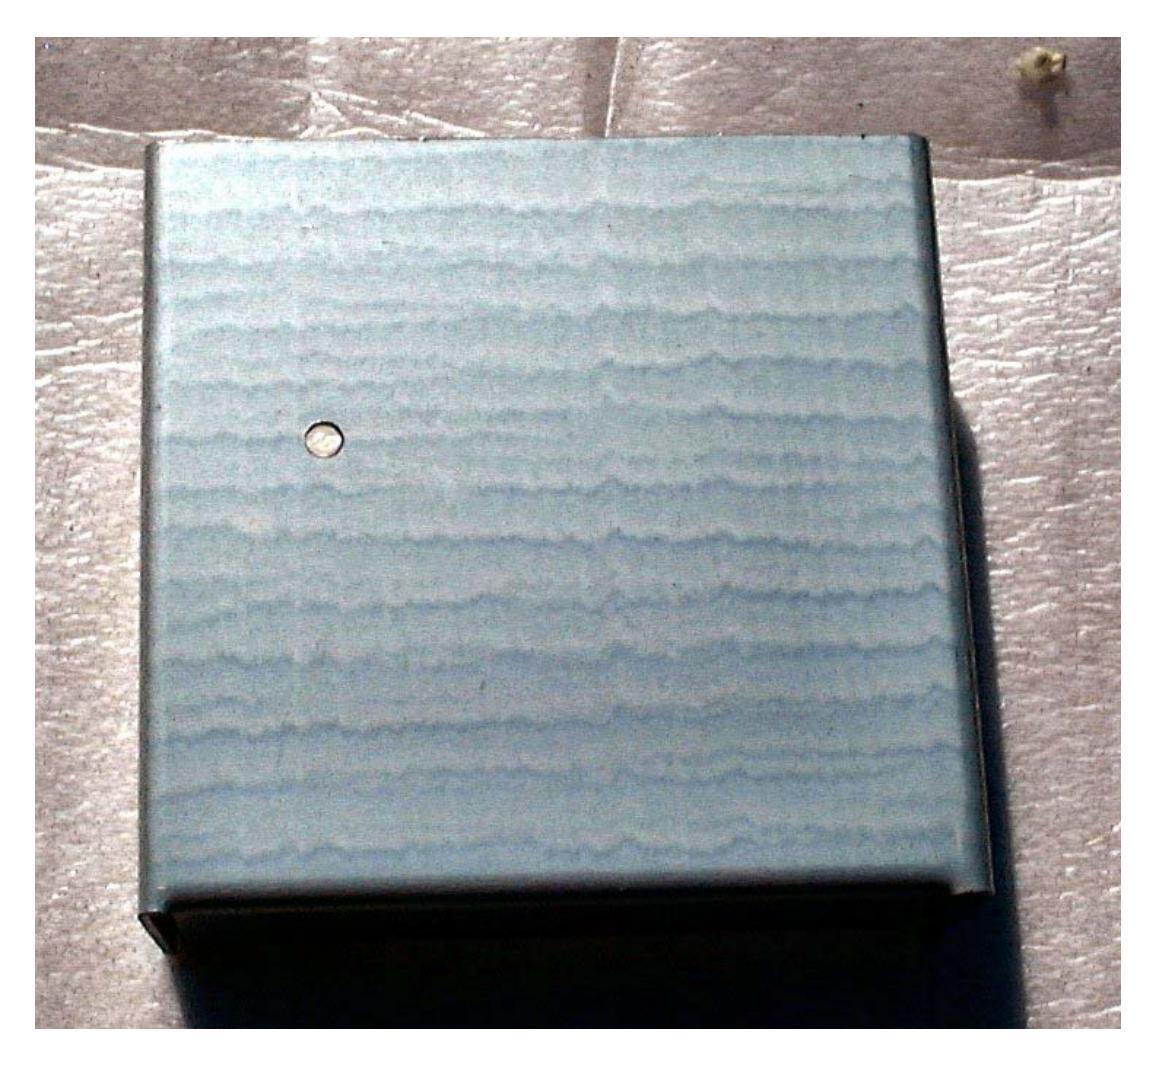
Figure 20. Inverse segregation effect on etched and anodized rolled sheet produced from an ingot that had not been scalped or had insufficient metal removed by the scalping operation.

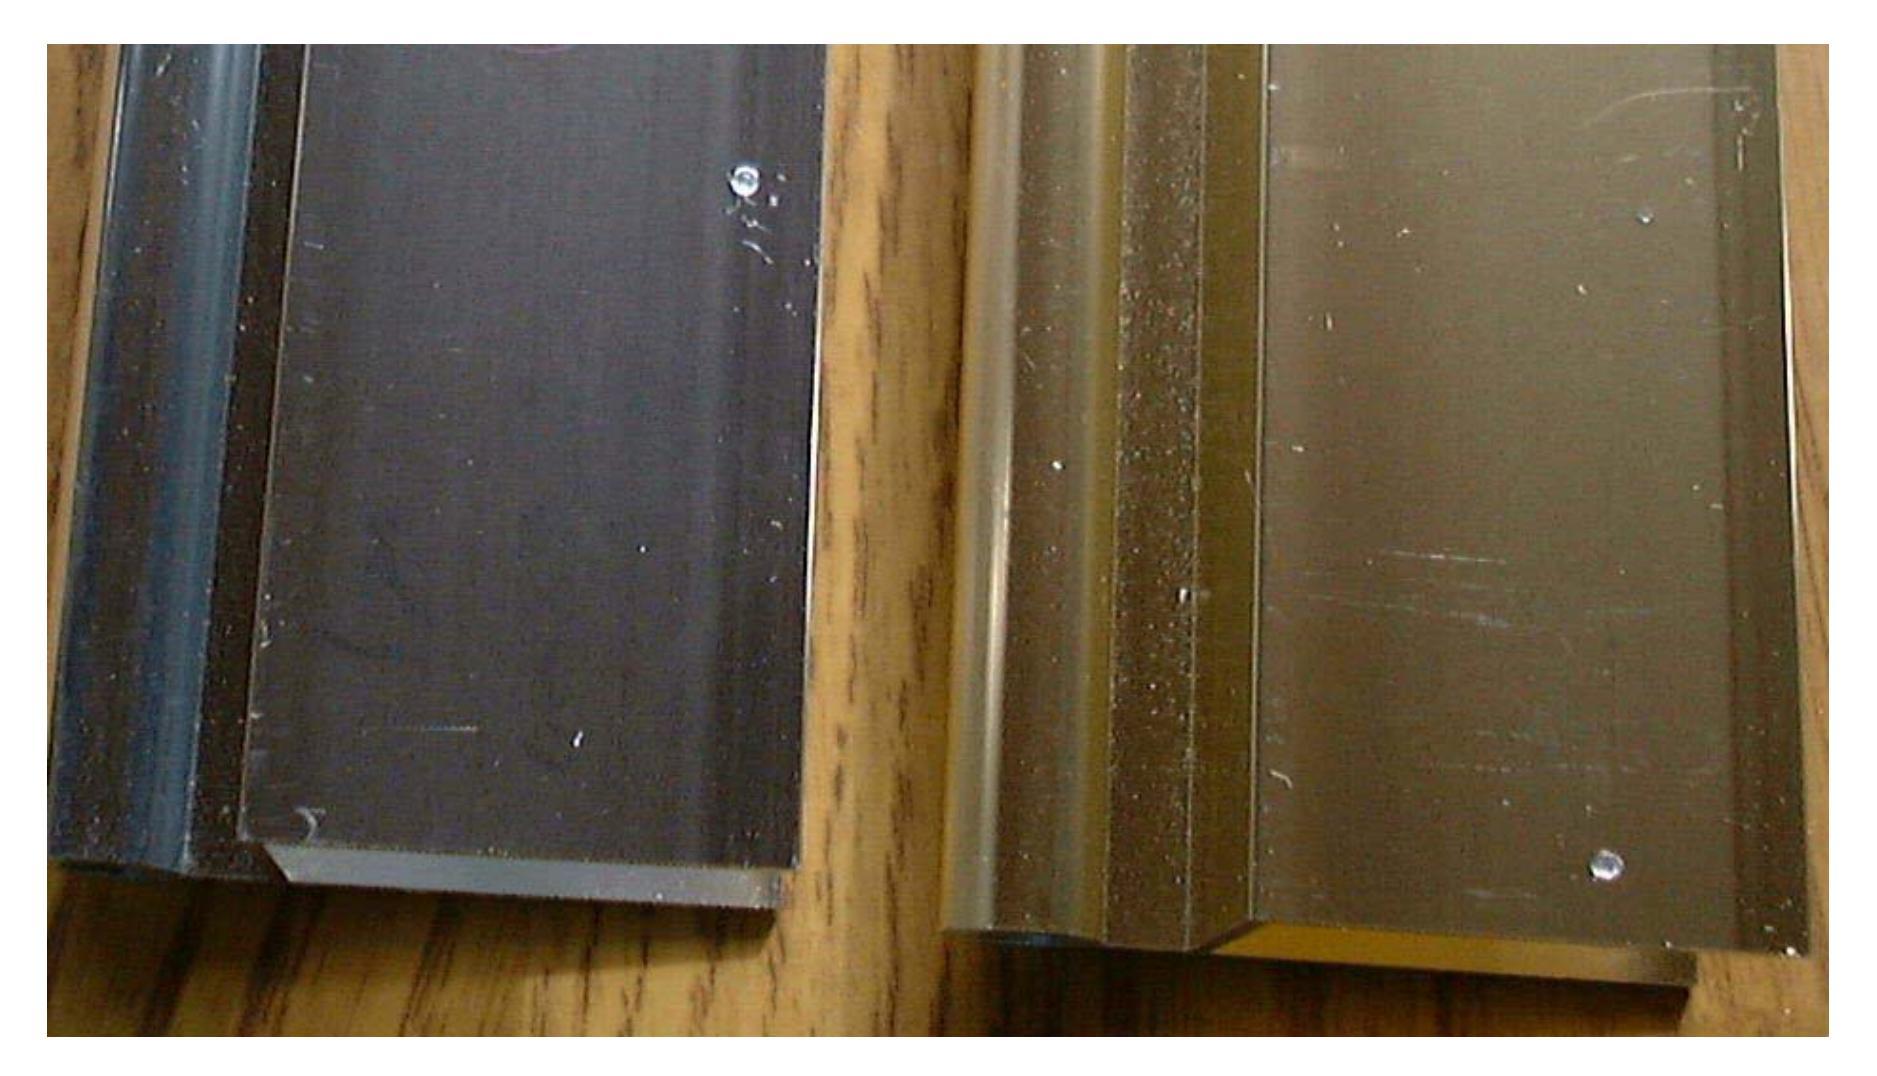
Figure 21. Structural or Die design streaking revealed by etching and anodizing a 6063 extruded section. (x 1

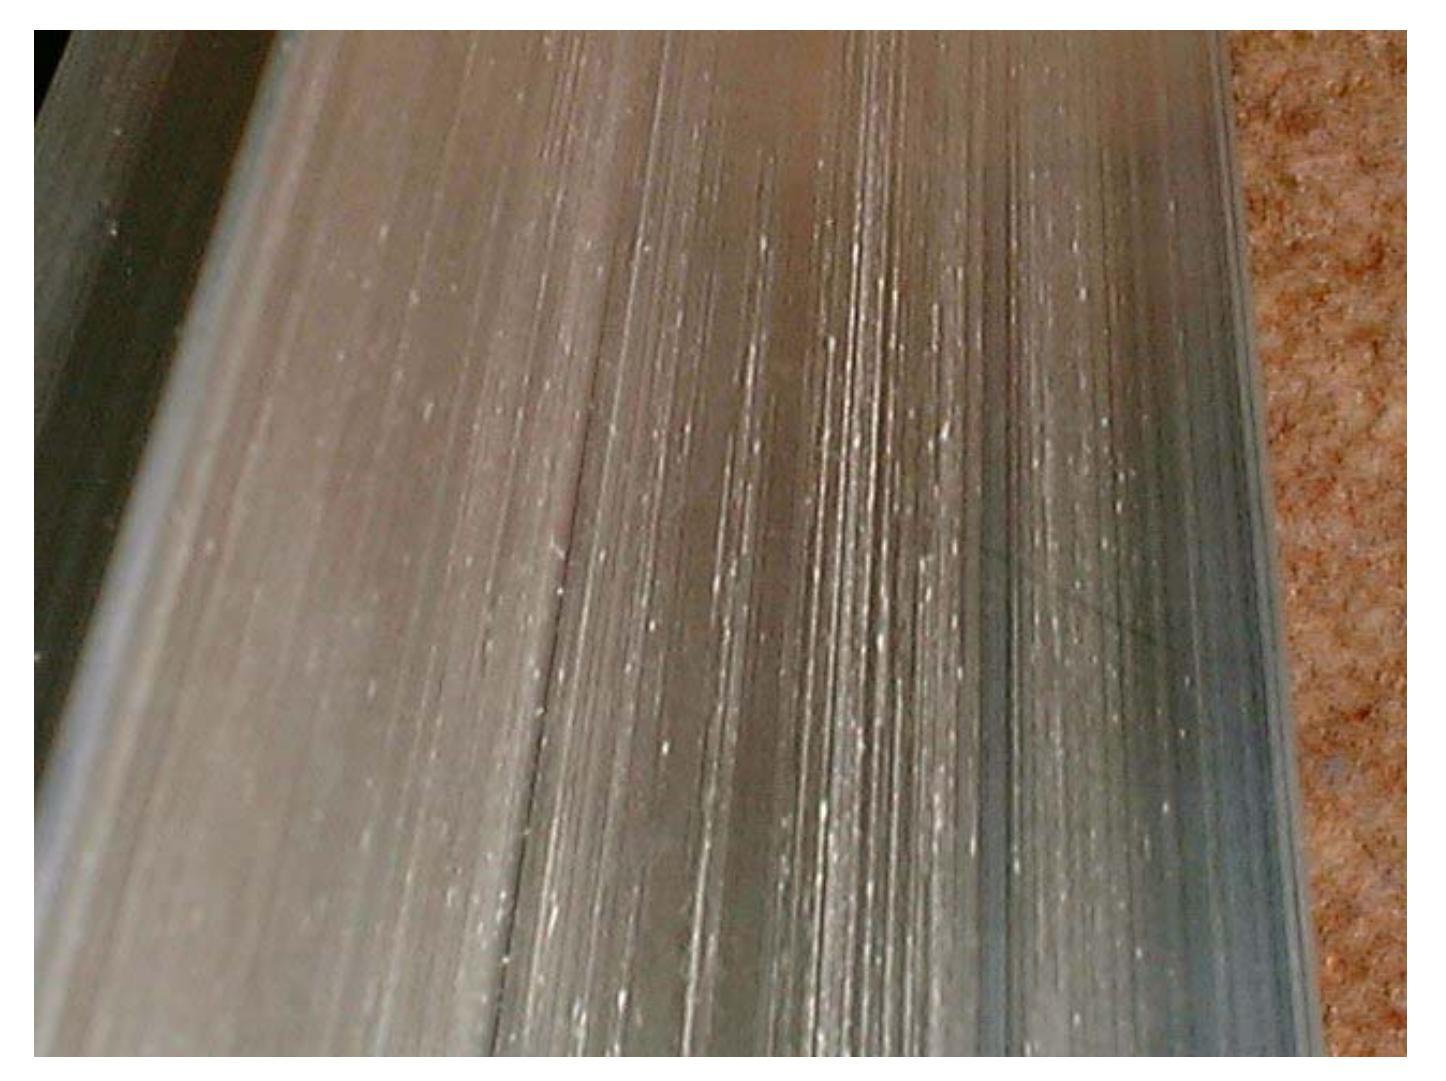
Figure 22. Examples of severe die lines on 'as extruded' section.
