The Identification and Prevention of Defects on Anodized Aluminium Parts

by Ted Short, Aluminium Finishing Consultant

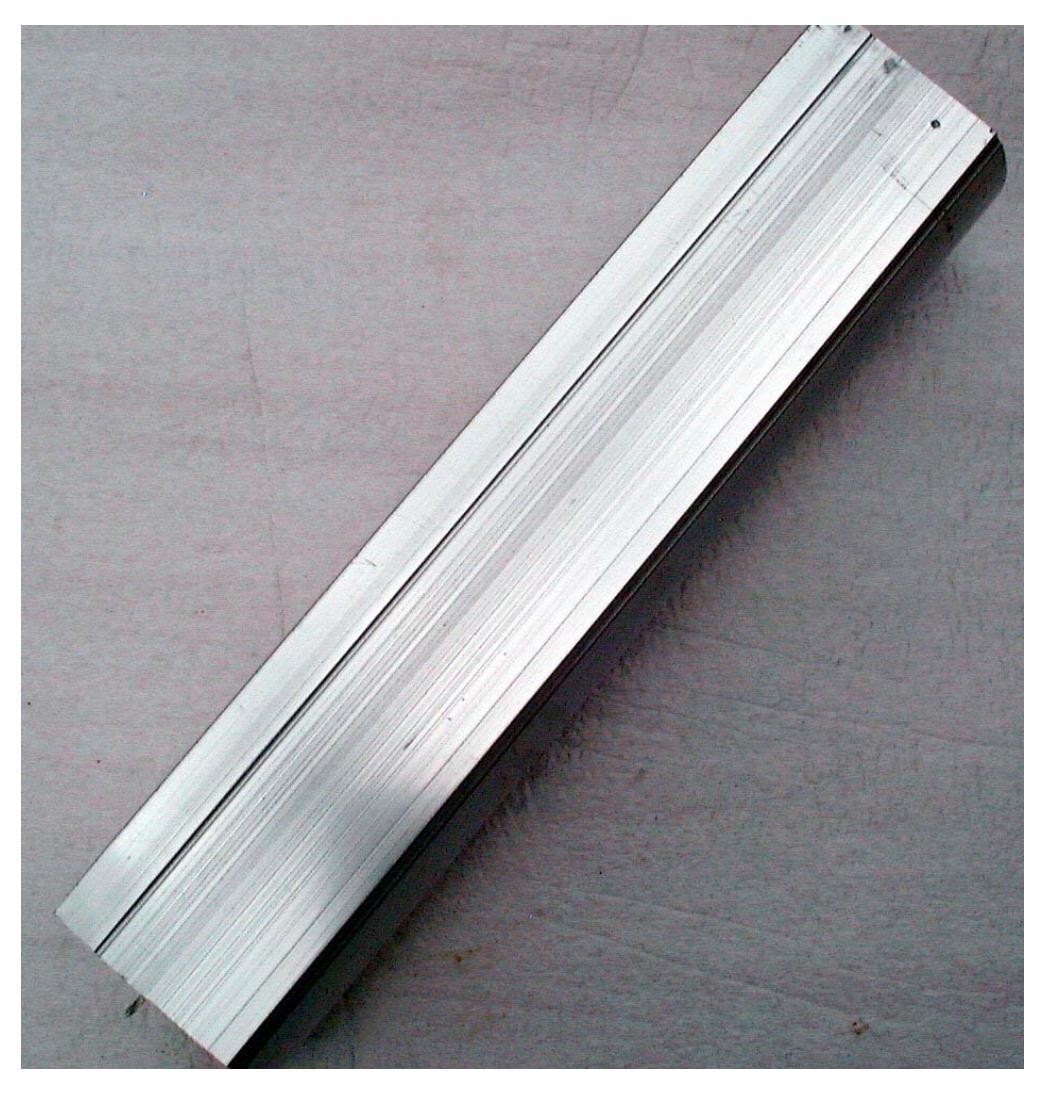
Figure 23. Severe die lines showing up as darker streaks after etching and anodizing.

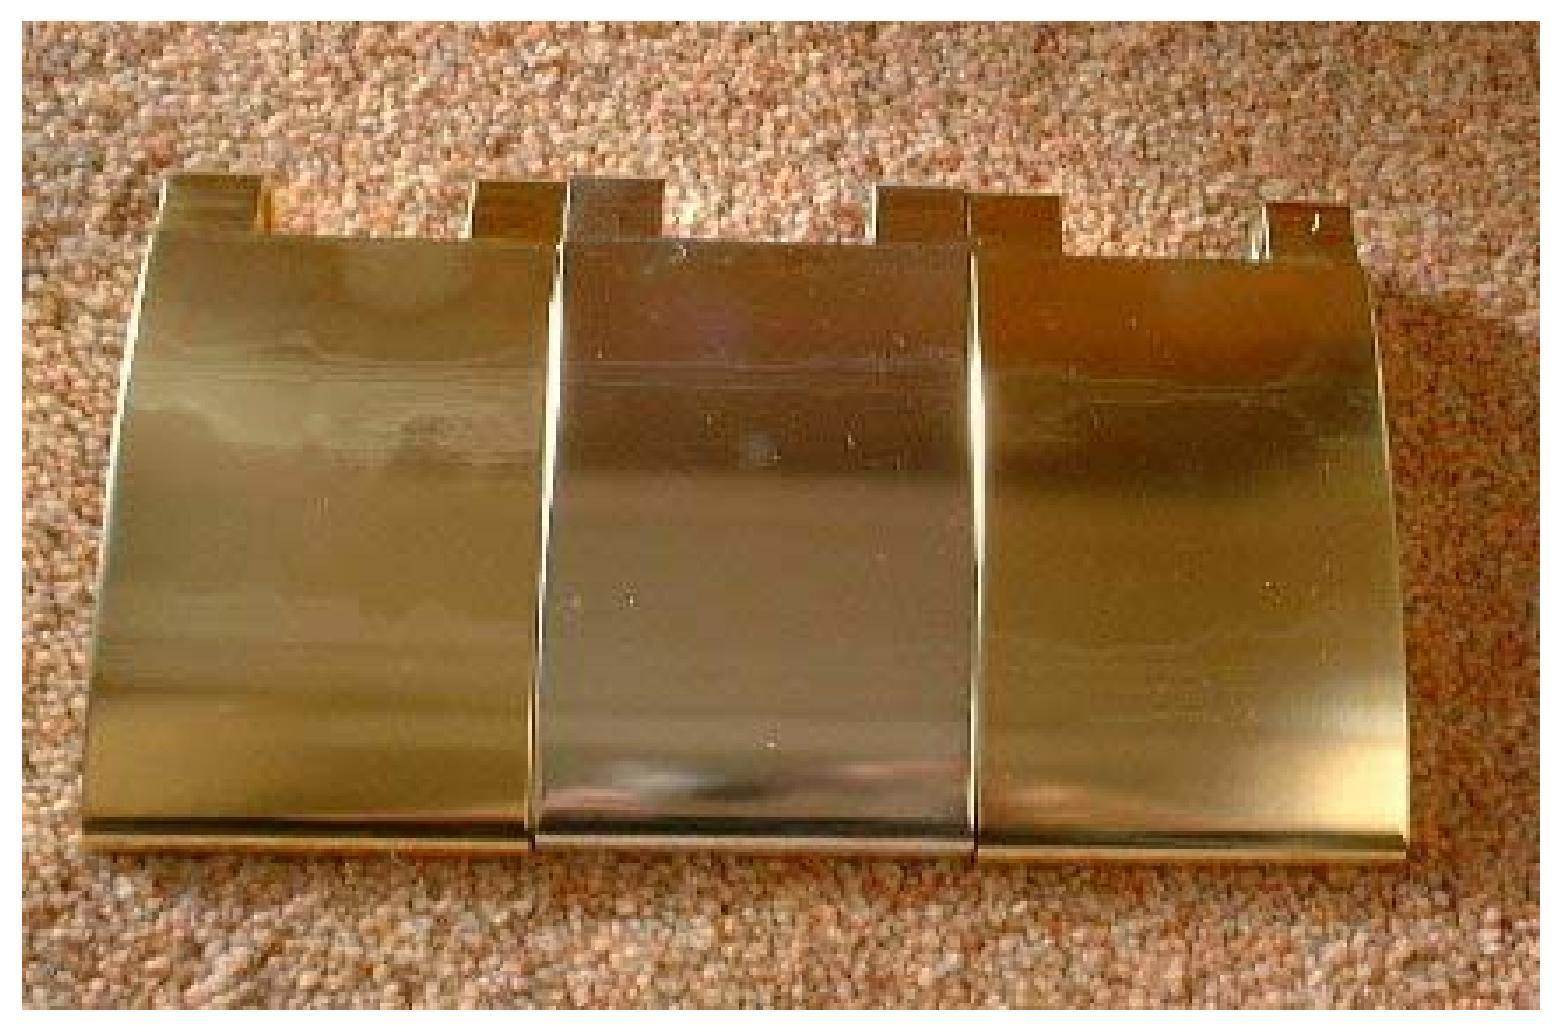
Figure 26. Non-uniform appearance of 6063 extrusion bright-anodized and dyed corresponding to the position of the transition from a transverse weld into the longitudinal welds and the effect of removal of the surface layer by mechanical polishing.

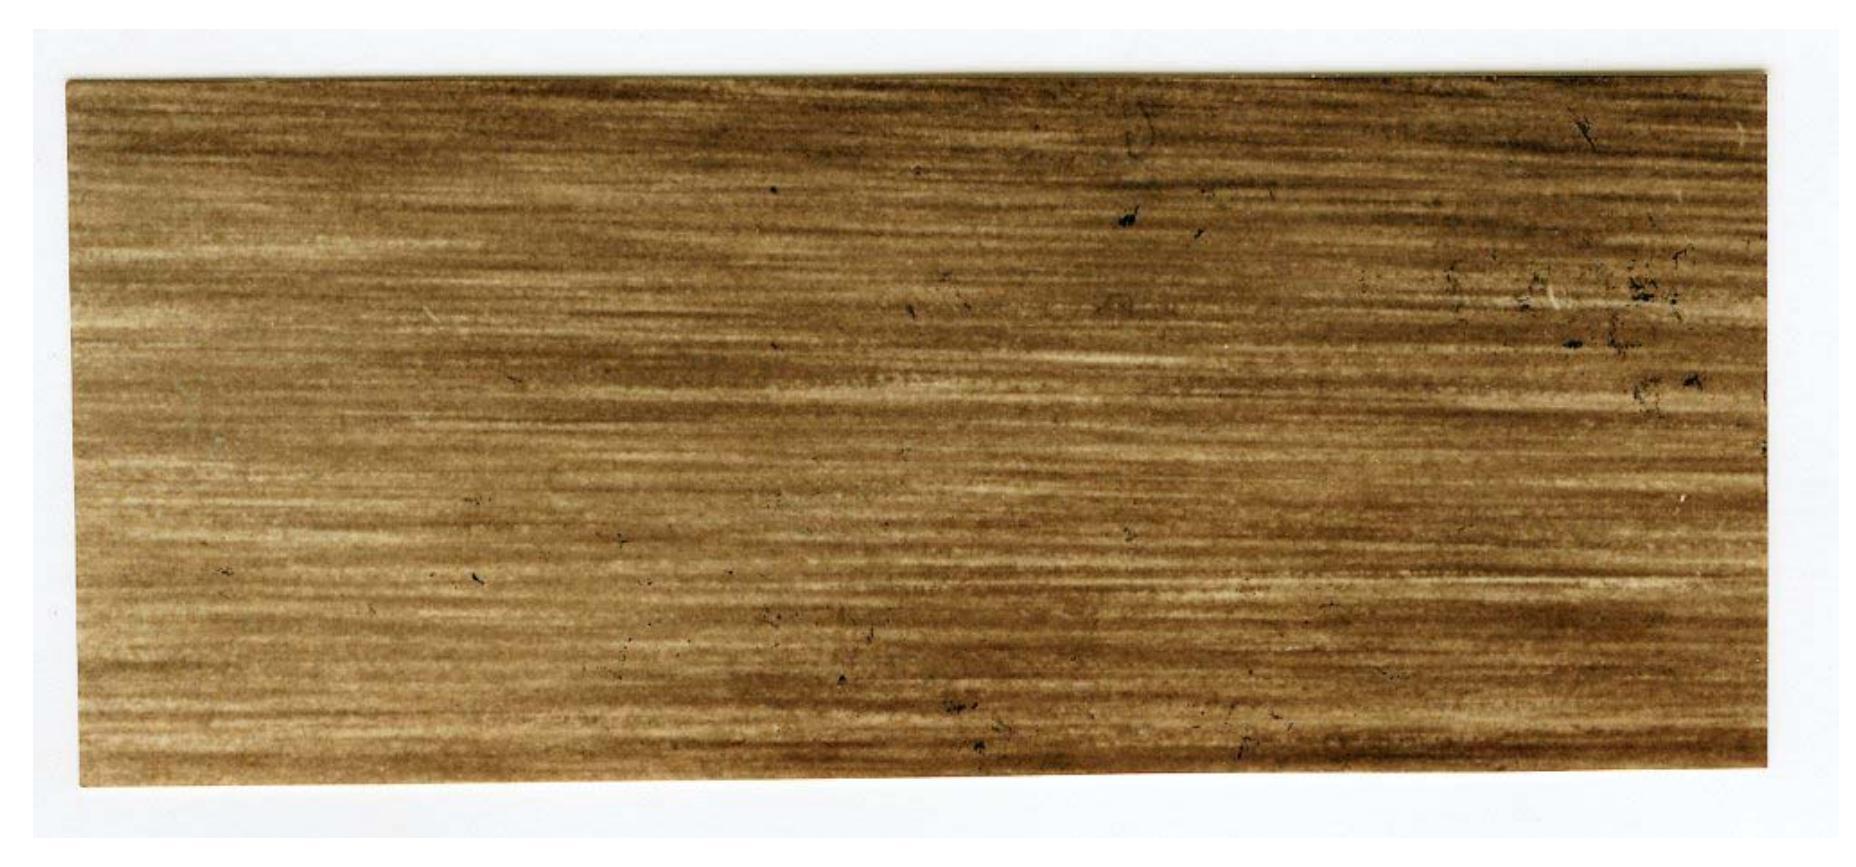
Figure 31. Flecking occuring during electro-colouring due to iron phase segregation

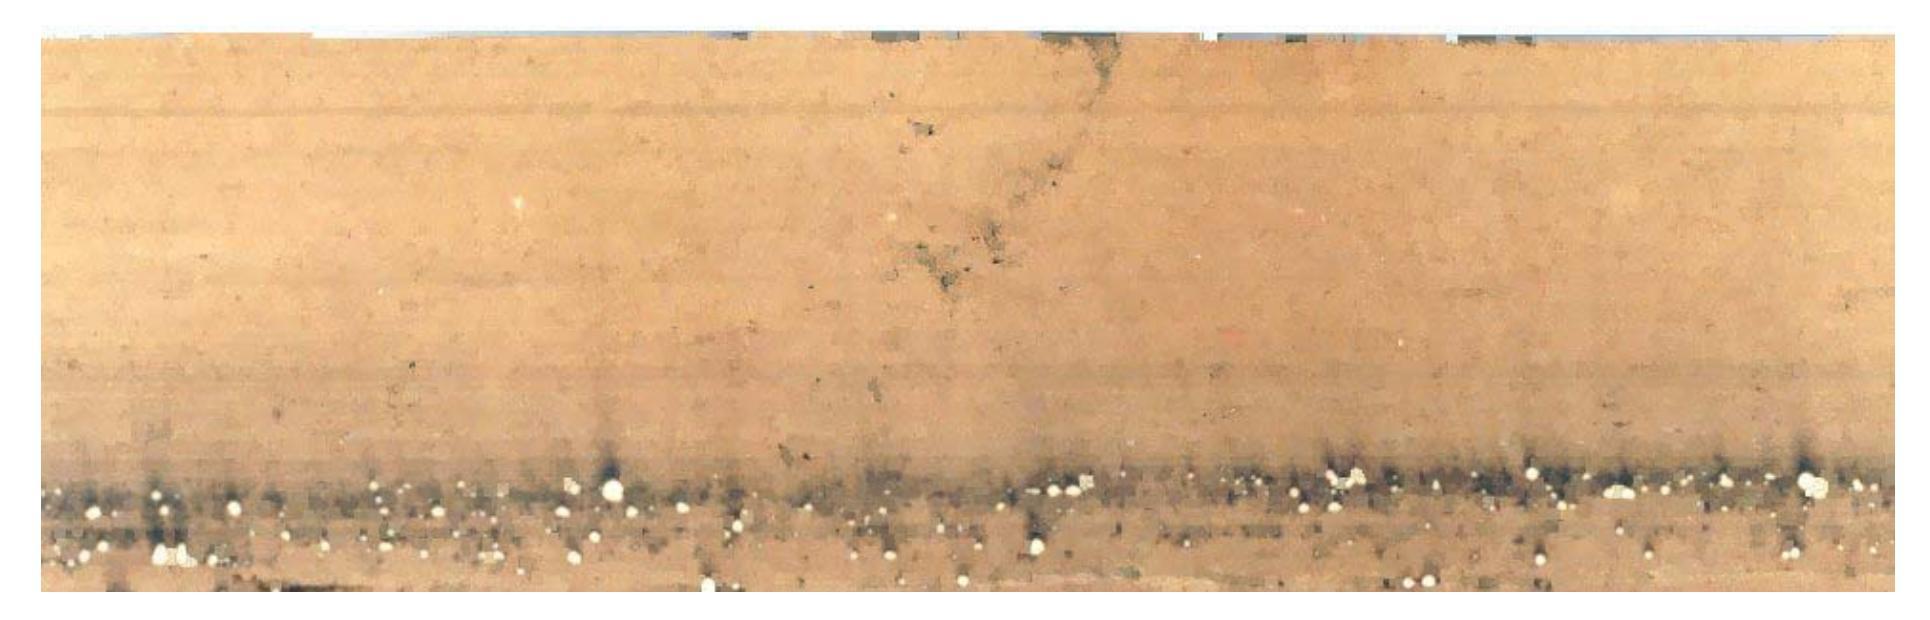
Figure 33. Streaking due to TiB₂ clusters and oxide inclusions in the extrusion ingot used to extrude a section as revealed by anodizing and electro-colouring of the section.

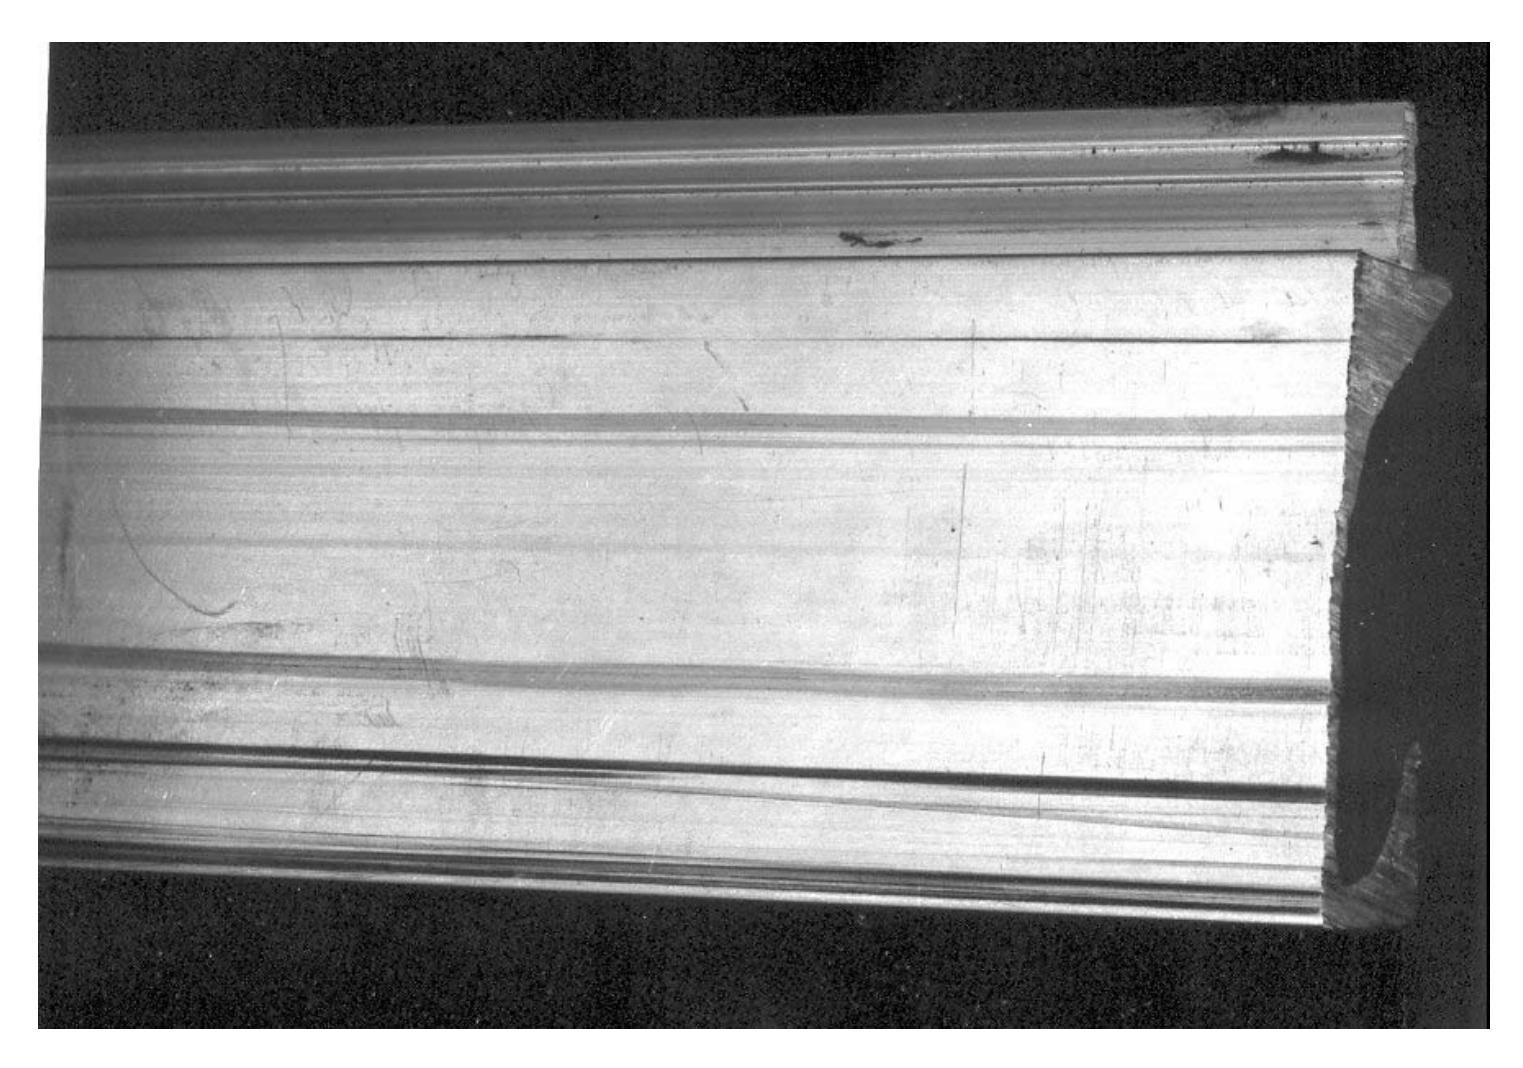
Figure 34. Carbon streaks on an 'as extruded' section.

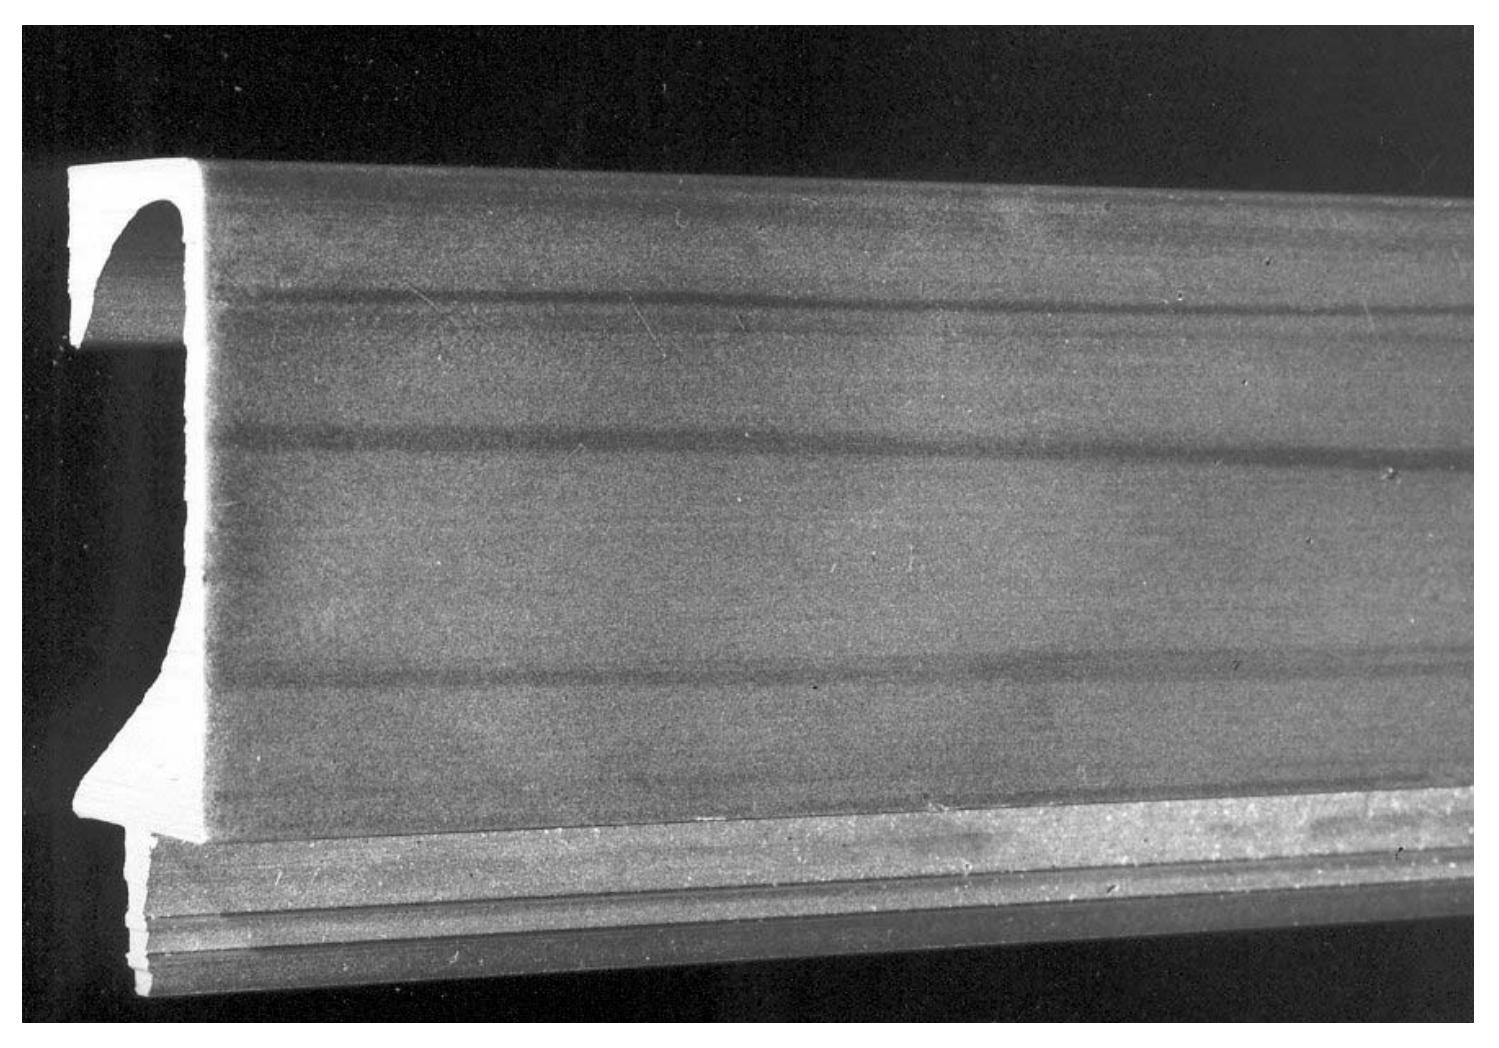
Figure 35. Carbon marks after etching for 10 minutes in 100g/l NaOH at 60°C.

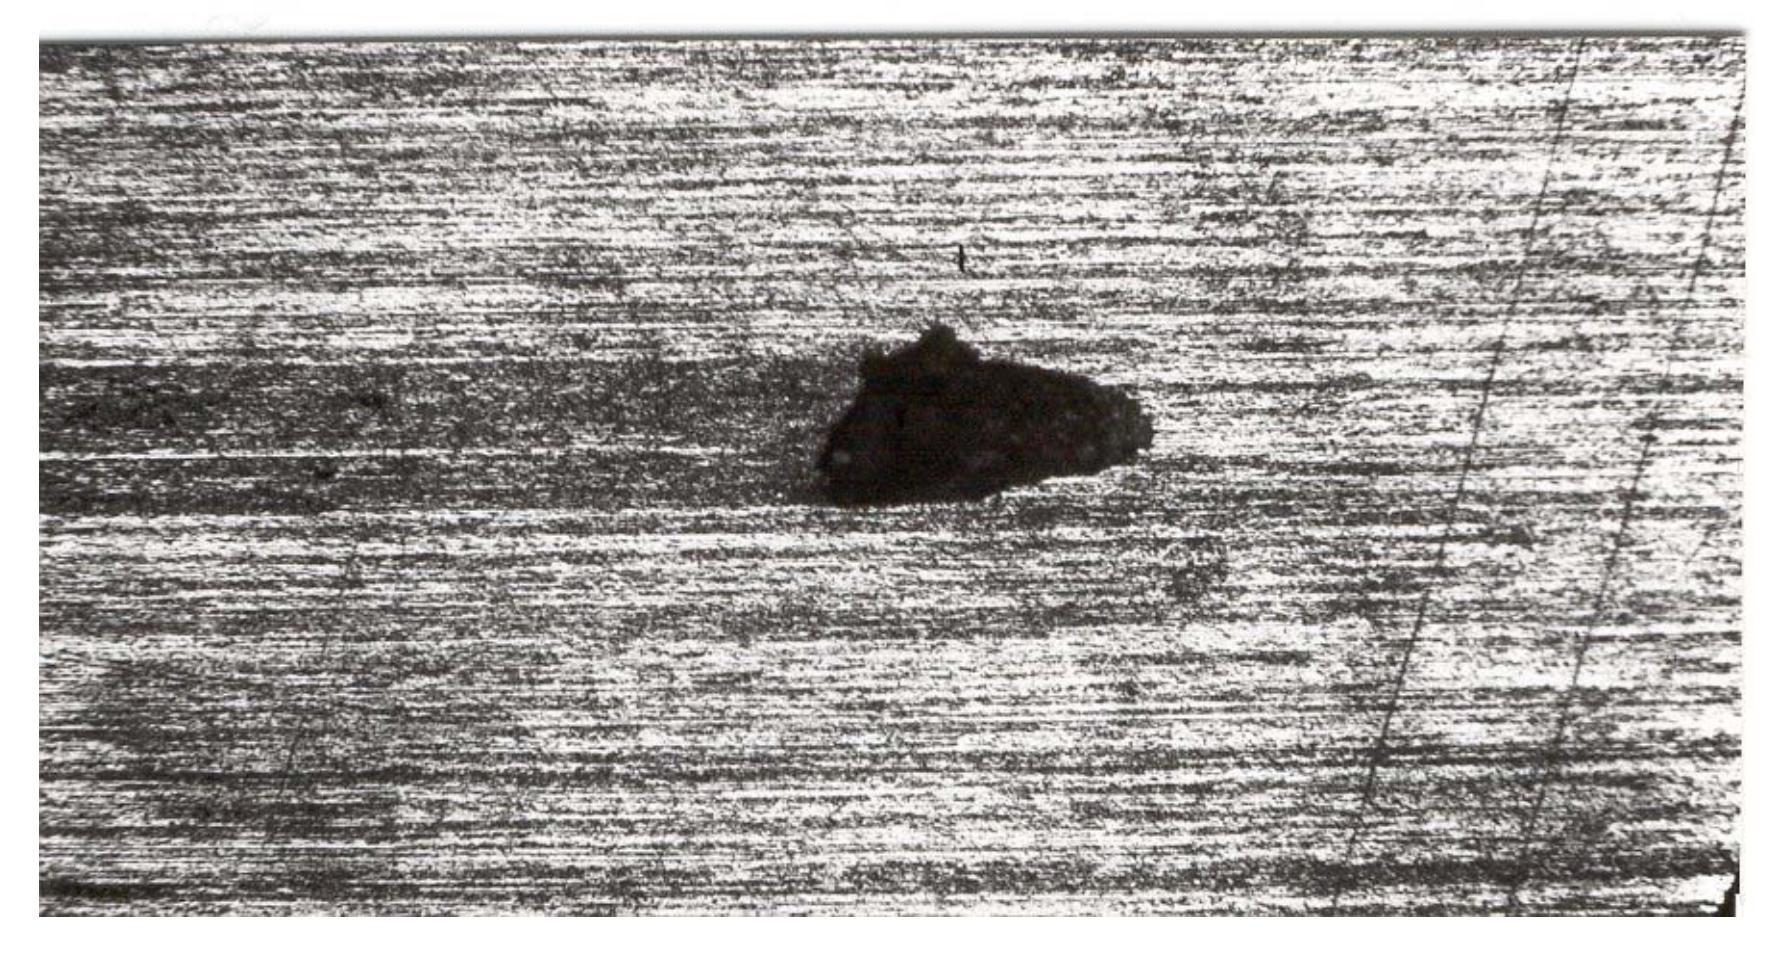
Figure 36. Graphite inclusion due to excess lubricant at front end of ingot. x 20

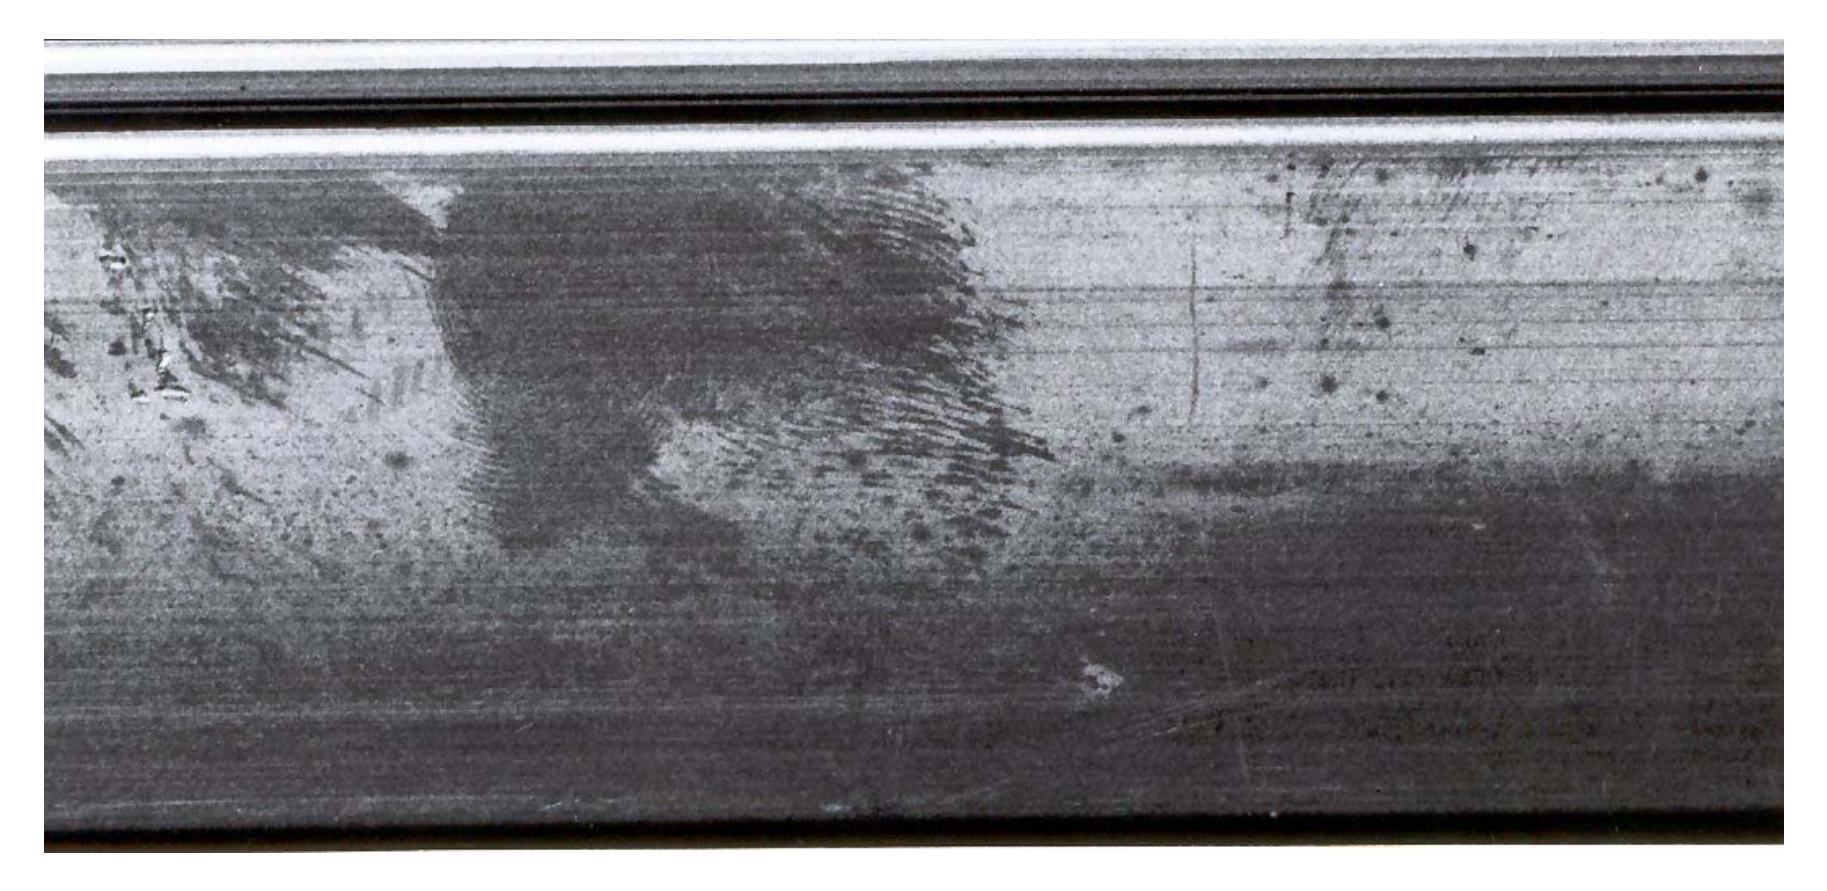
Figure 47. Sample of 'white etch bloom' on 6063 extrusion showing brighter, or darker, areas where fingerprints have removed the magnesia film before etching.

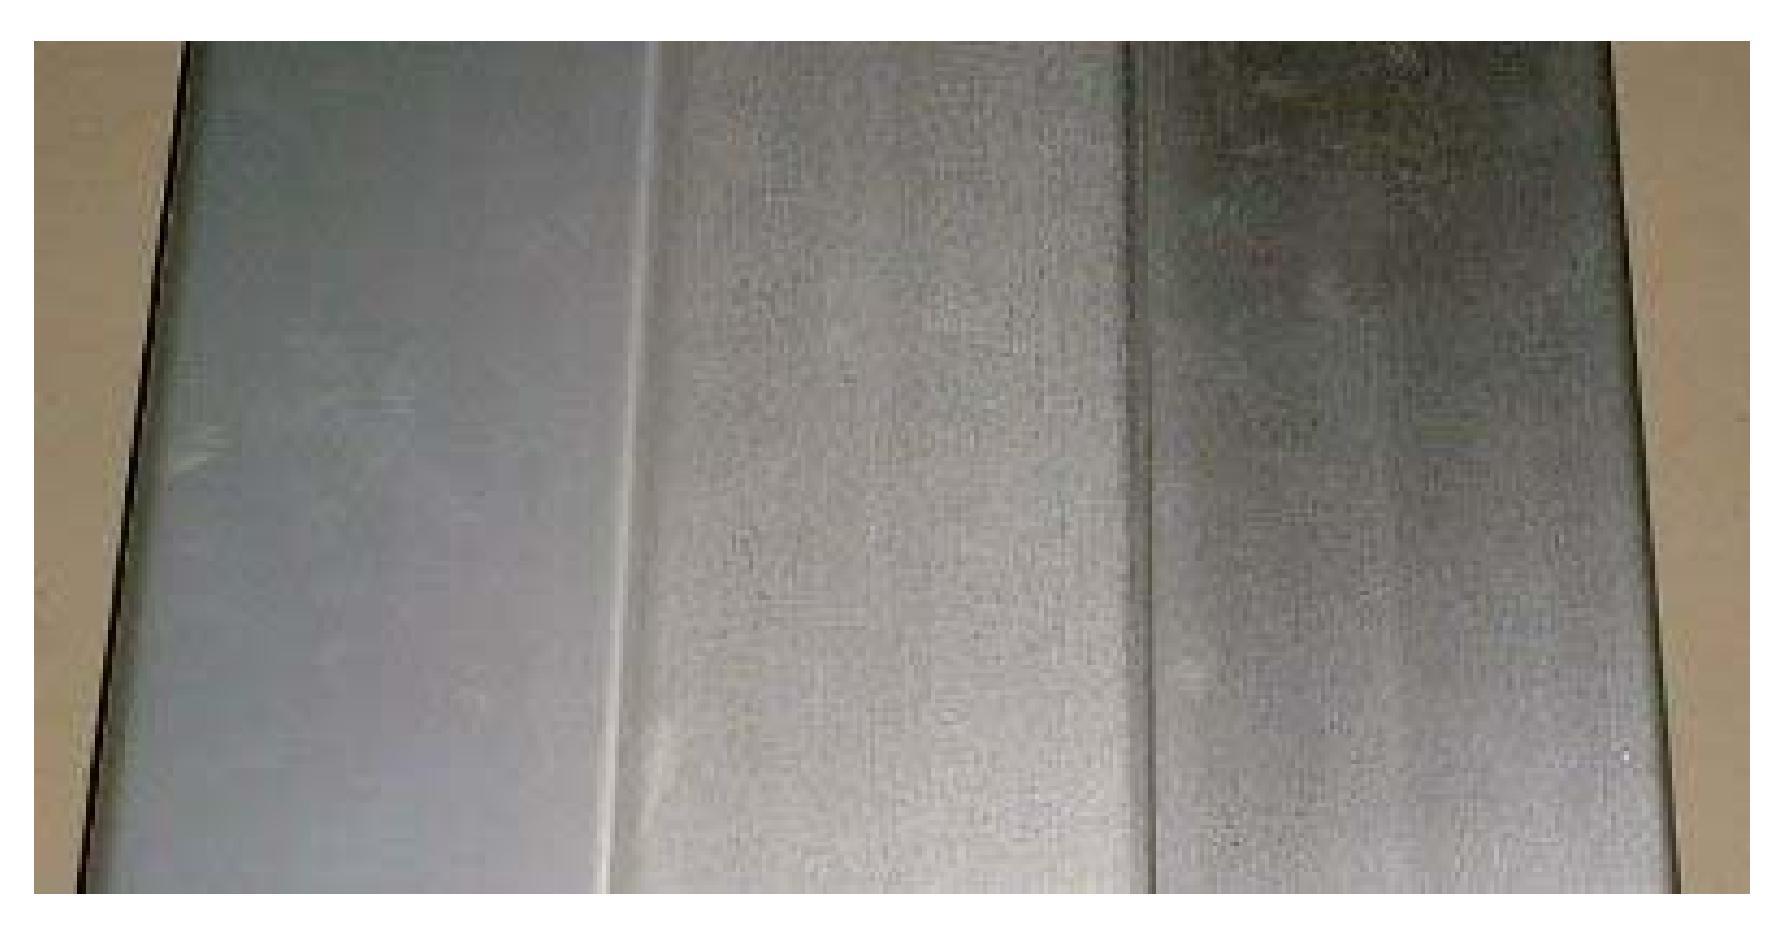
Figure 51. Variable etching response of 6063 extruded sections as etched and anodized.

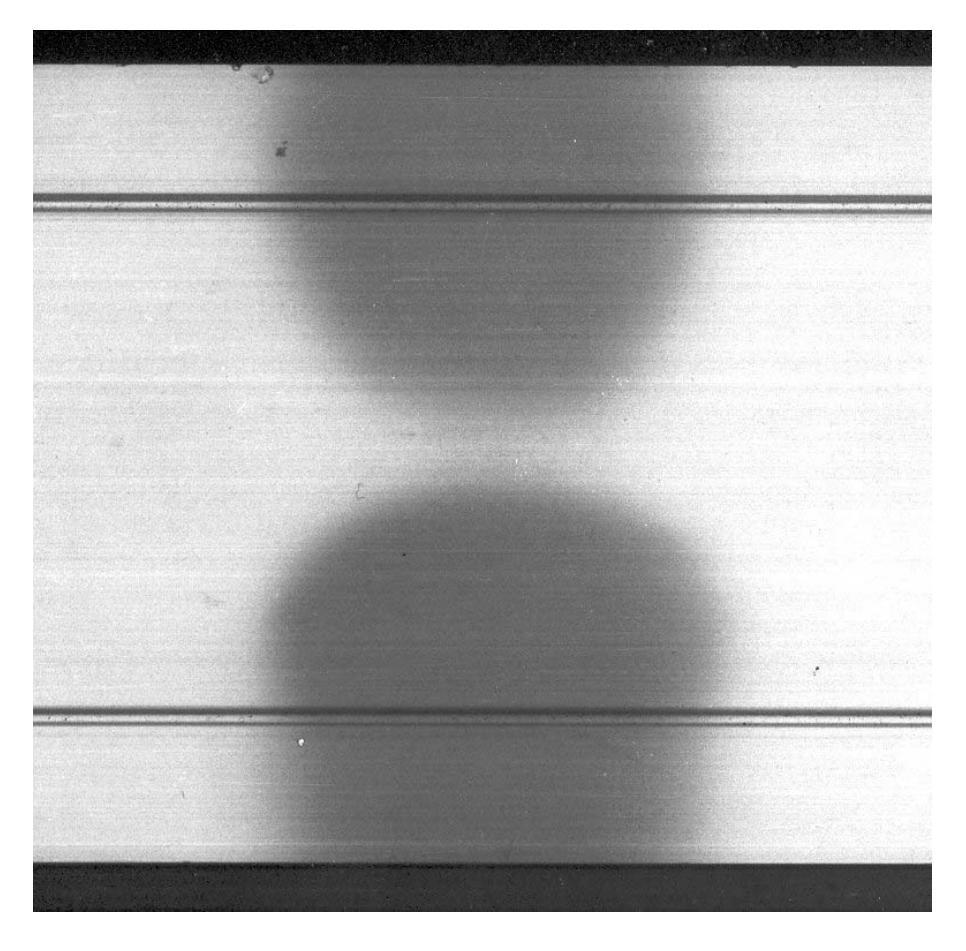
Figure 52. Example of a hot spot on an etched and anodized 6063 extrusion.

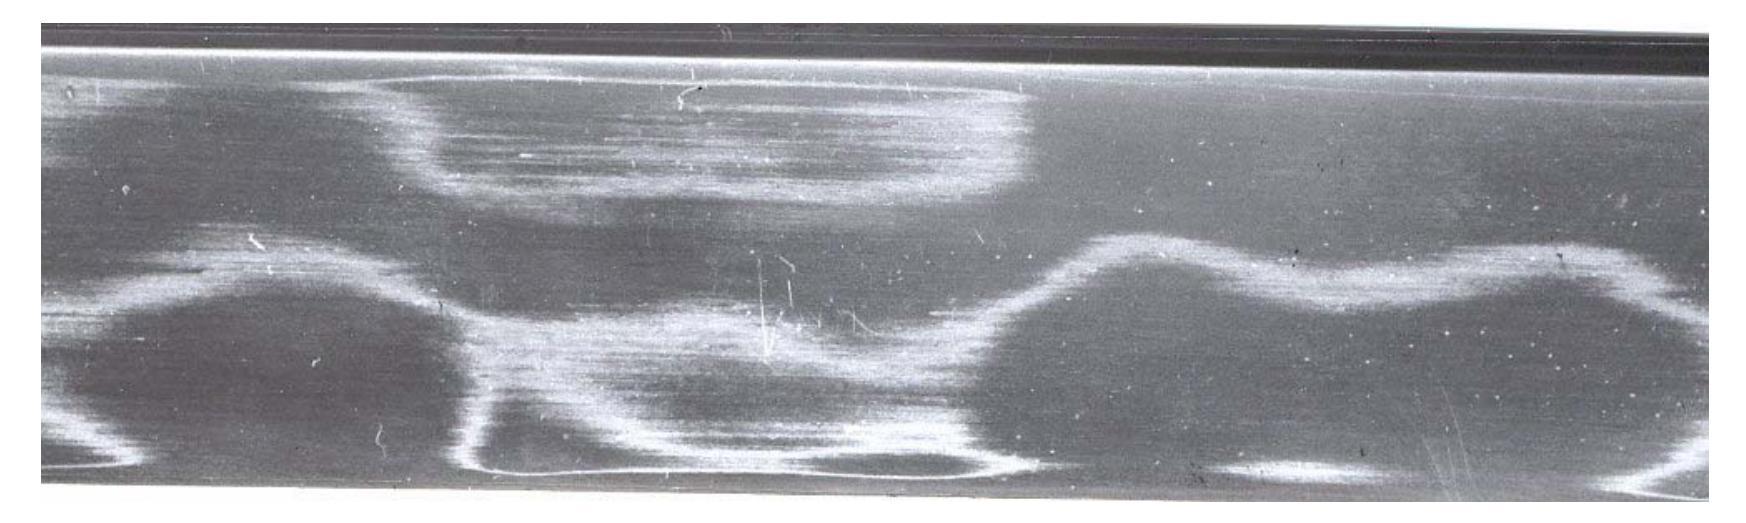
Figure 55. Effect of container skin contamination after etching and anodizing a 6063 alloy extrusion.

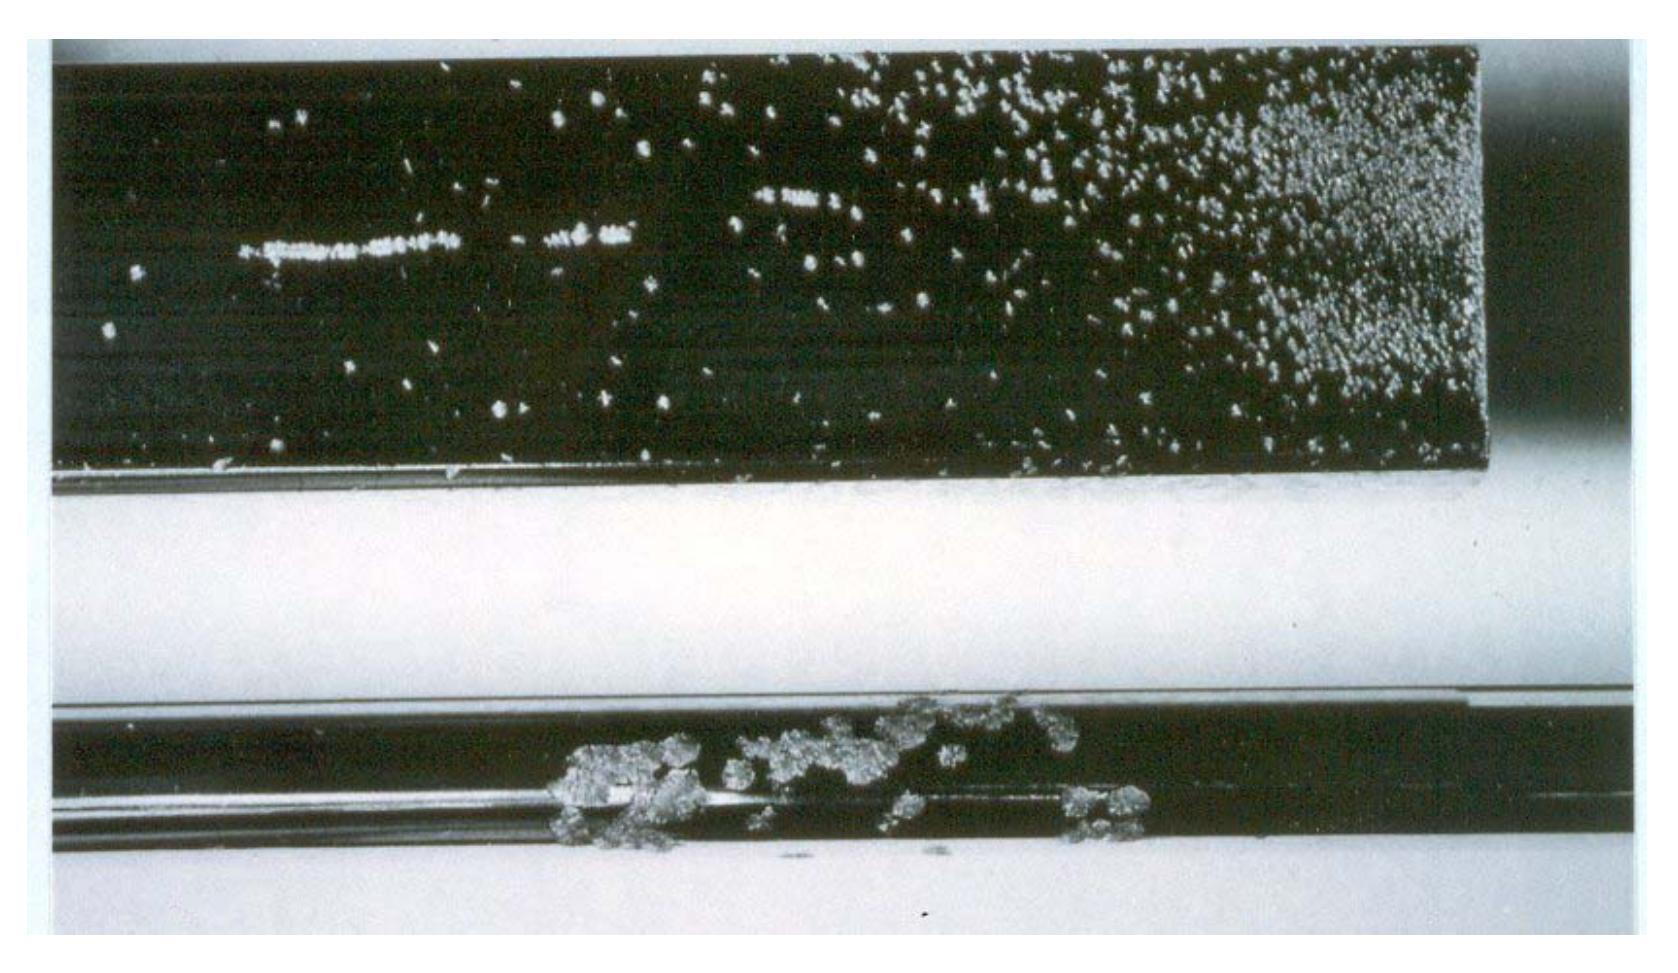
Figure 56. Barnacling on a sample of chemically brightened 6463 alloy.

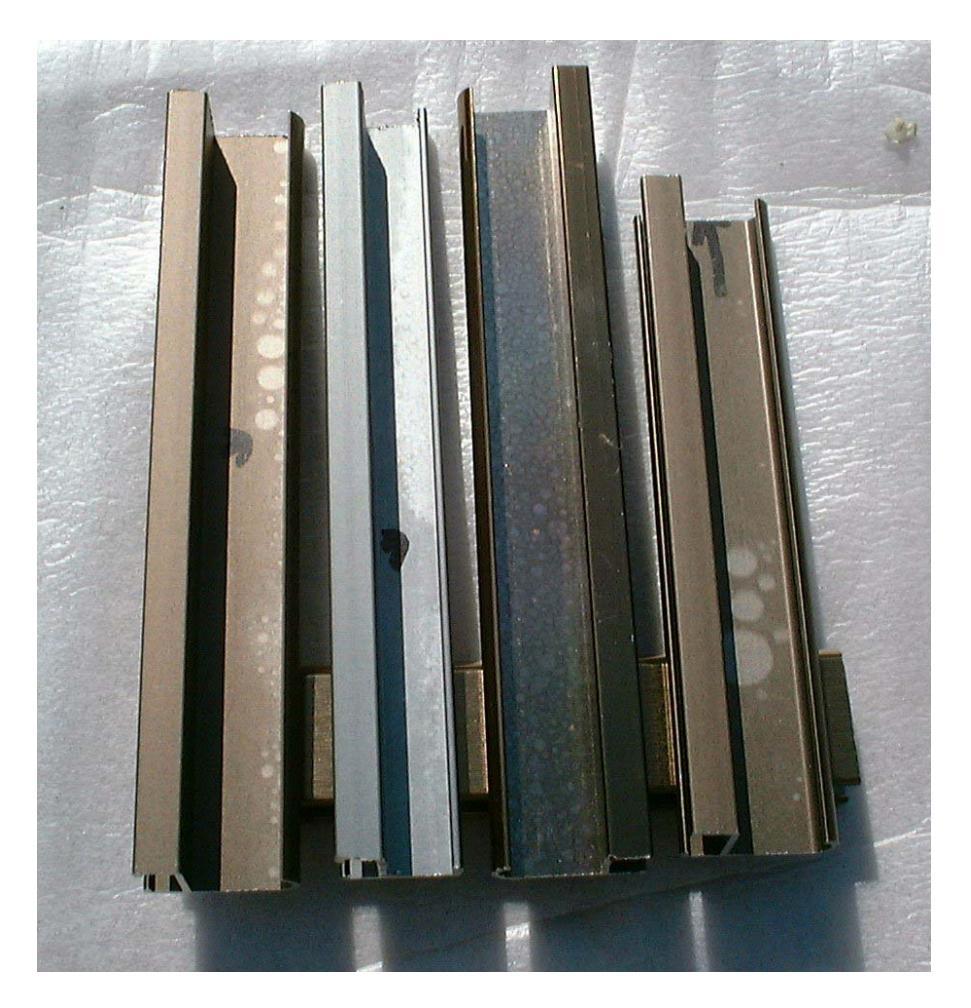
Figure 59 . Typical examples of non-coloured areas due to gas trapping

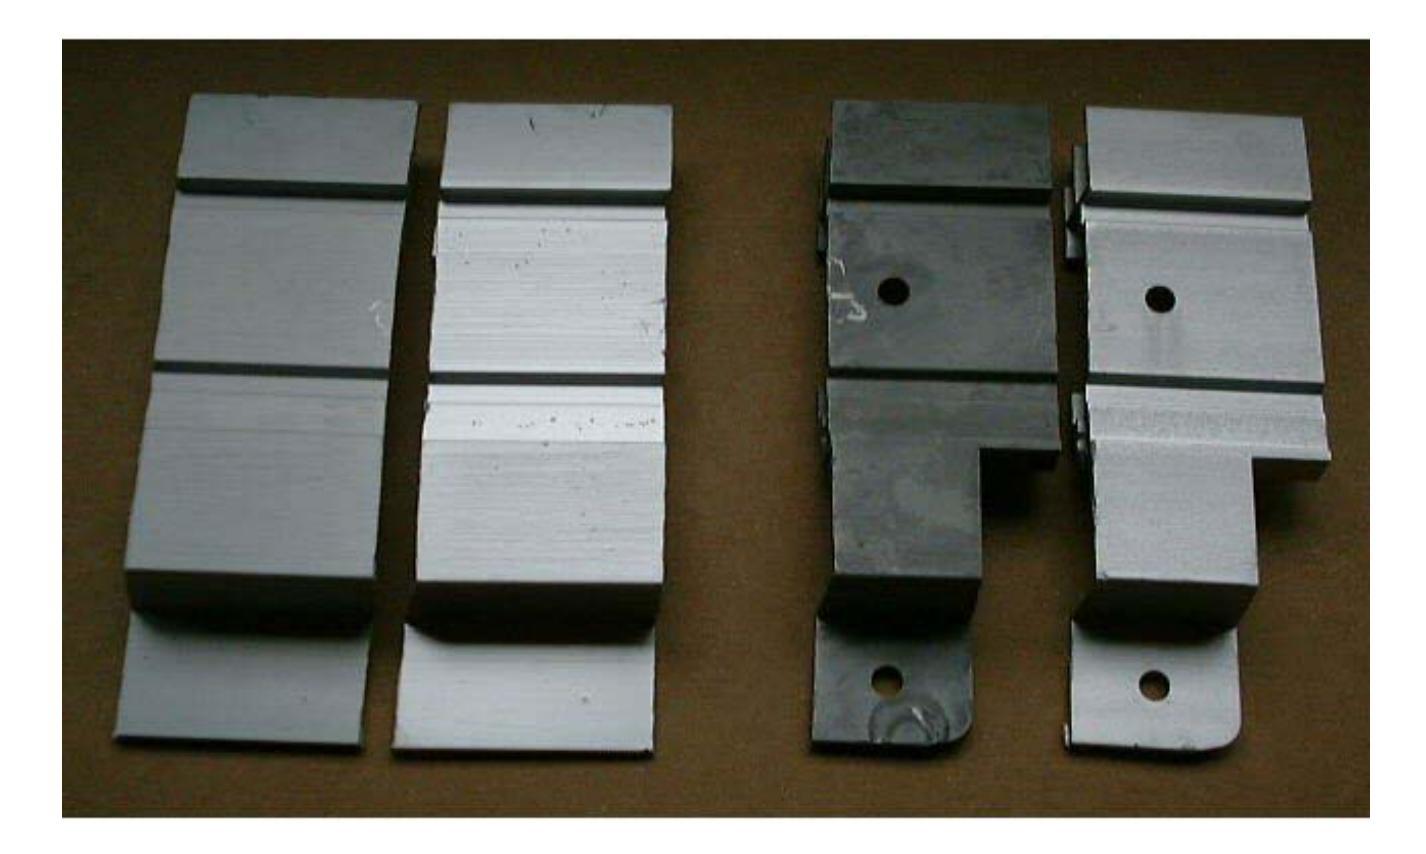
Figure 60. Variation of smut levels on two 6063 extrusions having different size Mg2Si precipitates due to under-ageing and over-ageing, after etching in 10% NaOH at 60°C for 10 minutes.

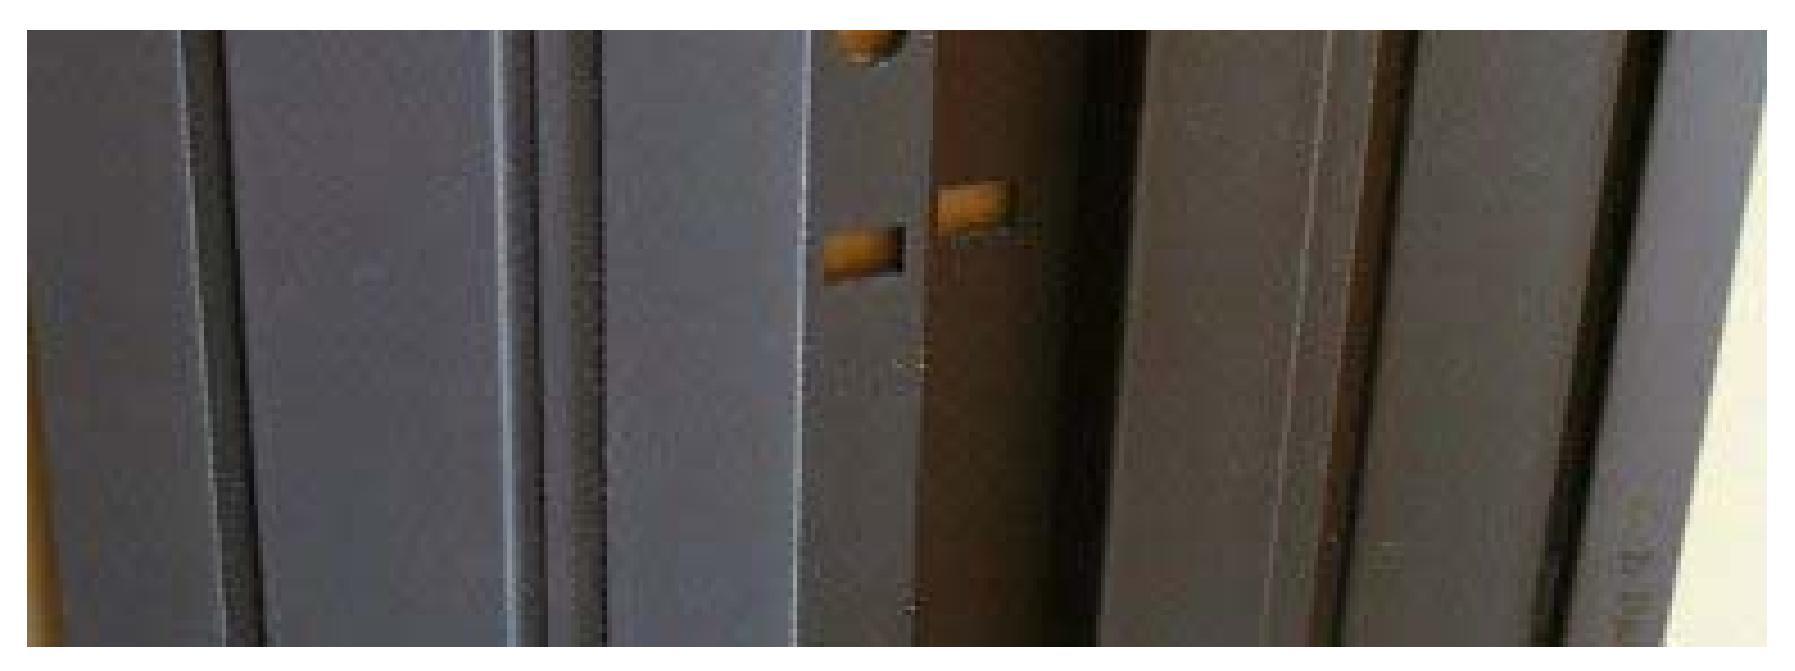
Figure 61. The same samples as in Figure 60 after anodizing and dyeing black.

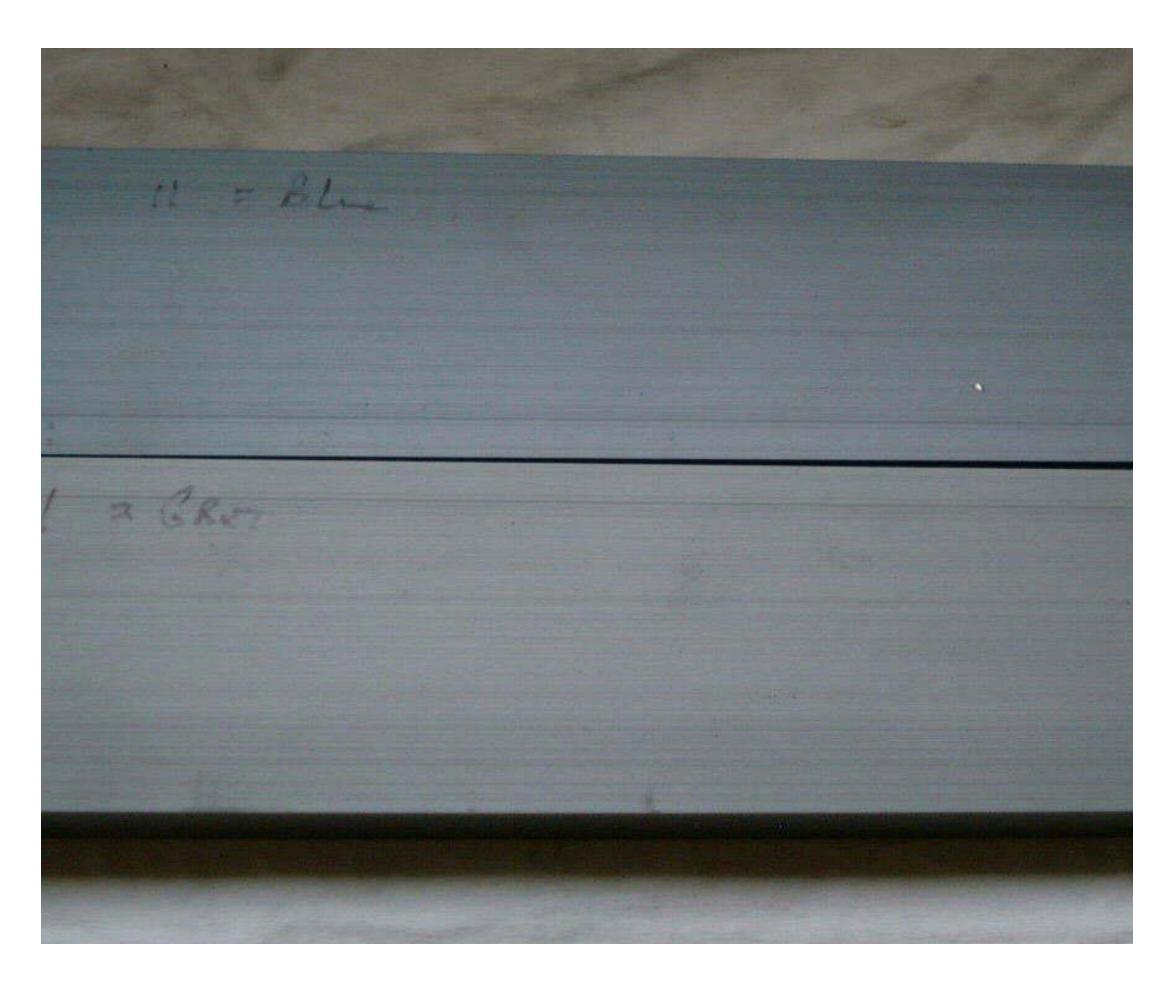
Figure 62. Variation in colour within a single load of interference-coloured grey finishes due to poor control of the ageing practice on the extrusions resulting in differences in Mg₂Si precipitate size.
