The Identification and Prevention of Defects on Anodized Aluminium Parts

by Ted Short, Aluminium Finishing Consultant

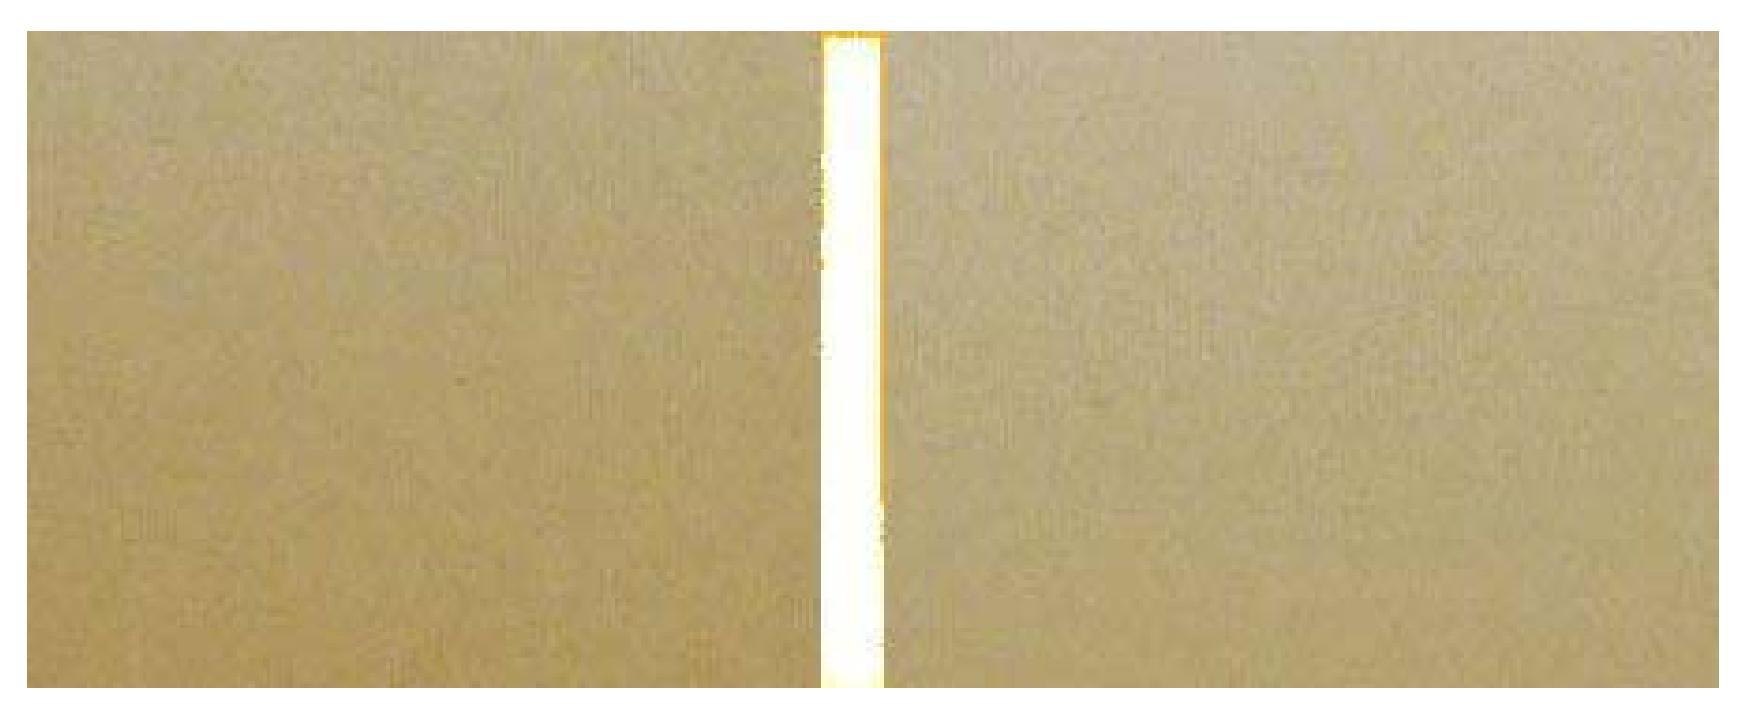
Figure 63. Fairly typical dark and light limits for a medium bronze anodized finish.

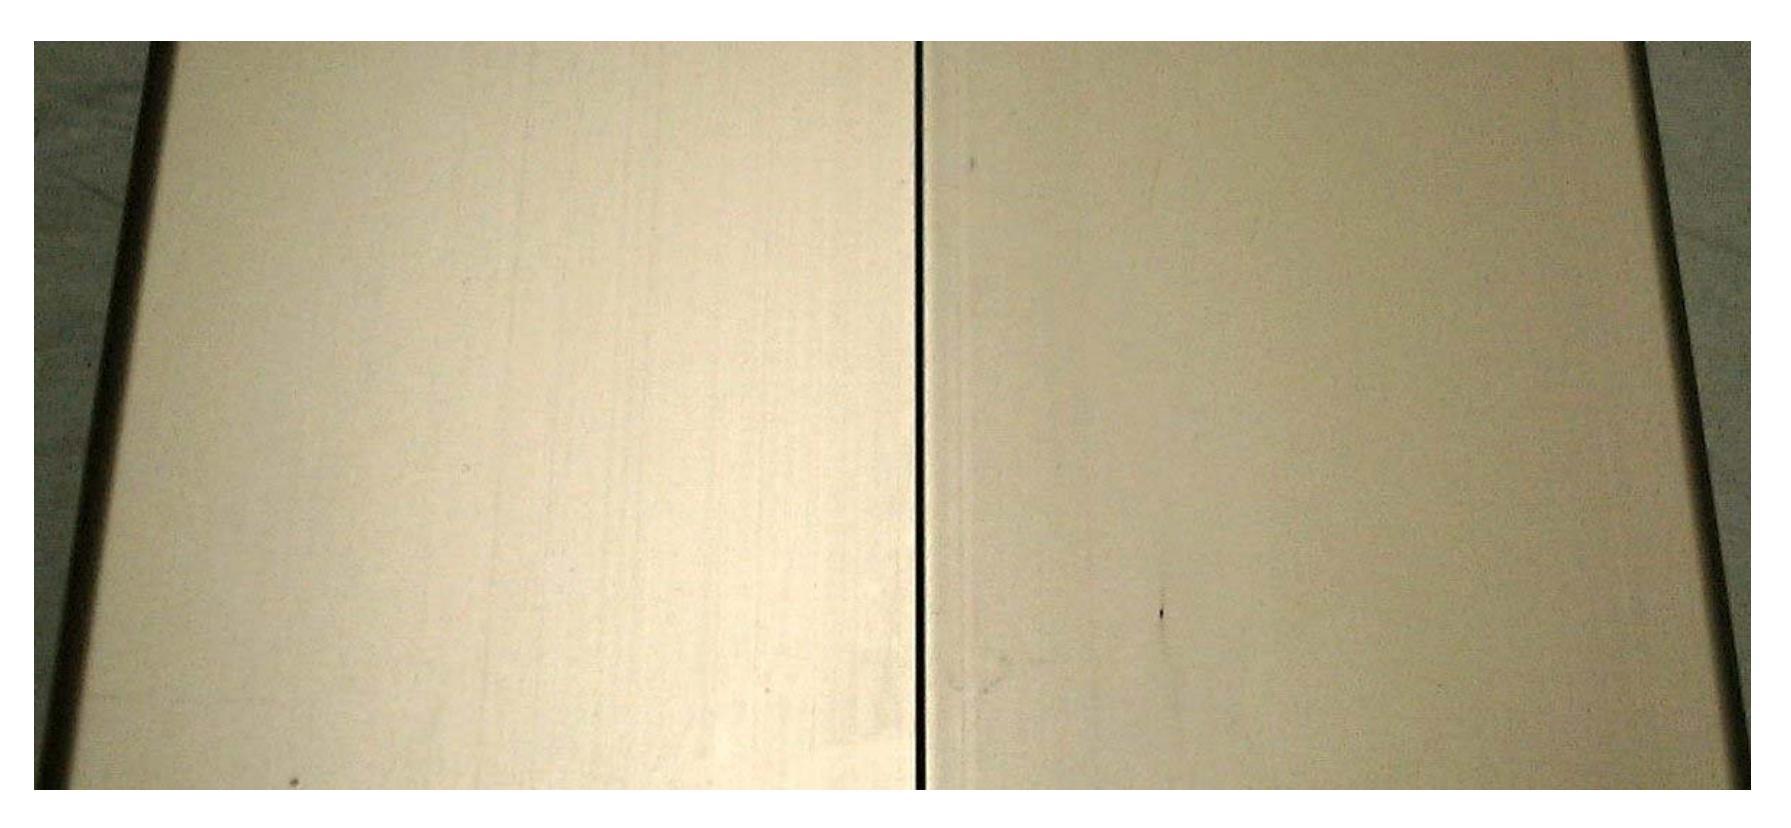
Figure 64. Poor colour match on an architectural bronze anodized finish.

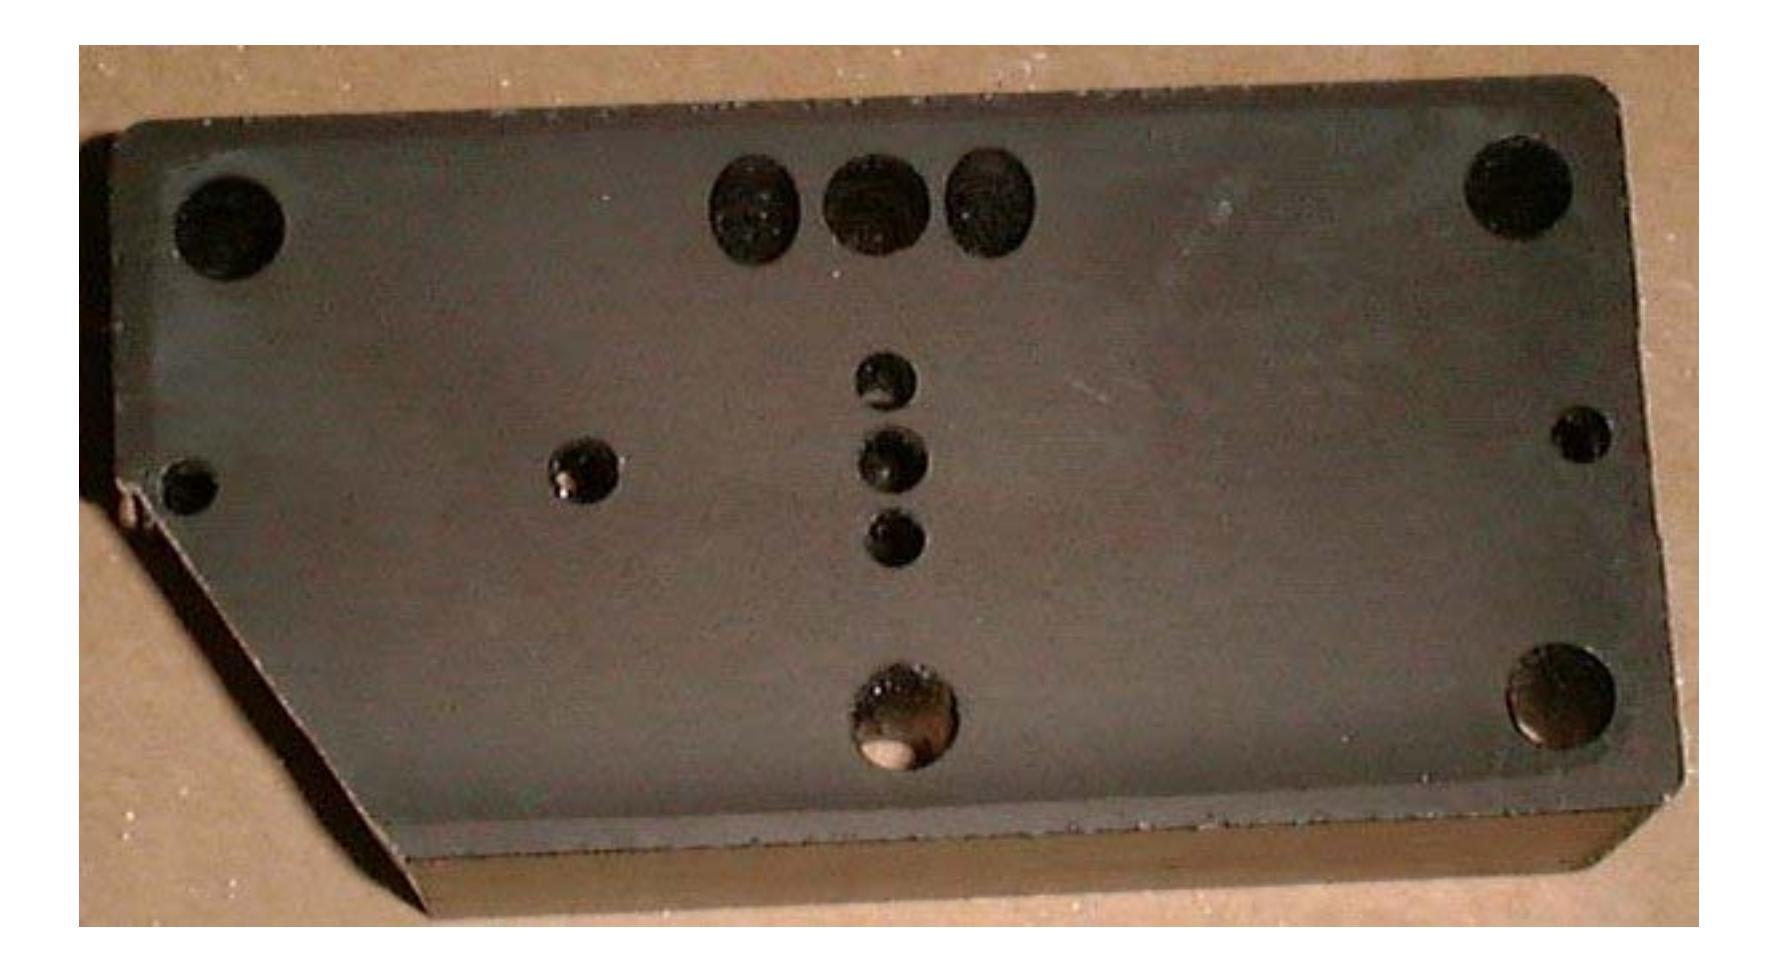
The effect of an outer band of coarse grain on a sample of etched, anodized and black dyed extrusion is illustrated in Figure 68.

Figure 68. Coarse grain outer band effect causing an apparent difference in colour on an etched, anodized and dyed 6082 extruded bar.

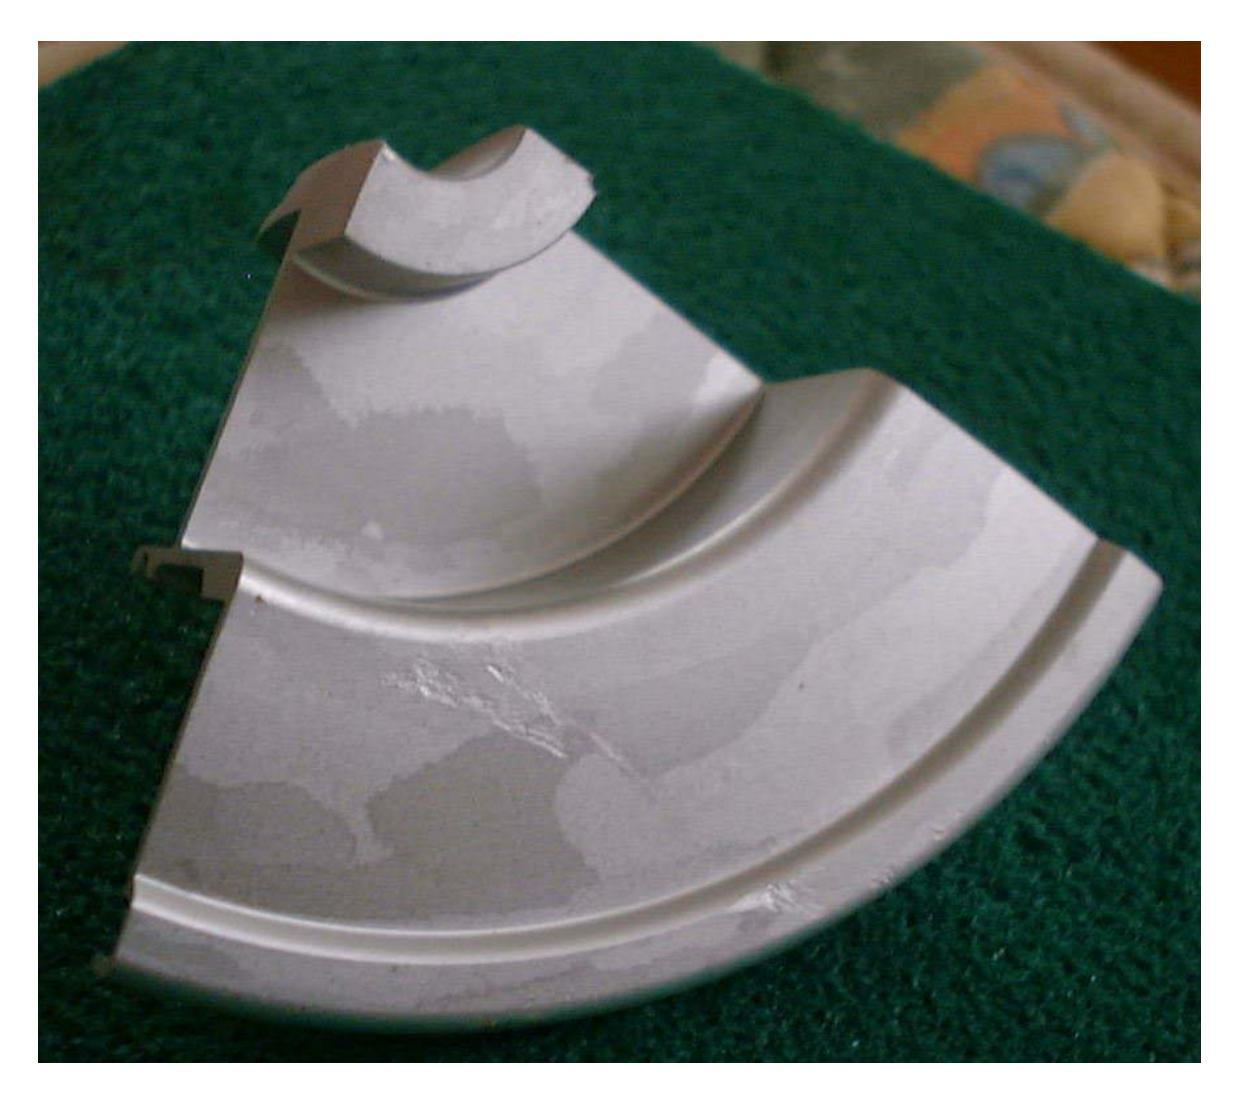
A similar problem can occur when attempts are made to anodize forged 6082 alloy an example of which is shown in Figure 69. Such components can exhibit very large grain size, depending upon the thermomechanical history.

Figure 69. Giant coarse recrystallised grains on a forged, etched and anodized anglers fishing reel.

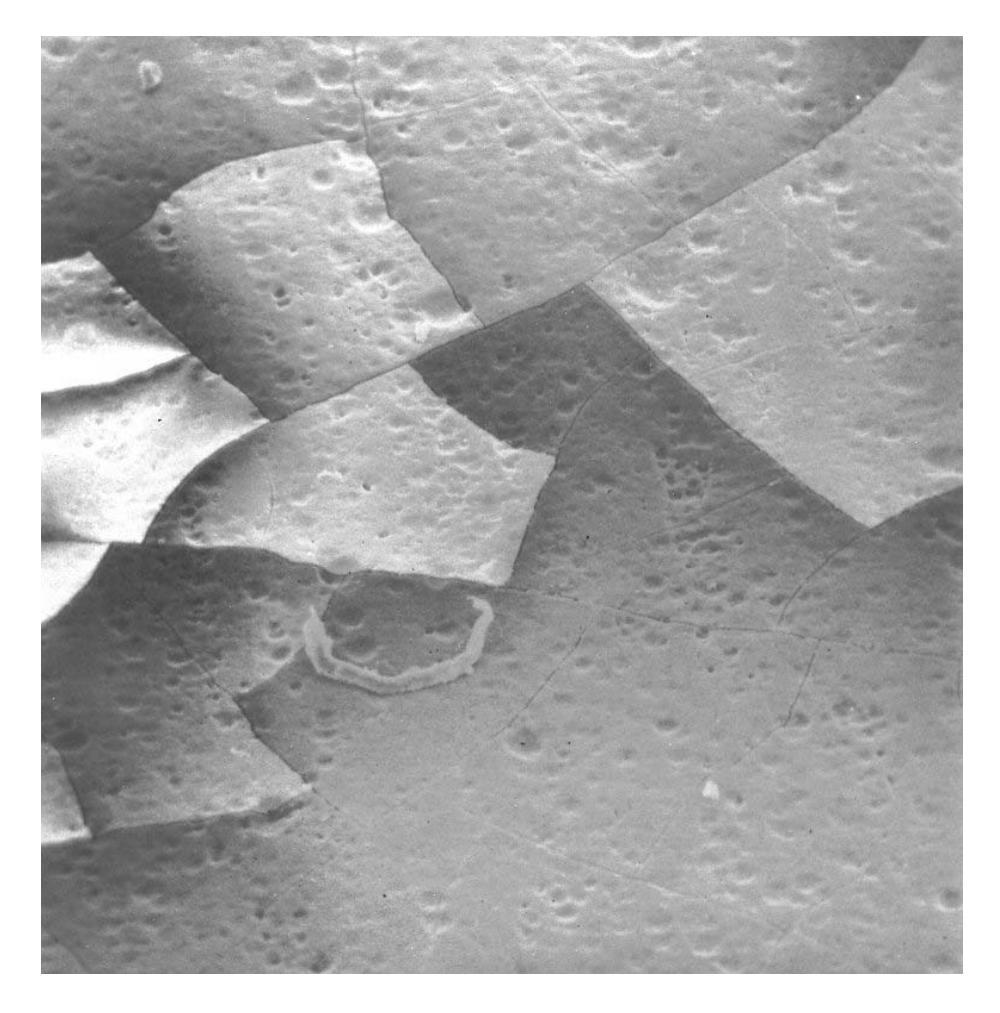
Some anodic films, especially if they are quite hard, can show a tendency to crazing during the final hydrothermal sealing stage of anodizing. Crazing has the appearance of a network of fine lines in a cobweb like pattern across the surface of the anodic film. As well as this thermal crazing, it is possible to form crazing in an anodic film by mechanically bending an anodized component. The fine lines produced by mechanical crazing are very similar to those of thermal crazing but they do tend to run parallel to each rather than in the random fashion typical of thermal crazing examples of which are shown in Figures 70 and 71. The tendency to crazing increases as the hardness of the anodic film increases. Samples having a smooth polished substrate before anodizing are also more likely to craze.

Figure 70. Example of thermal crazing. ~ (x 250)

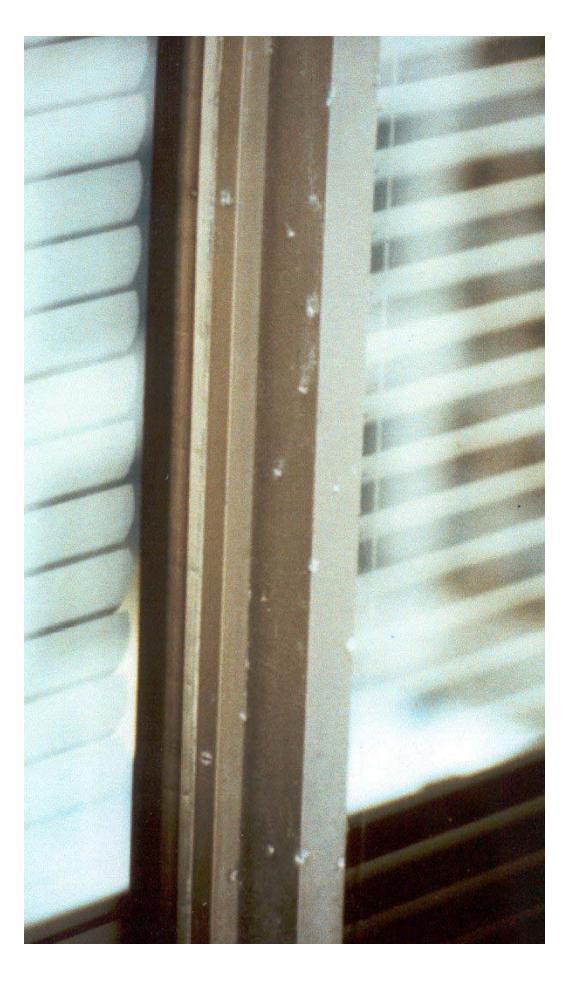
Pitting of finishes is usually associated with an inappropriate anodic film thickness being used for a particular application. Alternatively, lack of correct regular maintenance can be to blame. Typical examples are given in Figures 75 and 76.

Figure 75. Example of pitting on a bronze anodized architectural anodic finish in service due to inadequate anodic film thickness.

It is most important to ensure that the specification of an anodized finish for architectural applications is correctly defined. Normally the BS 3987 is used for this purpose in the UK, but there is often confusion when parts to be used on buildings in the UK are processed on the Continent, the Middle East or even North America. The local architectural specifications in these countries may not be as demanding as the British Specification, particularly regarding anodic film thickness requirements and the hardness or abrasion resistance of the anodized finish. It should be noted that BS specification 3987 was developed as a result of architectural anodized finishes displaying two main problems. These were isolated cases of premature pitting or very rapid formation of a white powdery bloom upon exposure to the elements. This specification calls for a minimum average anodized

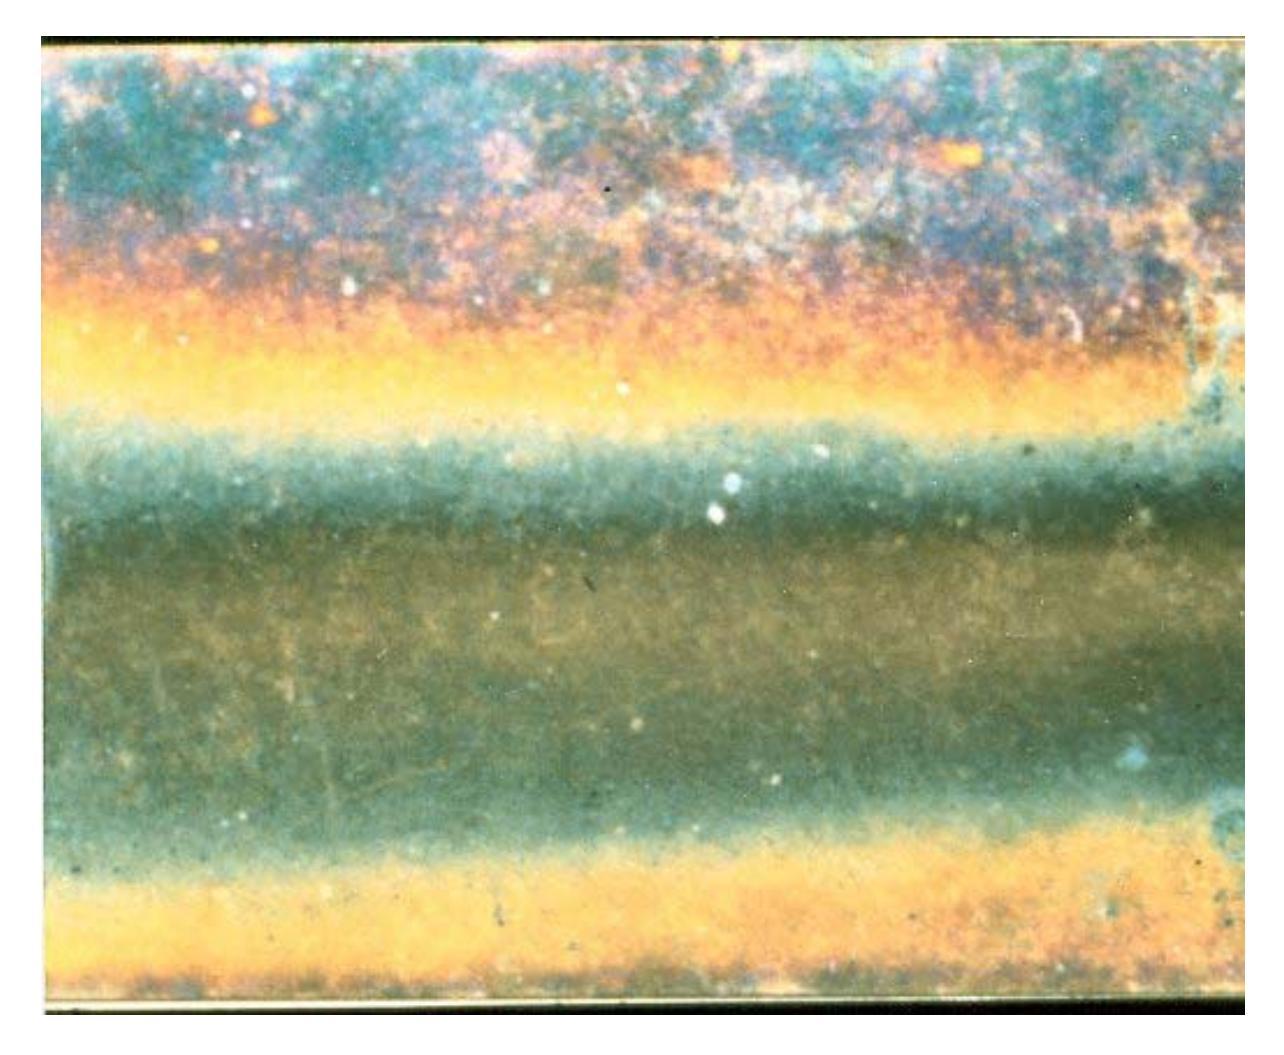
Iridescence is another form of staining caused by weathering or a further self-sealing of the film. It is usually most evident on electrolytically coloured finishes; in many cases occurring on finishes that have not been cleaned during the first 6 to 12 months of service. An example is shown in Figure 80. It can be removed by cleaning the anodized surface using a mild abrasive, such as pumice, on a damp cloth. No significant film thickness loss should result from the cleaning.

Figure 80. Iridescence formed during outdoor exposure on a sample of anodized and electrolytically coloured aluminium.

Figure 79. Curtain walling panels that had not been given regular cleaning maintenance showing on the right hand panel the white 'weathering bloom' before cleaning. The left hand panel is a similar panel after cleaning with a Scotchbrite pad and a solution of Teepol in water.

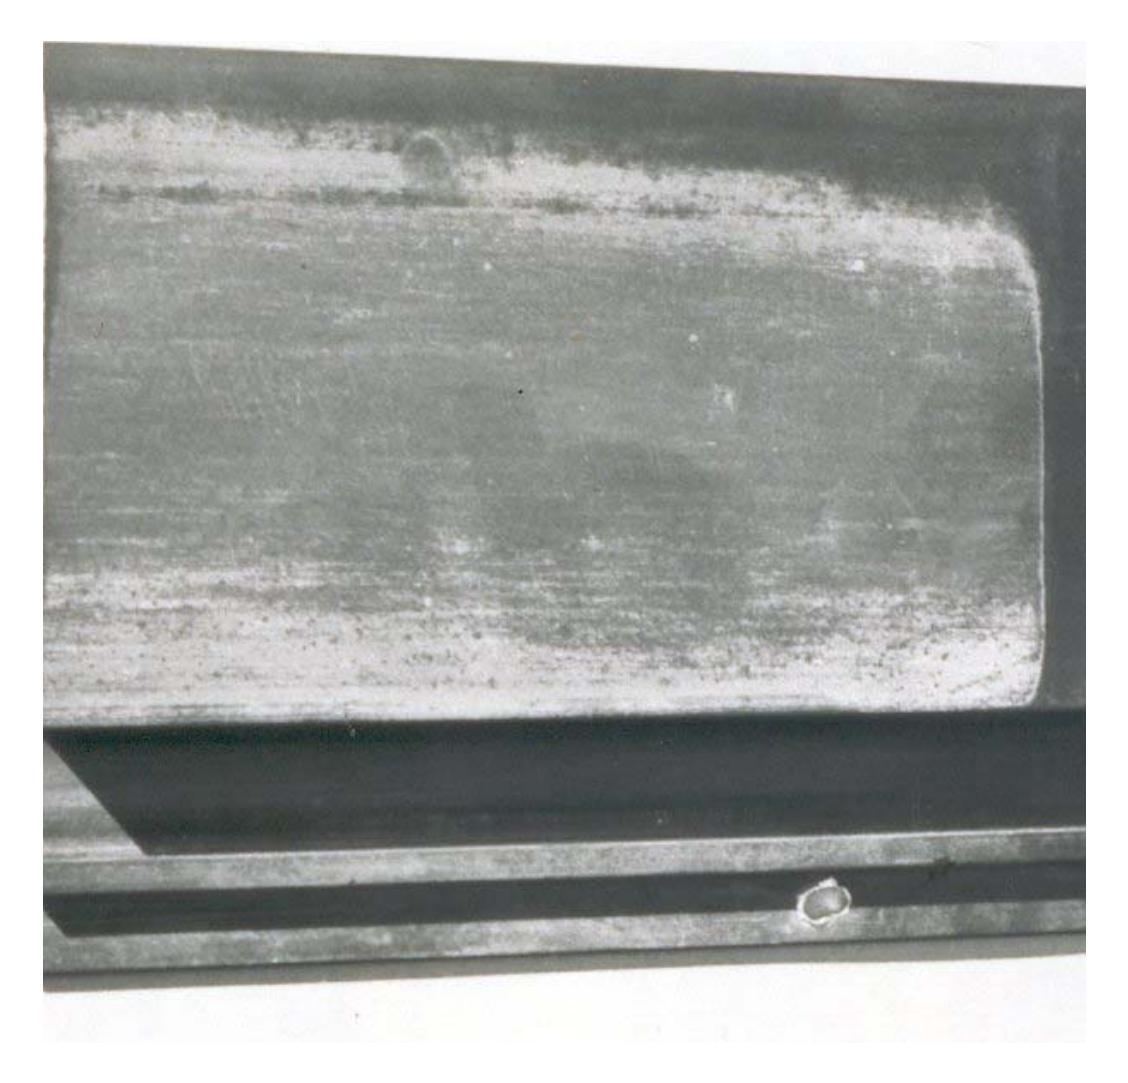
Chalking, or the formation of a heavy white deposit as illustrated in Figure 81, on an anodic film during the first year after installation on site, can be serious. It is usually associated with an anodic film of insufficient hardness, and the surface is often powdery (see Figure 82). The chalking can be removed by abrasive cleaning using a purpose designed anodized aluminium polish or pumice powder on a damp cloth. There is usually a significant (5 - 8µm) film thickness loss during such a cleaning treatment. An alternative cleaning media is Scotchbrite abrasive pads wetted with a solution of Teepol in water. Even after such cleaning treatments the bloom may return and a second cleaning will be required, removing even more anodic film, to eliminate the problem.

Figure 81. Chalking of an anodic finish in service due to a soft anodic film.

Figure 80. Iridescence formed during outdoor exposure on a sample of anodized and electrolytically coloured aluminium.

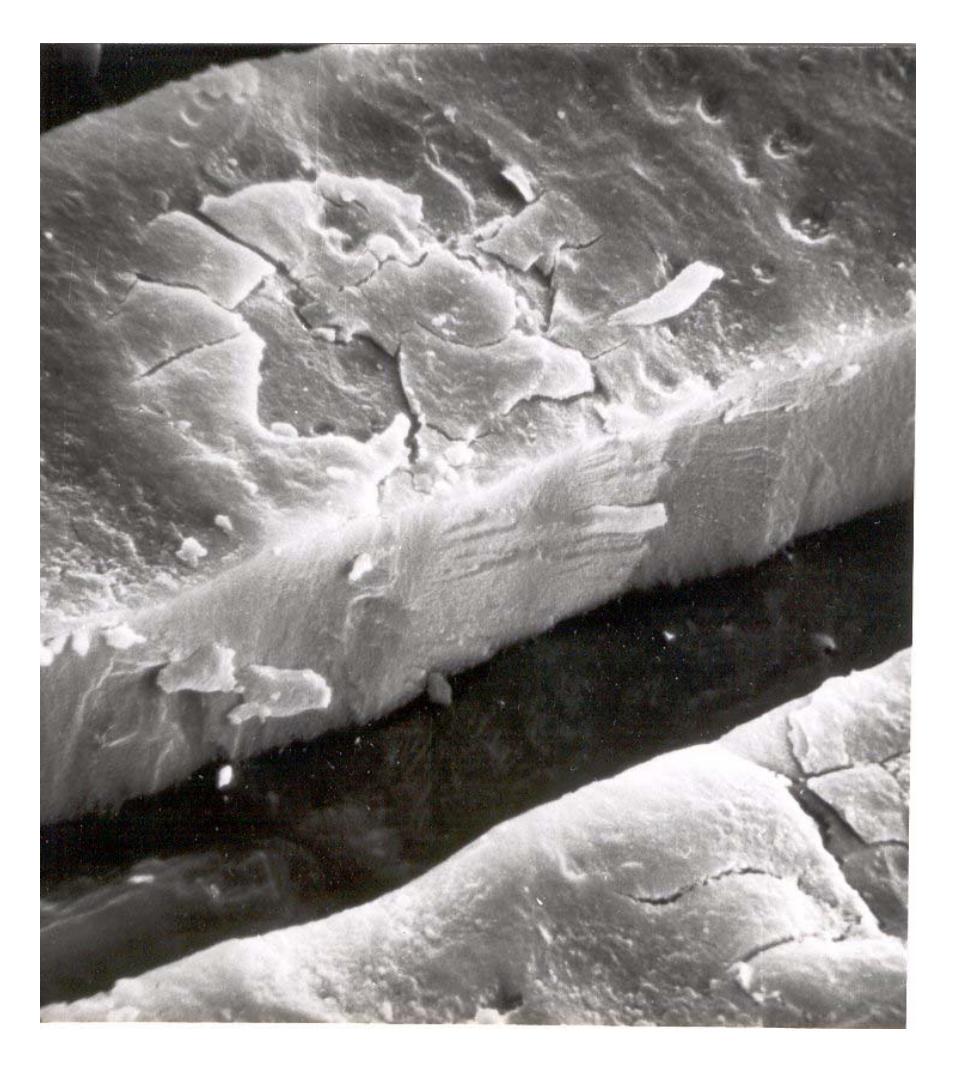
Figure 82. Detail of surface deposit on chalked anodic finish showing the powdery nature of the flaked surface.

Figure 81. Chalking of an anodic finish in service due to a soft anodic film.
